Project T01035 Lead in Soil Assessment  
Order Number T01035  
Samples 4

## Yarralumla Primary School & Preschool

24 Loftus St, Yarralumla

This Lead Paint Management Plan (LPMP) for Yarralumla Primary School and Preschool was commissioned by ACT Property Group based on lead paint surveys undertaken of the site on 23 April, 22 July and 27 August 2019 and a reinspection on 16 September 2019, after paint stabilisation was undertaken. The outcomes of this survey are presented in report *T01035 Yarralumla Primary School and Preschool Lead Paint Survey 20191015*.

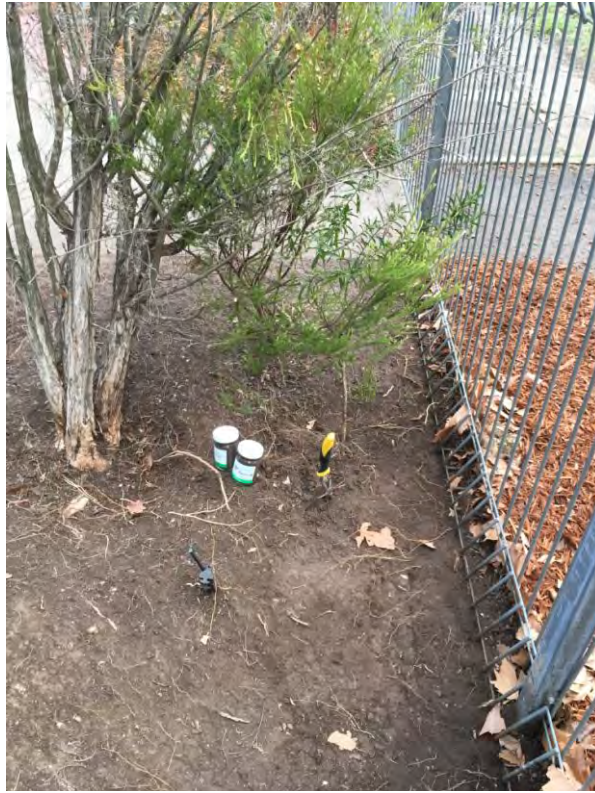
**Photograph 1**  
**Date:** 07/10/2019

Montessori north playground area soil samples.

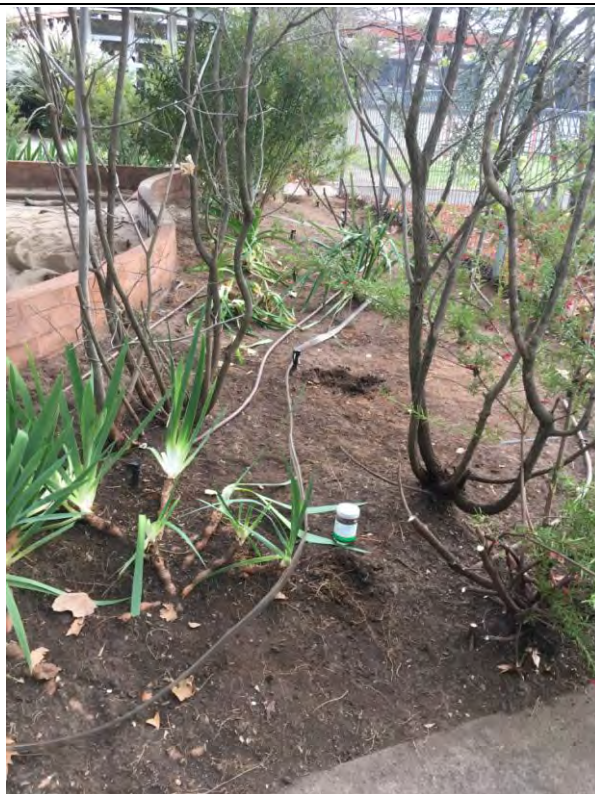
**Photograph 2**  
**Date:** 07/10/2019

Montessori north playground area soil sample.

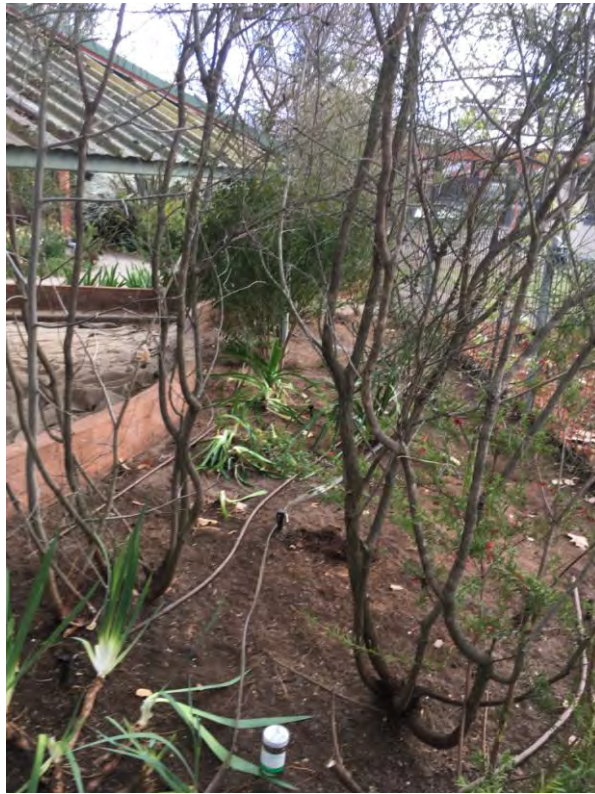
**Photograph 3**  
**Date:** 07/10/2019

Montessori north playground area soil sample.
