Lead Paint Assessment

T-01035 Yarralumla Primary & Preschool

Client: ACT Property Group

Survey Date: 23/04/2019

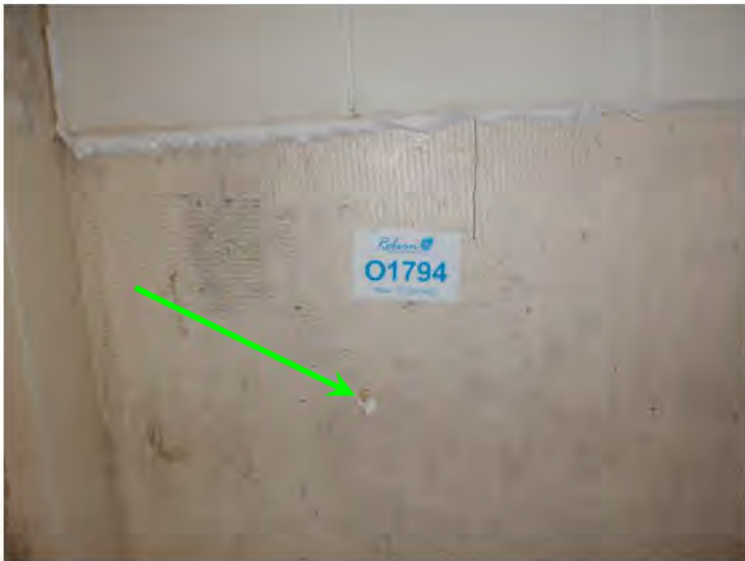
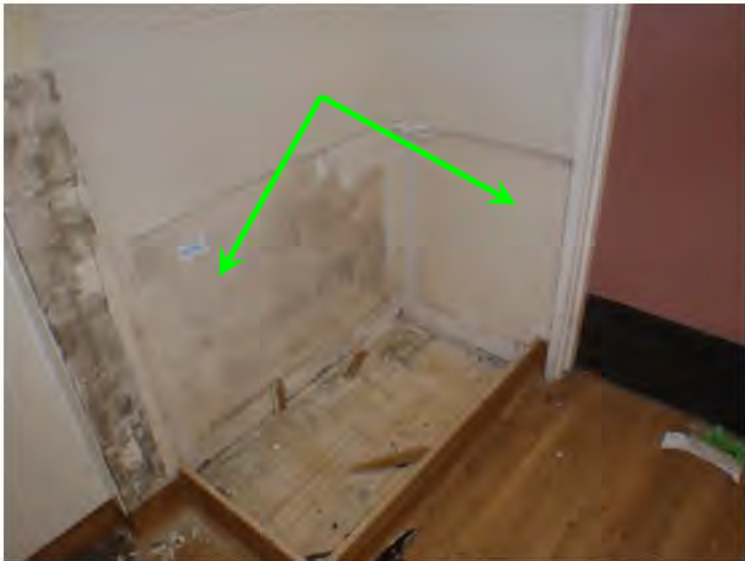
Sample Number	Location Description	Material	Photograph(s)
O1794	Kitchen area where cabinet had been removed	Wall sheet

O1794	Kitchen area where cabinet had been removed	Wall sheet

Sample No.	Client Ref.	Location	Physical Structure	Sample Description	Analysis of Fibrous Content
O1794		Kitchen area where cabinet had been removed	Wall sheet	<1g	No Asbestos Detected*

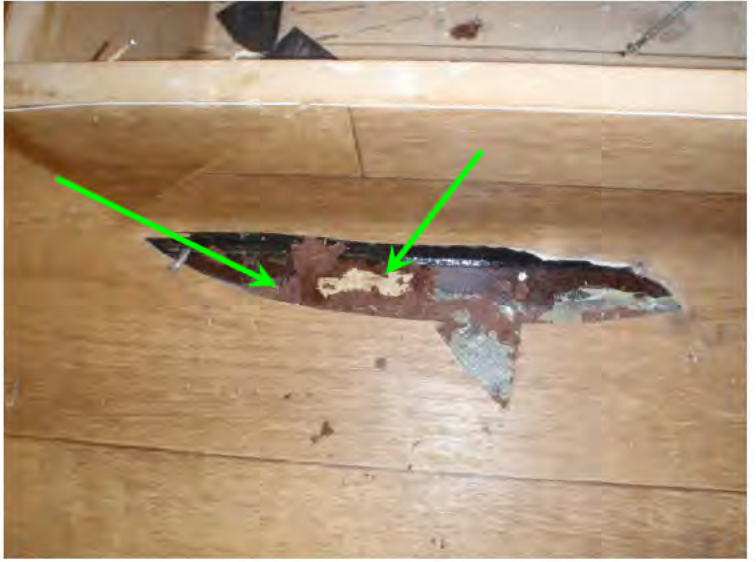
Sample Number	Location Description	Material	Photograph(s)
VA1	Kitchen flooring adjacent to where cabinets were removed	Masonite and timber floor boards

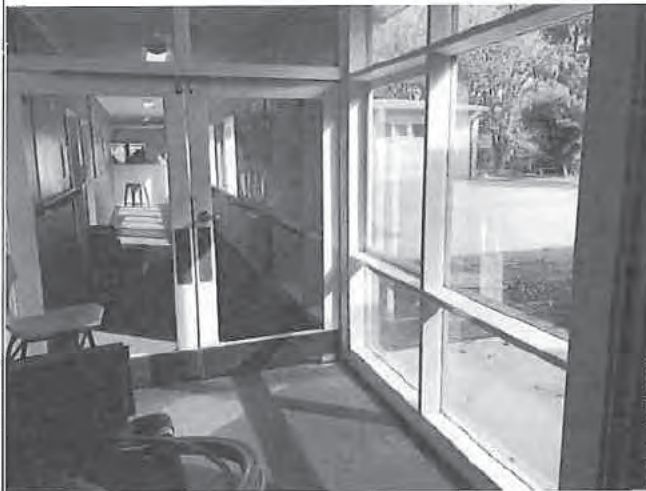
Sample ID	Sample Location	Paint Colour	Classified as Lead Paint?	Photograph(s)
Pb01	Yarralumla Primary School Main Building – Internal window frames, door frames and skirting boards throughout	White	Yes

Sample ID	Sample Location	Paint Colour	Classified as Lead Paint?	Percentage of Lead (%w/w)	Risk Rating	Recommendations
Pb01	Yarralumla Primary School Main Building – Internal window frames, door frames and skirting boards throughout	White	Yes	0.29	L	Ongoing preventative action should be planned. This includes: <ul style="list-style-type: none"> • Maintain the lead paint system in good condition. • Check it periodically to ensure a low exposure risk (i.e. no cracking, flaking, chalking or peeling observed and that it is not a friction or impact surface). • Review and update the risk rating appropriately.
Pb02	Yarralumla Primary School Main Building – Internal radiator heating pipes throughout	White	No	0.090	N	No action required.
Pb03	Yarralumla Primary School Main Building – Internal Cleaners'/Bathroom masonry walls	Grey	Yes	0.19	M	Action should be taken as soon as practicable to reduce exposure risk. This includes: <ul style="list-style-type: none"> • Remediate using method detailed in this report.

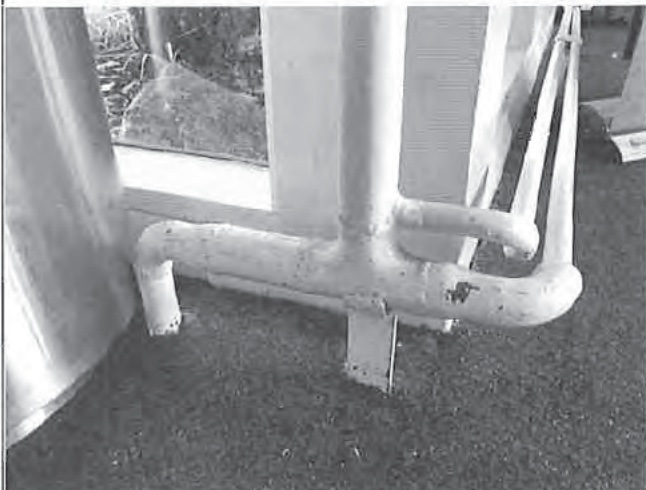
Pb02	Yarralumla Primary School Main Building – Internal radiator heating pipes throughout	White	No

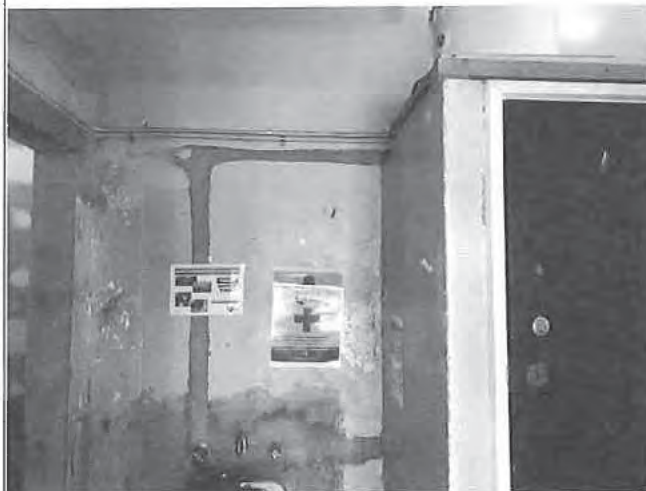
Sample ID	Sample Location	Paint Colour	Classified as Lead Paint?	Photograph(s)
Pb03	Yarralumla Primary School Main Building – Internal Cleaners’/Bathroom masonry walls	Grey	Yes

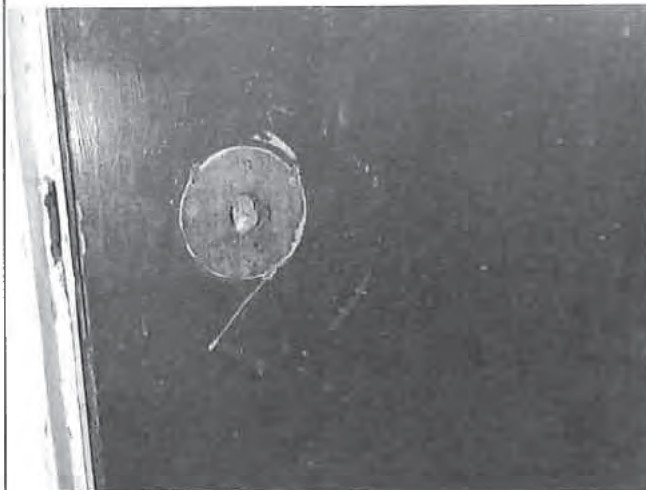
Pb04	Yarralumla Primary School Main Building –Internal Cleaners’/Bathroom walls	Dark Blue	Yes

Pb04	Yarralumla Primary School Main Building – Internal Cleaners'/Bathroom walls	Dark Blue	Yes	0.82	L	<p>Ongoing preventative action should be planned. This includes:</p> <ul style="list-style-type: none"> • Maintain the lead paint system in good condition. • Check it periodically to ensure a low exposure risk (i.e. no cracking, flaking, chalking or peeling observed and that it is not a friction or impact surface). • Review and update the risk rating appropriately.
Pb05	Yarralumla Primary School Main Building – Internal Cleaners'/Bathroom riser walls and pipes	Spearmint/Green	Yes	0.26	L	<p>Ongoing preventative action should be planned. This includes:</p> <ul style="list-style-type: none"> • Maintain the lead paint system in good condition. • Check it periodically to ensure a low exposure risk (i.e. no cracking, flaking, chalking or peeling observed and that it is not a friction or impact surface). • Review and update the risk rating appropriately.

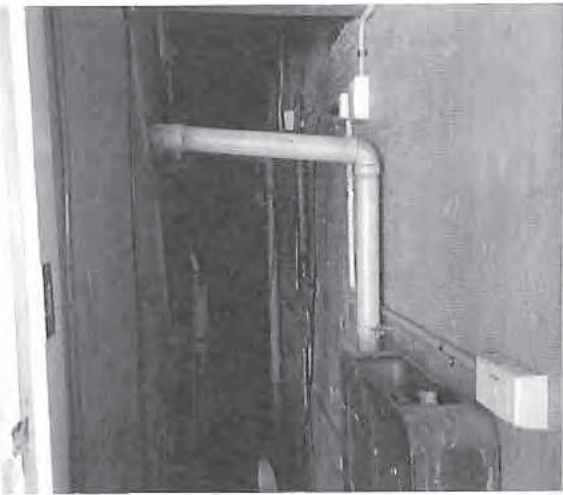
Sample ID	Sample Location	Paint Colour	Classified as Lead Paint?	Photograph(s)
Pb05	Yarralumla Primary School Main Building – Internal Cleaners’/Bathroom riser walls and pipes	Spearmint/Green	Yes

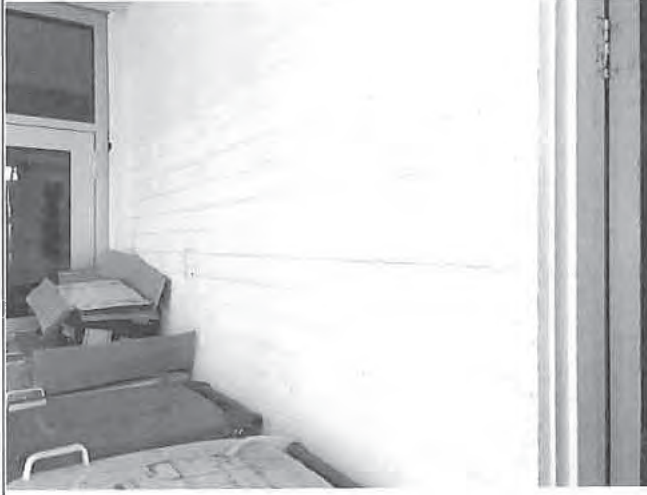
Pb06	Yarralumla Primary School Main Building – Internal brick walls throughout	White	No	<0.005	N	No action required.

Pb06	Yarralumla Primary School Main Building – Internal brick walls throughout	White	No

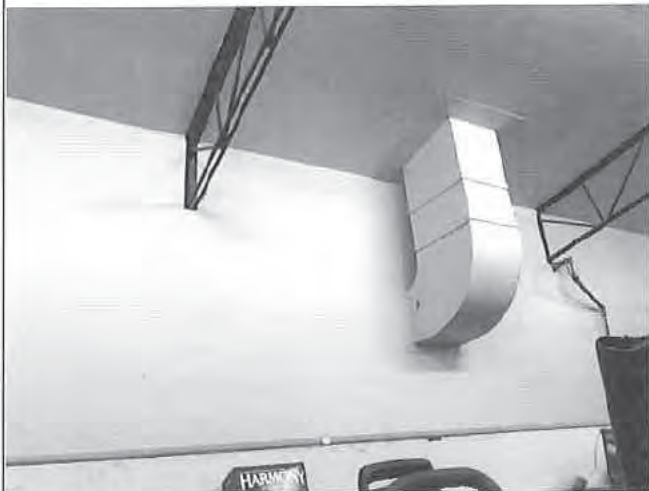
Sample ID	Sample Location	Paint Colour	Classified as Lead Paint?	Photograph(s)
Pb07	Yarralumla Primary School Main Building –Internal masonry walls throughout	Yellow	No

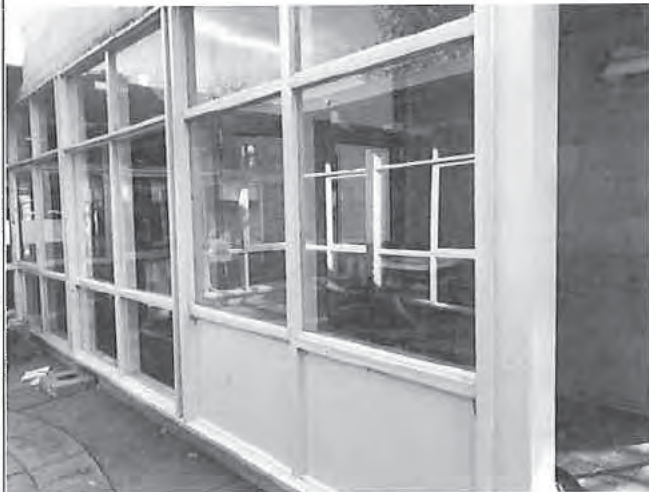
Pb08	Yarralumla Primary School Main Building – Exterior windows and infill panels	Green	Yes

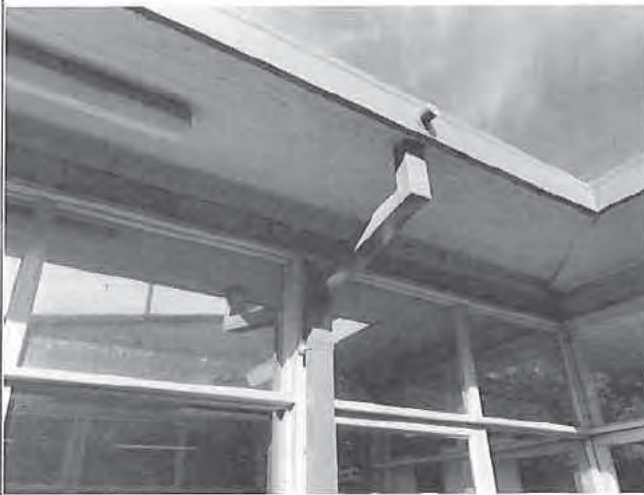
Sample ID	Sample Location	Paint Colour	Classified as Lead Paint?	Photograph(s)
Pb09	Yarralumla Primary School Main Building – Exterior down pipes and fascias	Grey	No

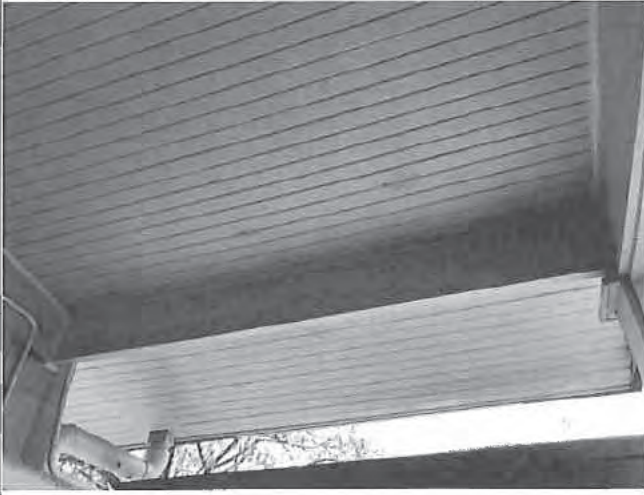
Pb10	Yarralumla Primary School Main Building – Exterior timber eaves	Grey	No

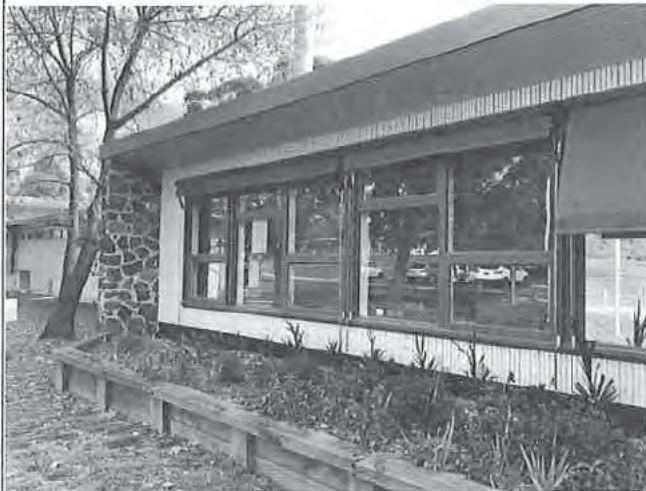
Sample ID	Sample Location	Paint Colour	Classified as Lead Paint?	Photograph(s)
Pb11	Yarralumla Primary School Main Building – External window frames and doors	Grey	No

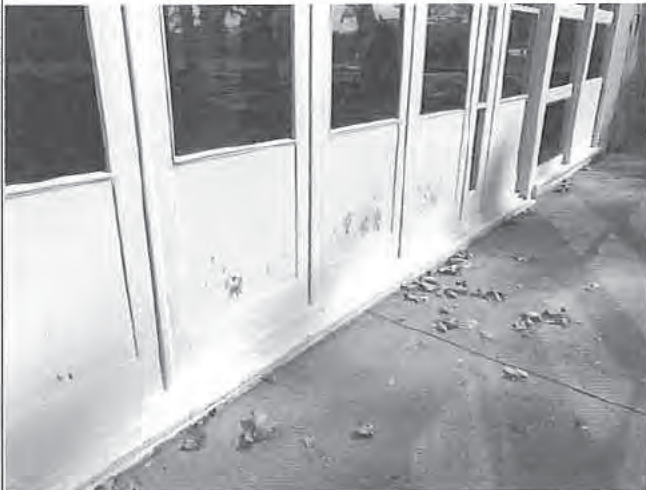
Pb12	Yarralumla Gambarri and Preschool – Exterior window frames and doors	White	Yes

Pb12	Yarralumla Gambarri and Preschool – Exterior window frames and doors	White	Yes	0.13	H	Action should be taken immediately to reduce exposure risk. This includes: <ul style="list-style-type: none"> Remediate using method detailed in this report.
Pb13	Yarralumla Primary School After School Care – Exterior window frames and eaves	White	Yes	0.28	H	Action should be taken immediately to reduce exposure risk. This includes: <ul style="list-style-type: none"> Remediate using method detailed in this report.
Pb14	Yarralumla Preschool – Internal roof support beam	Yellow	No	<0.005	N	No action required.
Pb15	Yarralumla Preschool – Internal and external window frames, pergola frame and doors	Grey	No	<0.005	N	No action required.

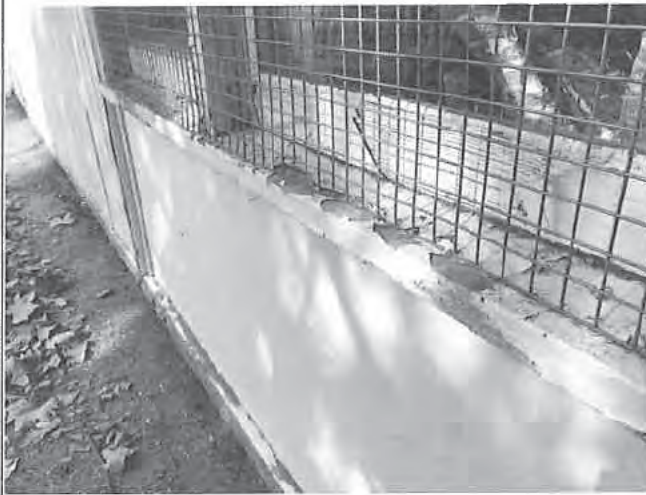
Sample ID	Sample Location	Paint Colour	Classified as Lead Paint?	Photograph(s)
Pb13	Yarralumla Primary School After School Care – Exterior window frames and eaves	White	Yes

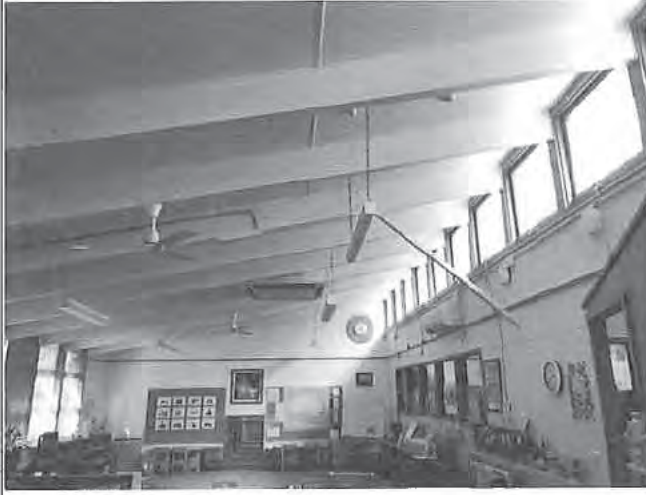
Pb14	Yarralumla Preschool – Internal roof support beam	Yellow	No

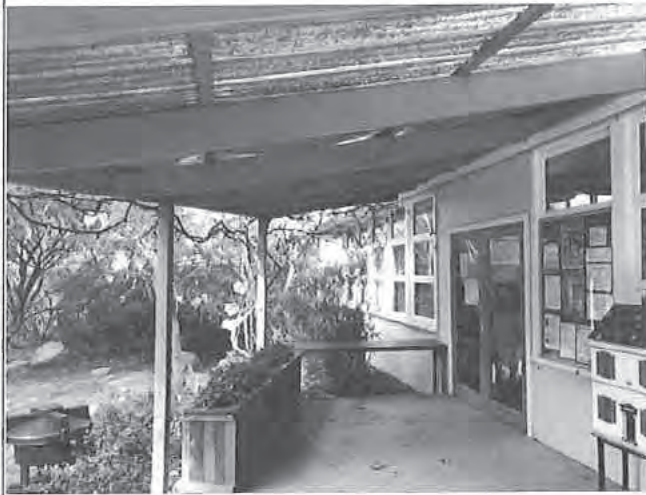
Sample ID	Sample Location	Paint Colour	Classified as Lead Paint?	Photograph(s)
Pb15	Yarralumla Preschool – Internal and external window frames, pergola frame and doors	Grey	No
