Lead Paint Clearance

(Visual Inspection Only)

Yarralumla Primary School 21 July, 2019

Document Name	Lead Paint Clearance – Gambarri Preschool Yarralumla Primary School		
Date of Issue	18 August 2019	Job Number	T-01035
Client	ACT Property Group		
Site Sampling and Report Preparation

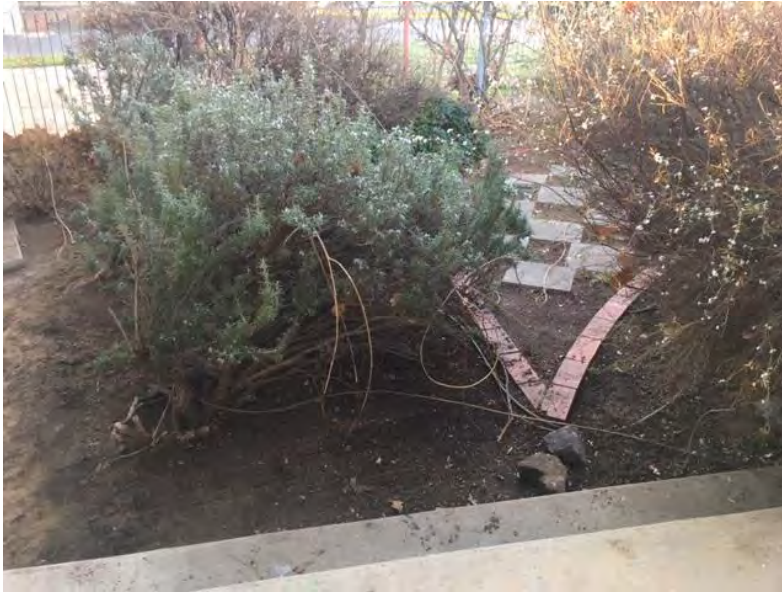
Figure 1: Ground surfaces after removal of leaf litter and lead paint fragments

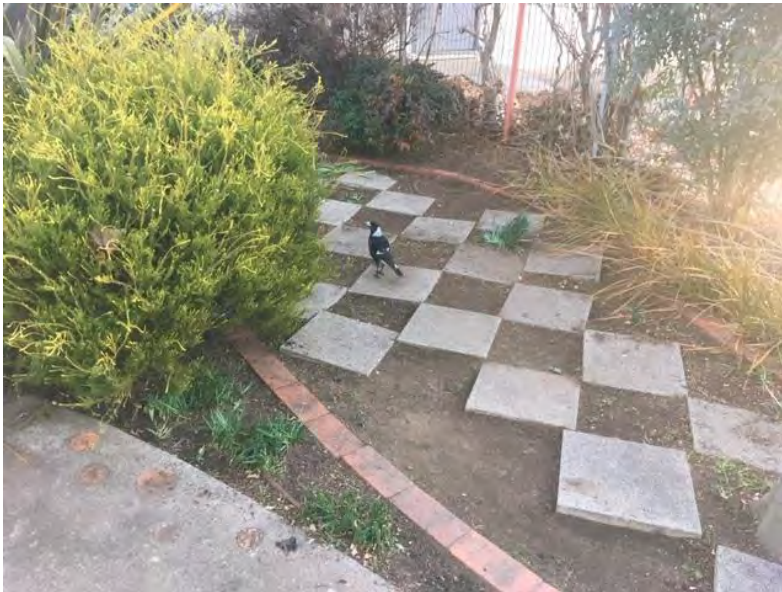
Figure 2: Ground surfaces after removal of leaf litter and lead paint fragments

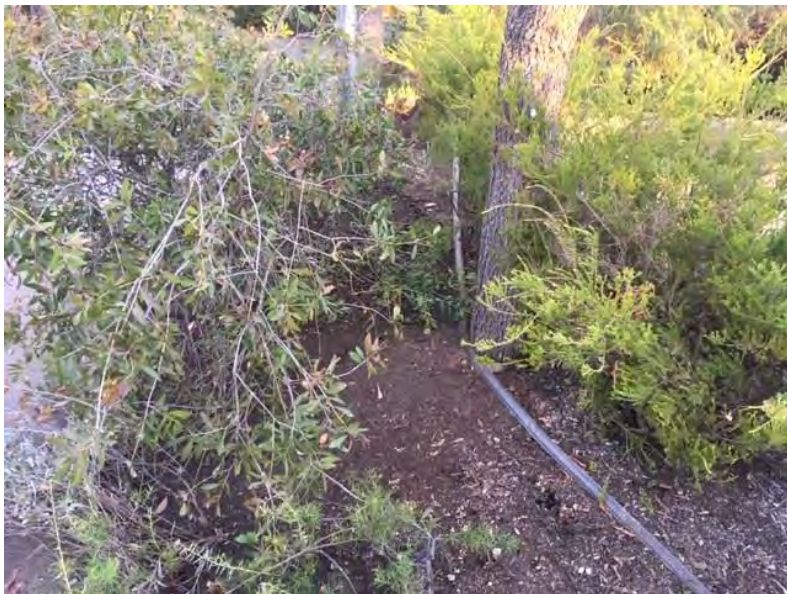
Figure 3: Ground surfaces after removal of leaf litter and lead paint fragments

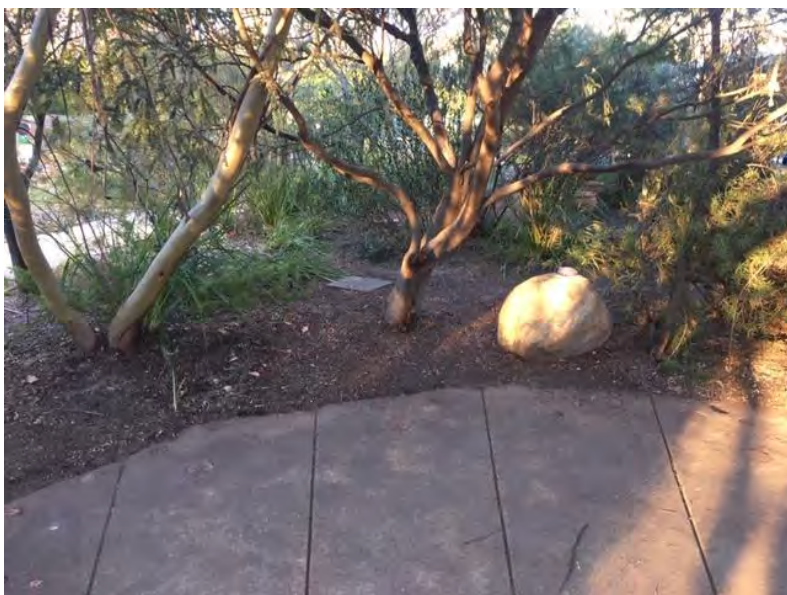
Figure 4: Ground surfaces after removal of leaf litter and lead paint fragments

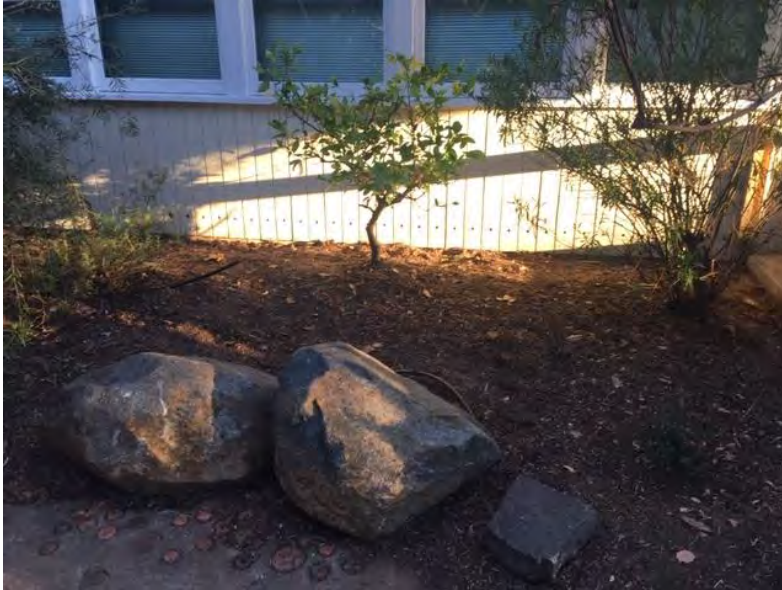
Figure 5: Ground surfaces after removal of leaf litter and lead paint fragments

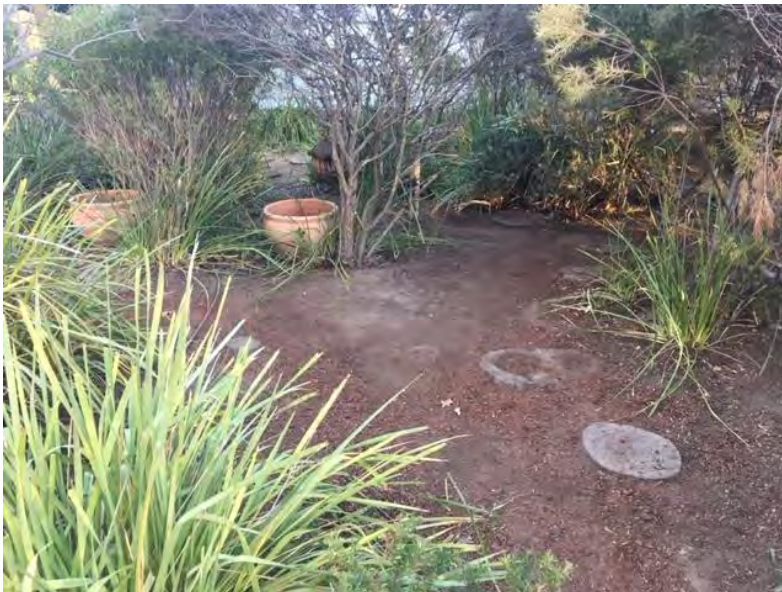
Figure 6: Ground surfaces after removal of leaf litter and lead paint fragments

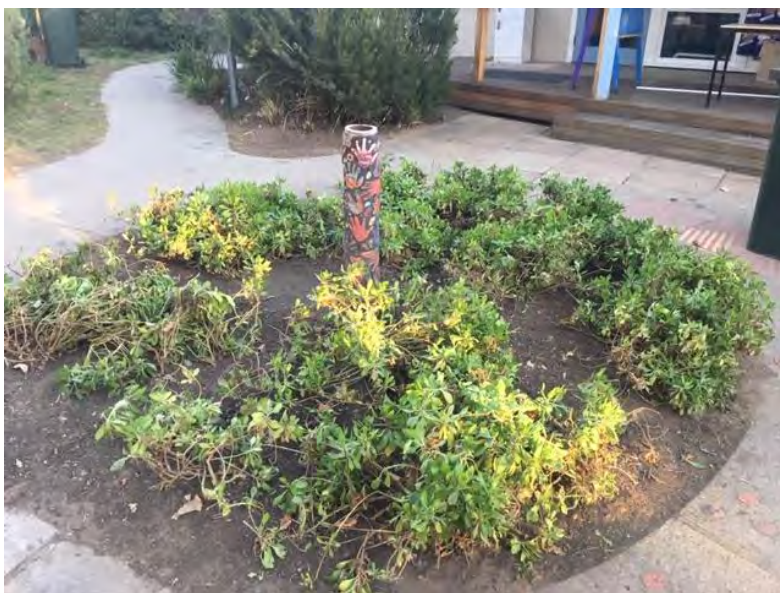
Figure 7: Ground surfaces after removal of leaf litter and lead paint fragments

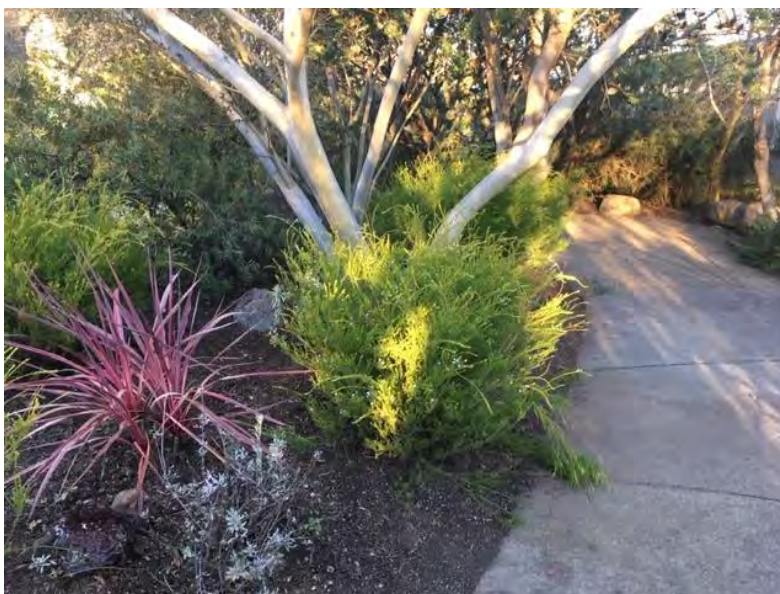
Figure 8: Ground surfaces after removal of leaf litter and lead paint fragments

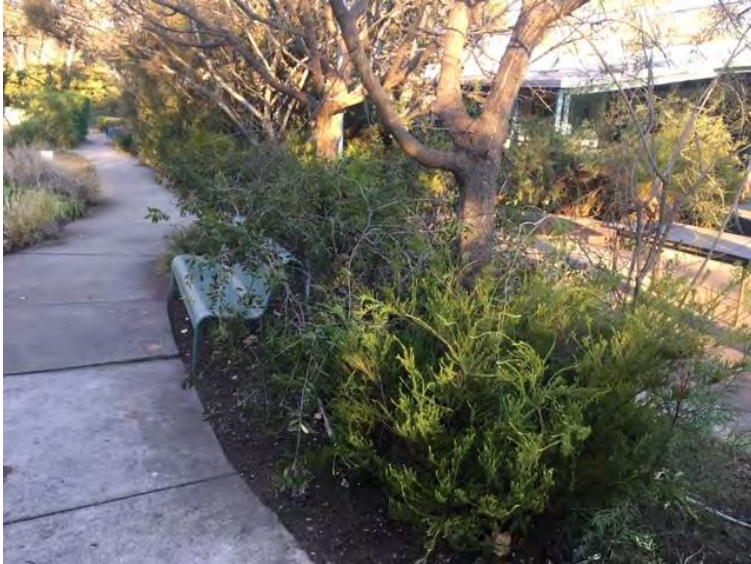
Figure 9: Ground surfaces after removal of leaf litter and lead paint fragments

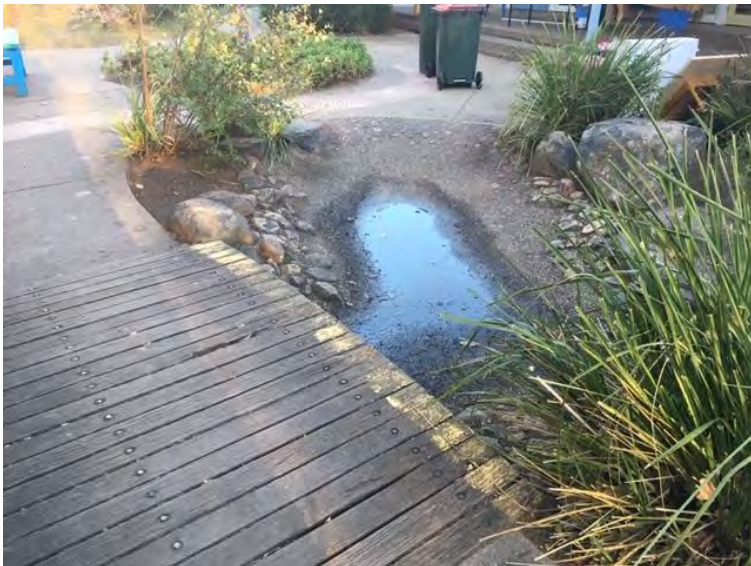
Figure 10: Ground surfaces after removal of leaf litter and lead paint fragments

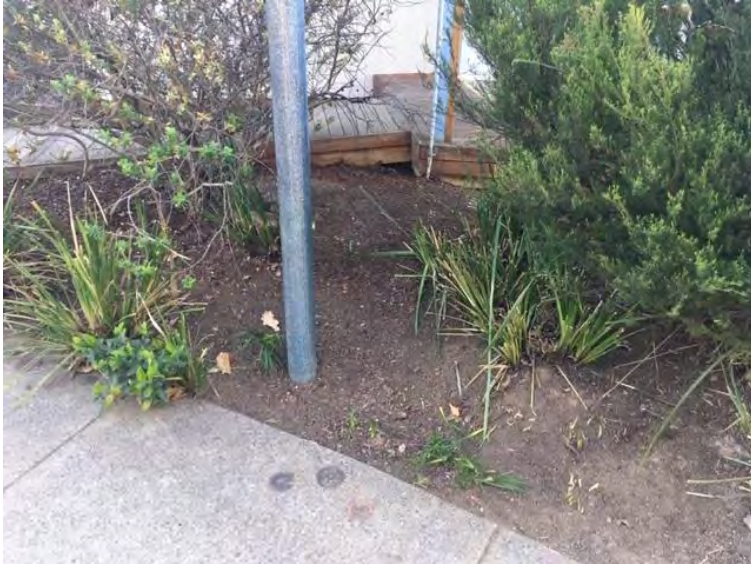
Figure 11: Ground surfaces after removal of leaf litter and lead paint fragments

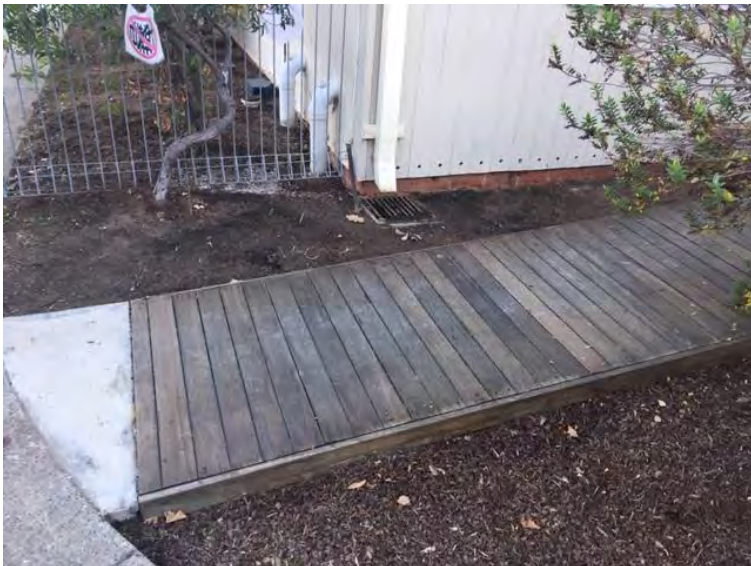
Figure 12: Ground surfaces after removal of leaf litter and lead paint fragments

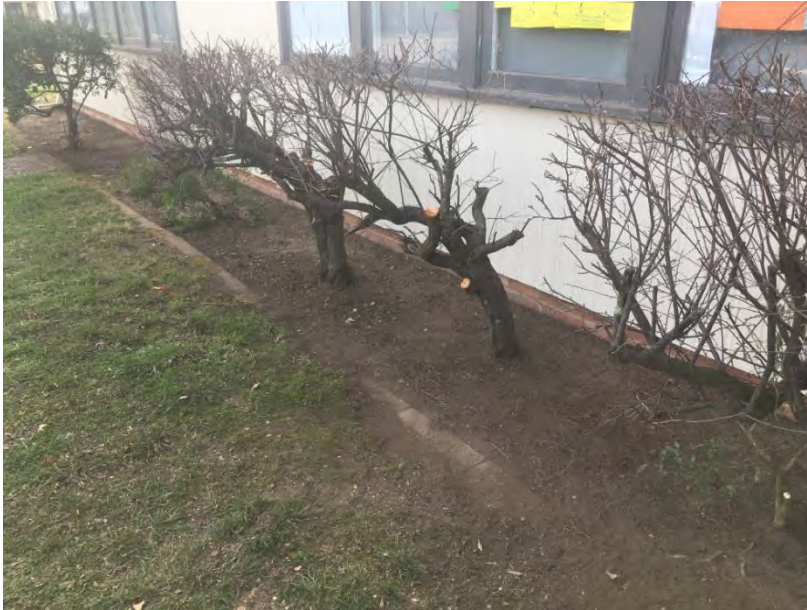
Figure 1: Location of garden bed along Gambarri centre SW corner where remediation works were undertaken

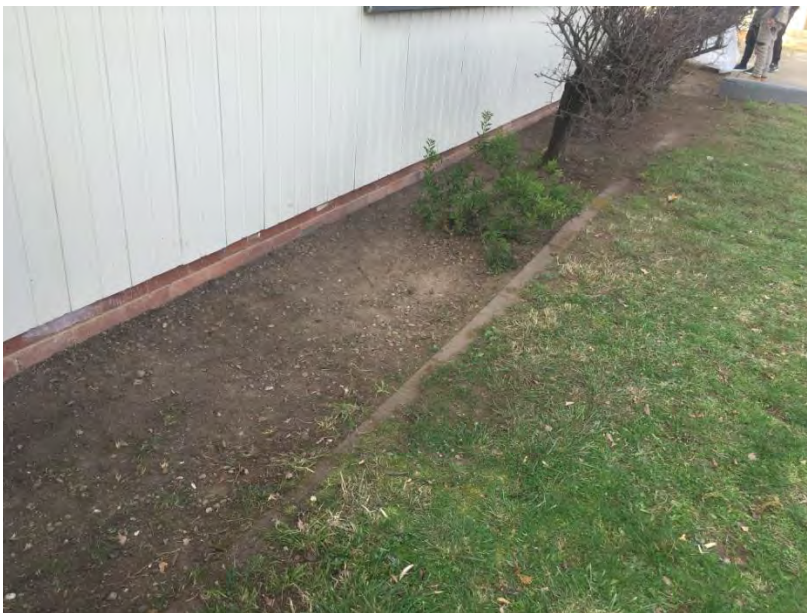
Figure 2: Ground surface after remediation works at garden bed along Gambarri centre SW corner

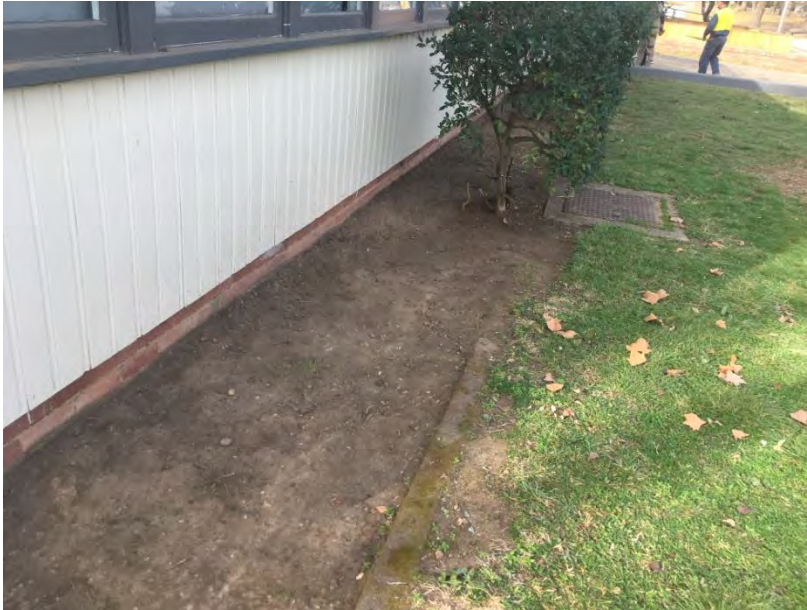
Figure 3: Ground surface after remediation works at garden bed along Gambarri centre SW corner

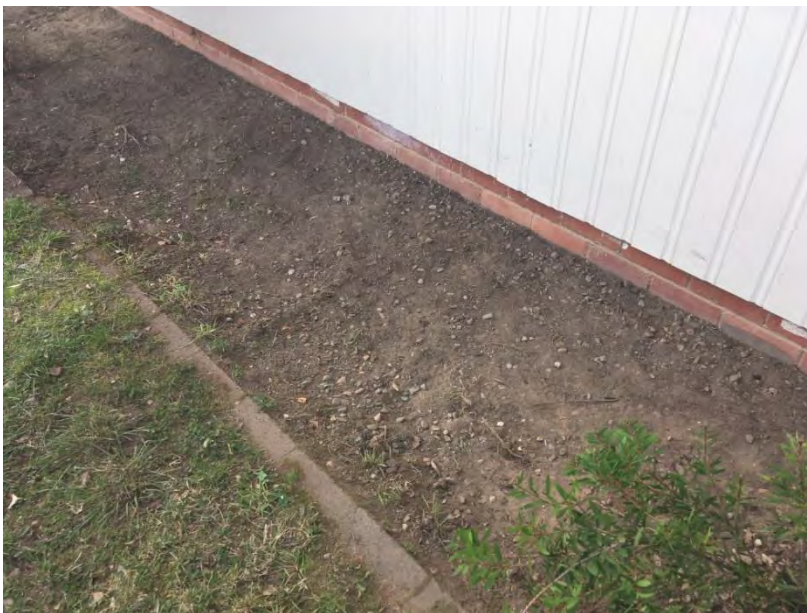
Figure 4: Ground surface after remediation works at garden bed along Gambarri centre SW corner

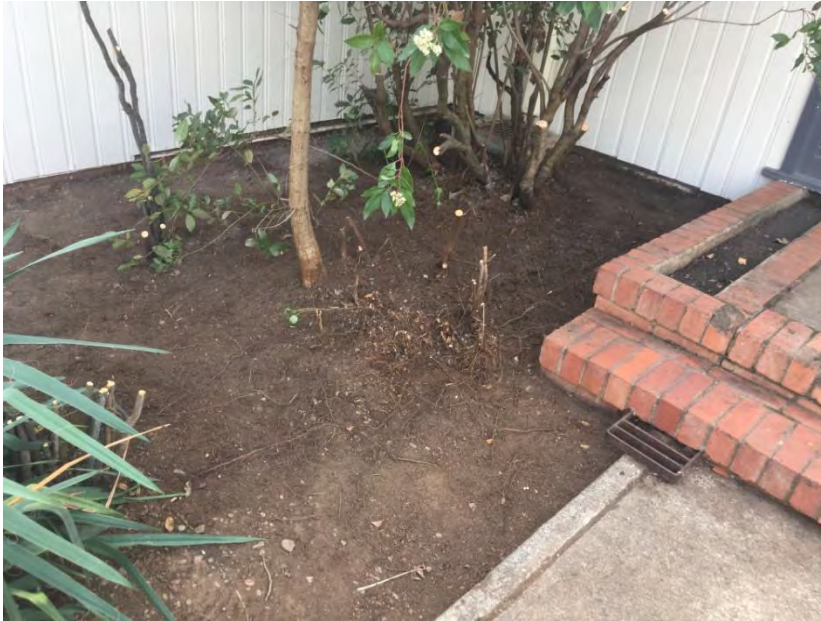
Figure 5: Ground surface after remediation works at garden bed along Gambarri centre SW corner

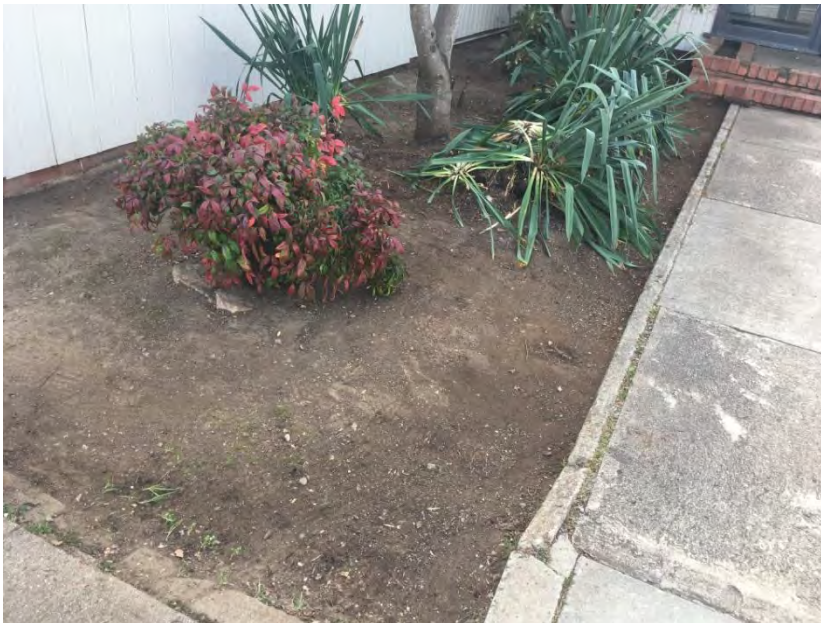
Figure 6: Ground surface after remediation works at garden bed along Gambarri centre SW corner

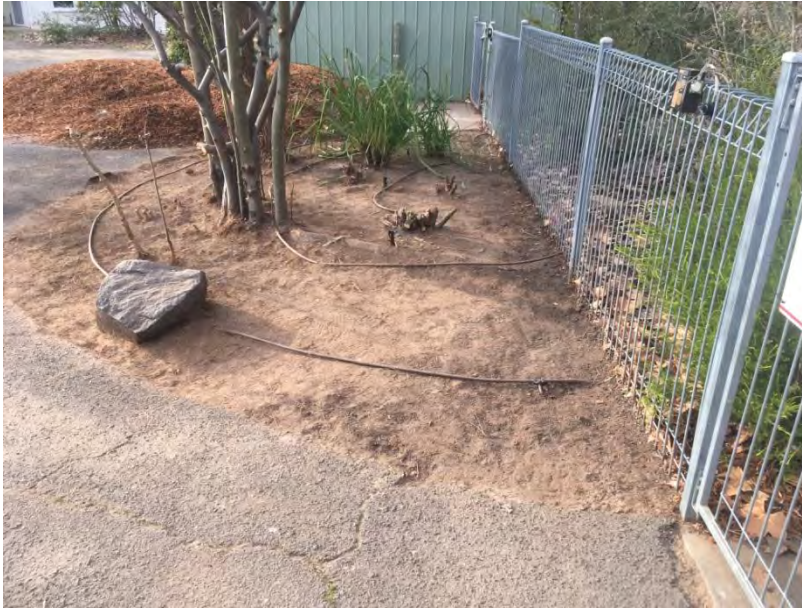
Figure 7: Location of garden bed along Gambarri centre west side where remediation works were undertaken

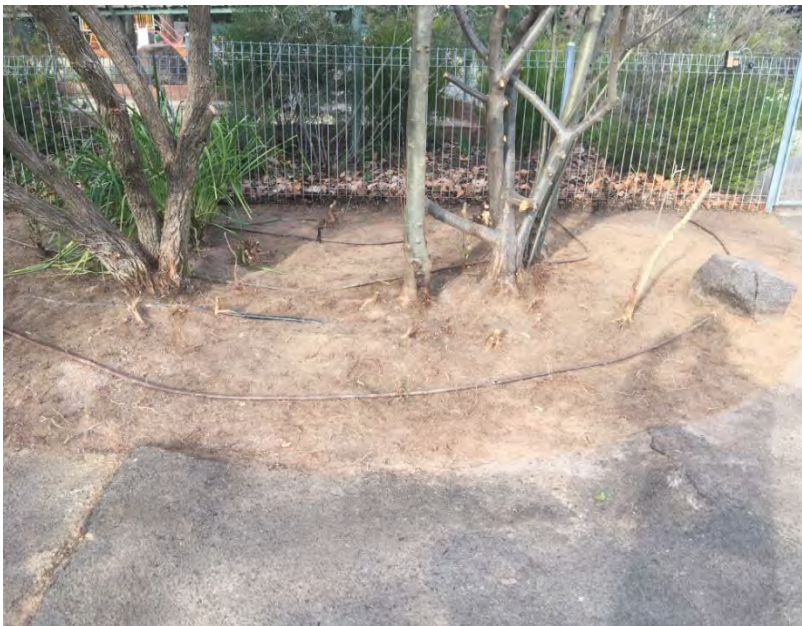
Figure 8: Ground surface after remediation works at garden bed along Gambarri centre West side

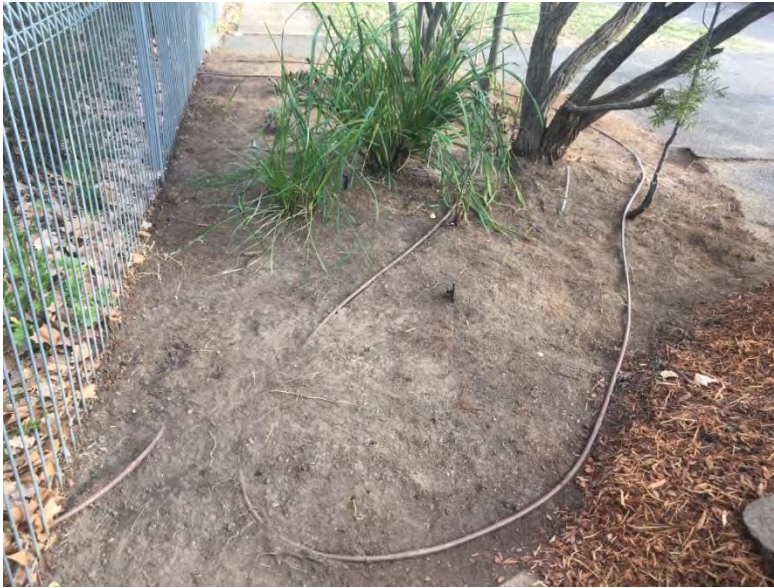
Figure 9: Ground surface after remediation works at garden bed along Gambarri centre West side

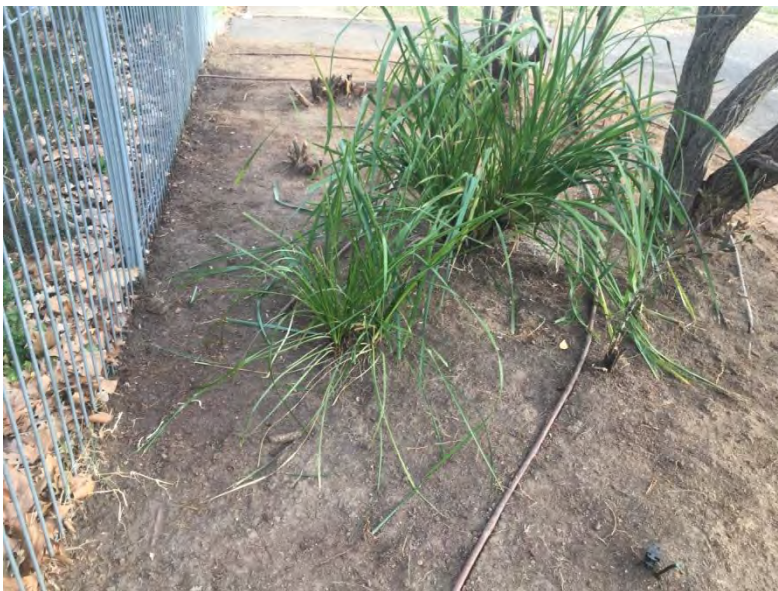
Figure 10: Ground surface after remediation works at garden bed along Gambarri centre West side

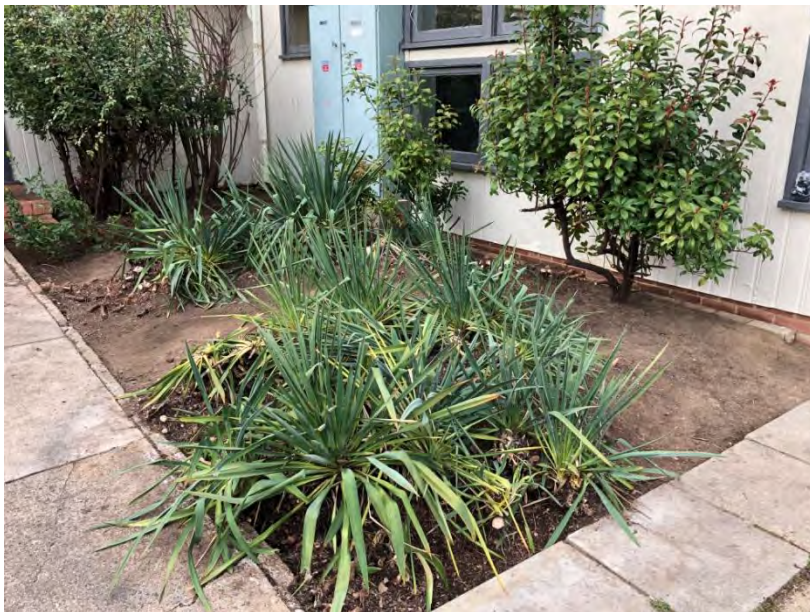
Figure 1: Location of garden bed south east of Gambarri Centre entrance where the remediation works was undertaken

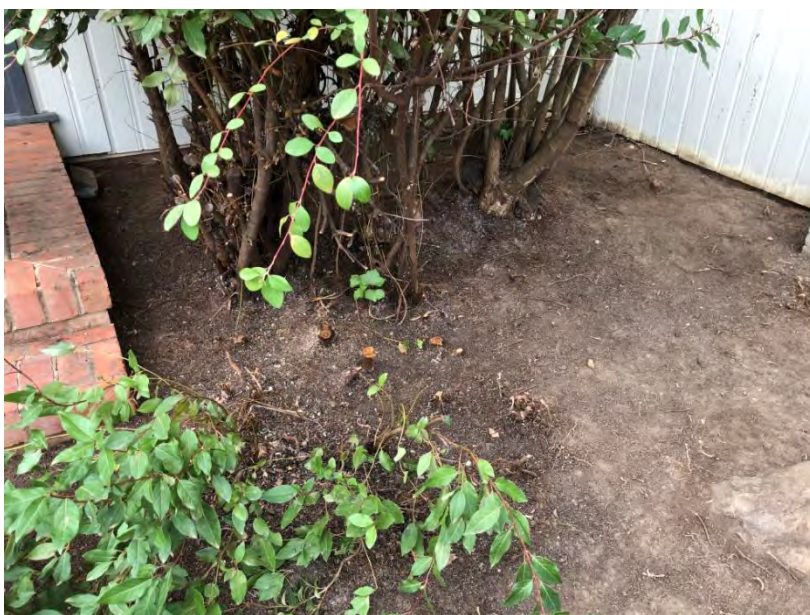
Figure 2: Ground surface after the remediation works in garden bed south east of Gambarri Centre entrance where the remediation works was undertaken

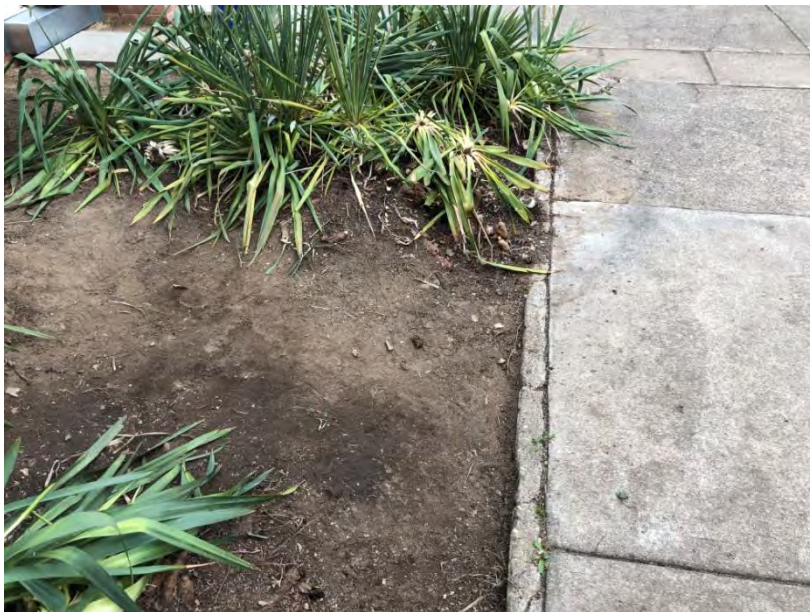
Figure 3: Ground surface after the remediation works in garden bed south east of Gambarri Centre entrance where the remediation works was undertaken

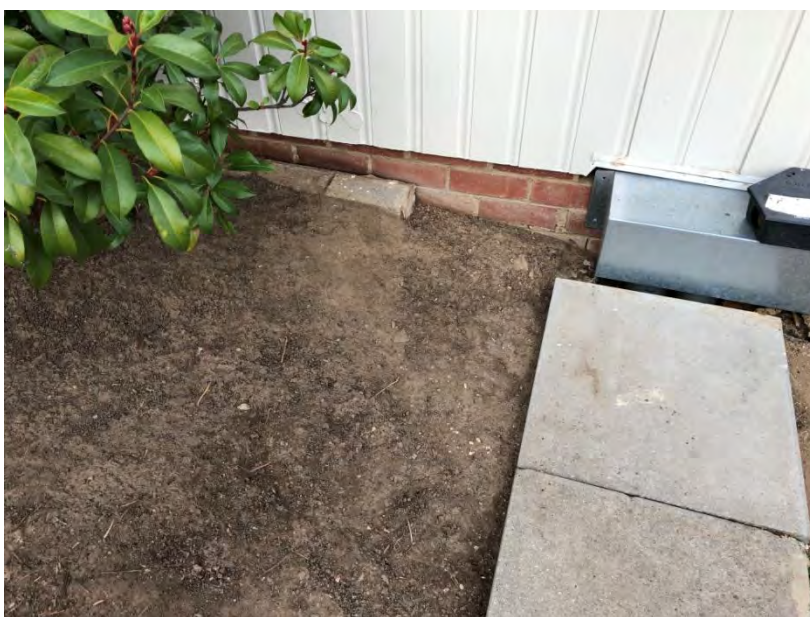
Figure 4: Ground surface after the remediation works in garden bed south east of Gambarri Centre entrance where the remediation works was undertaken

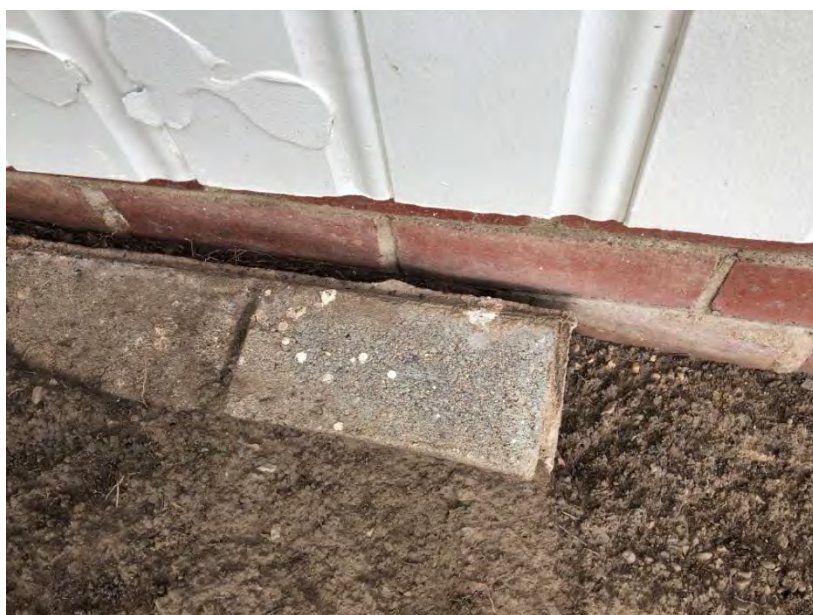
Figure 5: Ground surface after the remediation works in garden bed south east of Gambarri Centre entrance where the remediation works was undertaken

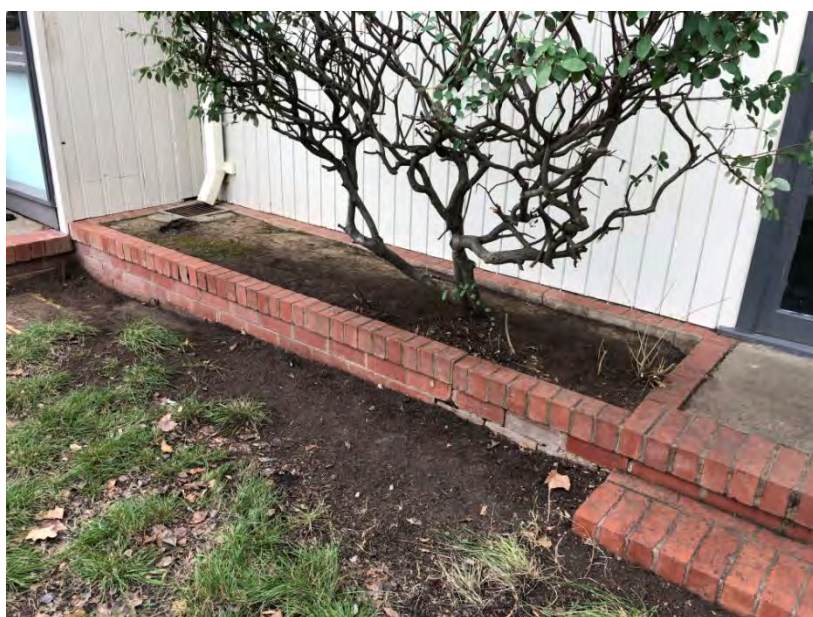
Figure 6: Location of garden bed south east of Gambarri Centre Music Room where the remediation works was undertaken

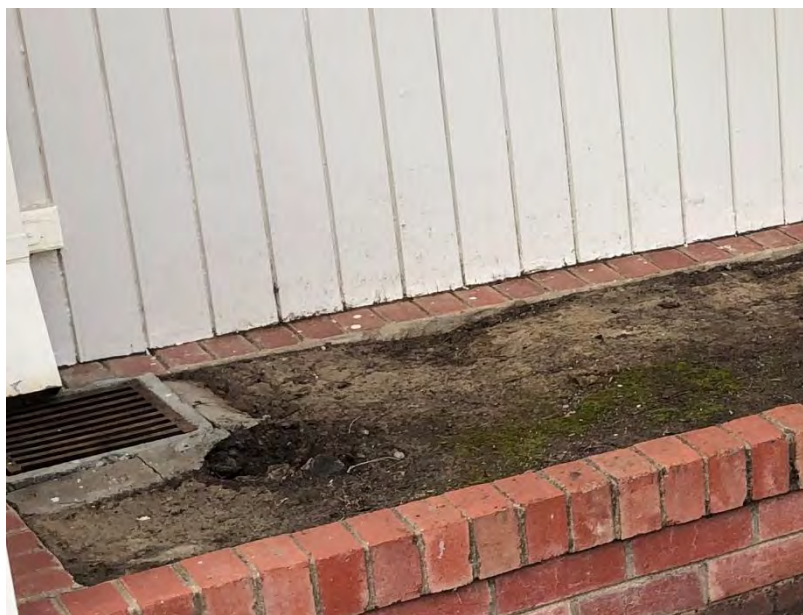
Figure 7: Ground surface after the remediation works in garden bed south east of Gambarri Centre Music Room where the remediation works was undertaken
