Re: Asbestos analysis and Risk Assessment of pipe lagging insulation to hot water pipes in the sub floor of the Gambarri Centre and Montessori Building during [REDACTED] between the staff room and classroom 16 at Yarralumla Primary School on the 8th of May 2018.

ASBESTOS CLEARANCE CERTIFICATE INSPECTION PASS

Project/Location: Yarralumla Primary School, Loftus Street, Yarralumla, ACT, 2600

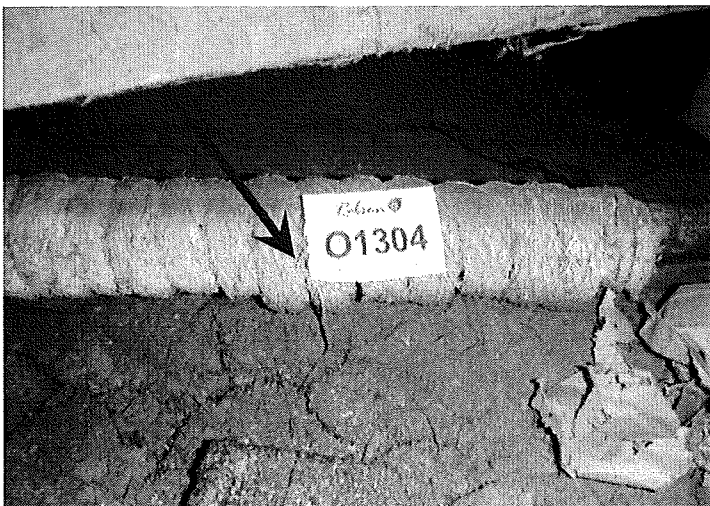
The pipe lagging insulation sampled from the hot water pipe in the sub floor of the Gambarri Centre and Montessori Building was found to contain chrysotile asbestos.

SAMPLE NO	LOCATION DESCRIPTION	MATERIAL	PHOTOGRAPH
O1303	Sub floor below corridor between staff room and classroom 16	Pipe lagging (fibrous)

It is recommended that the friable asbestos pipe lagging to the hot water pipes be removed by licensed Class A Asbestos Removalist as soon as possible. In addition the loose soil below the asbestos lagged pipes should be removed back to a hard packed surface. As a minimum the asbestos pipe lagging to the hot water pipes should be removed from at least two meters beyond where the termite damage to the timber floor has occurred so as to facilitate the repair works and investigation of the termite damage. This will allow the pest control contractor safe access to complete the above mentioned repair works. Consideration should be given to remove all of the asbestos lagging to the pipes in this area. All of the asbestos removal works must be carried out under friable asbestos removal conditions. Air monitoring must be carried out during all friable asbestos removal works. It is presumed that the asbestos pipe lagging to the hot water pipes in sub floor continues as a minimum along the full length of the building.

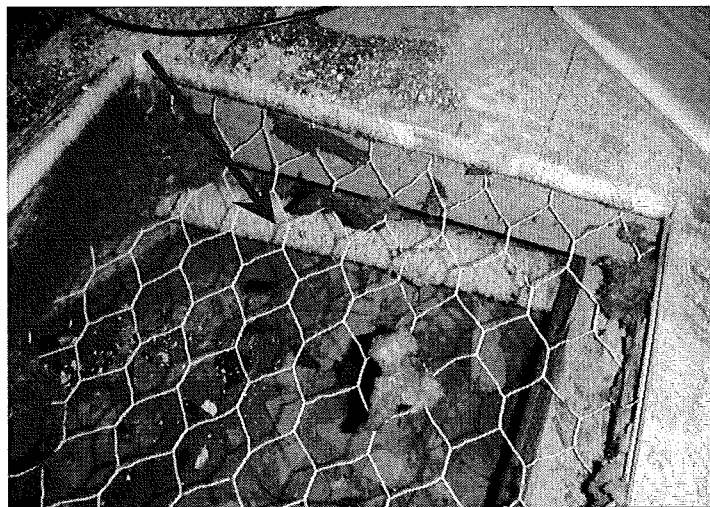
O1303	Sub floor below corridor between staff room and classroom 16	Pipe lagging (fibrous)

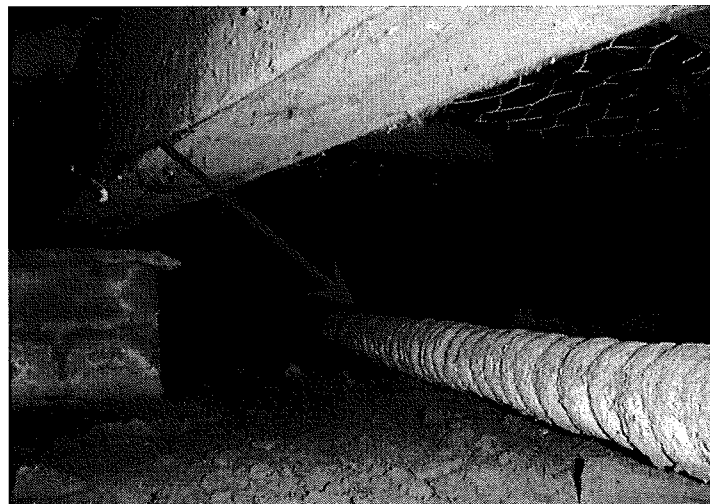
O1303	Sub floor below corridor between staff room and classroom 16	Pipe lagging (fibrous)

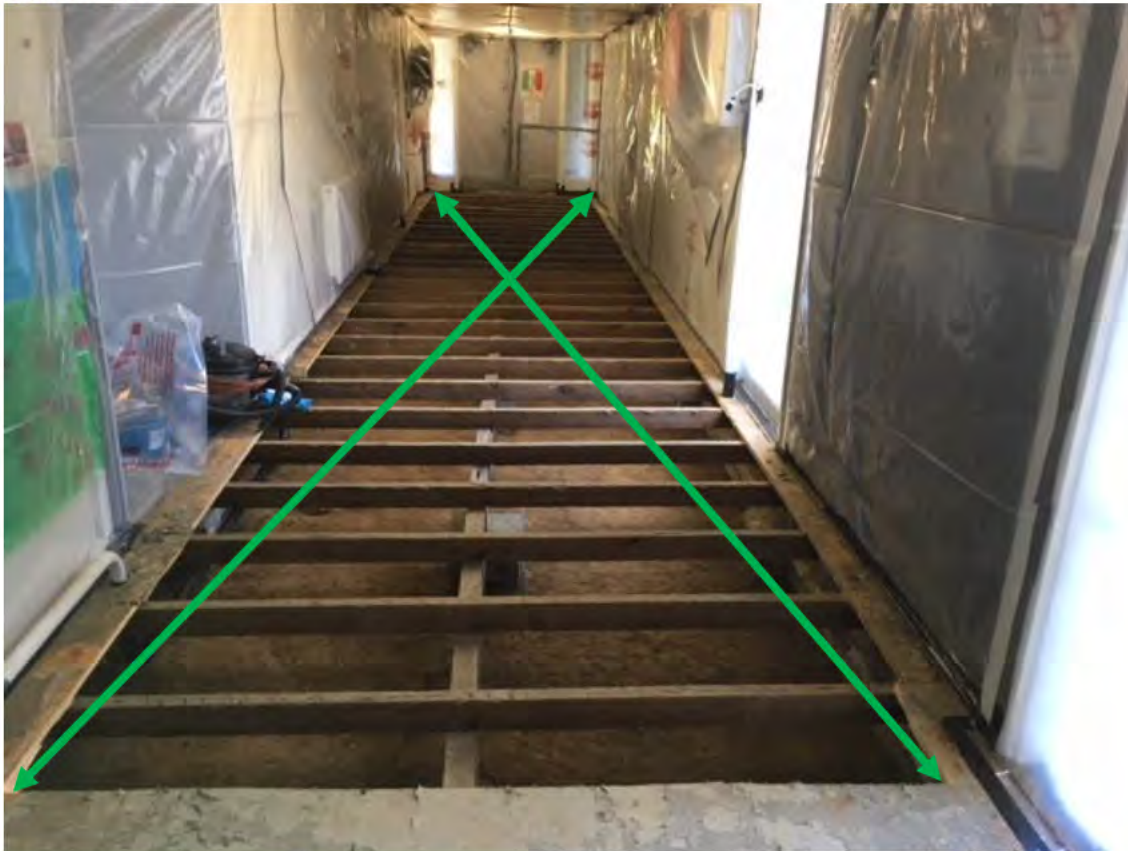
The inspection found no visible asbestos residue from the asbestos work in the area or in the vicinity of the area where the work was carried out.

Area of works

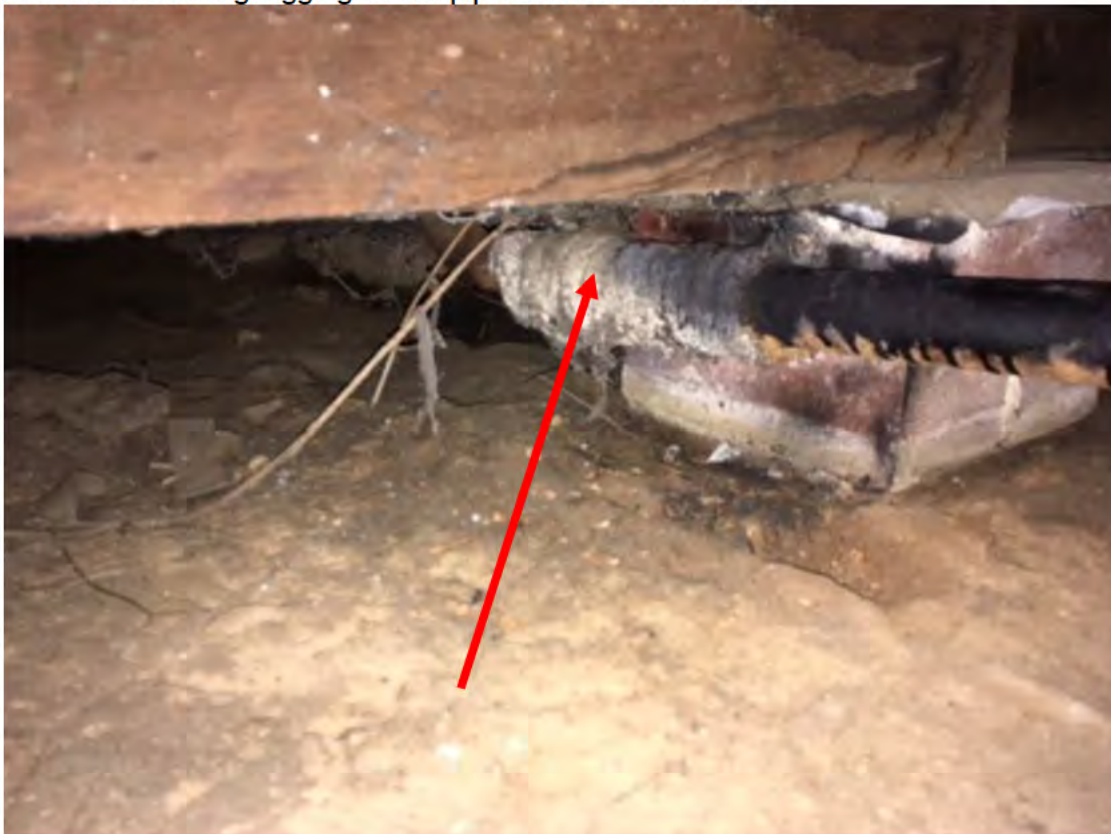
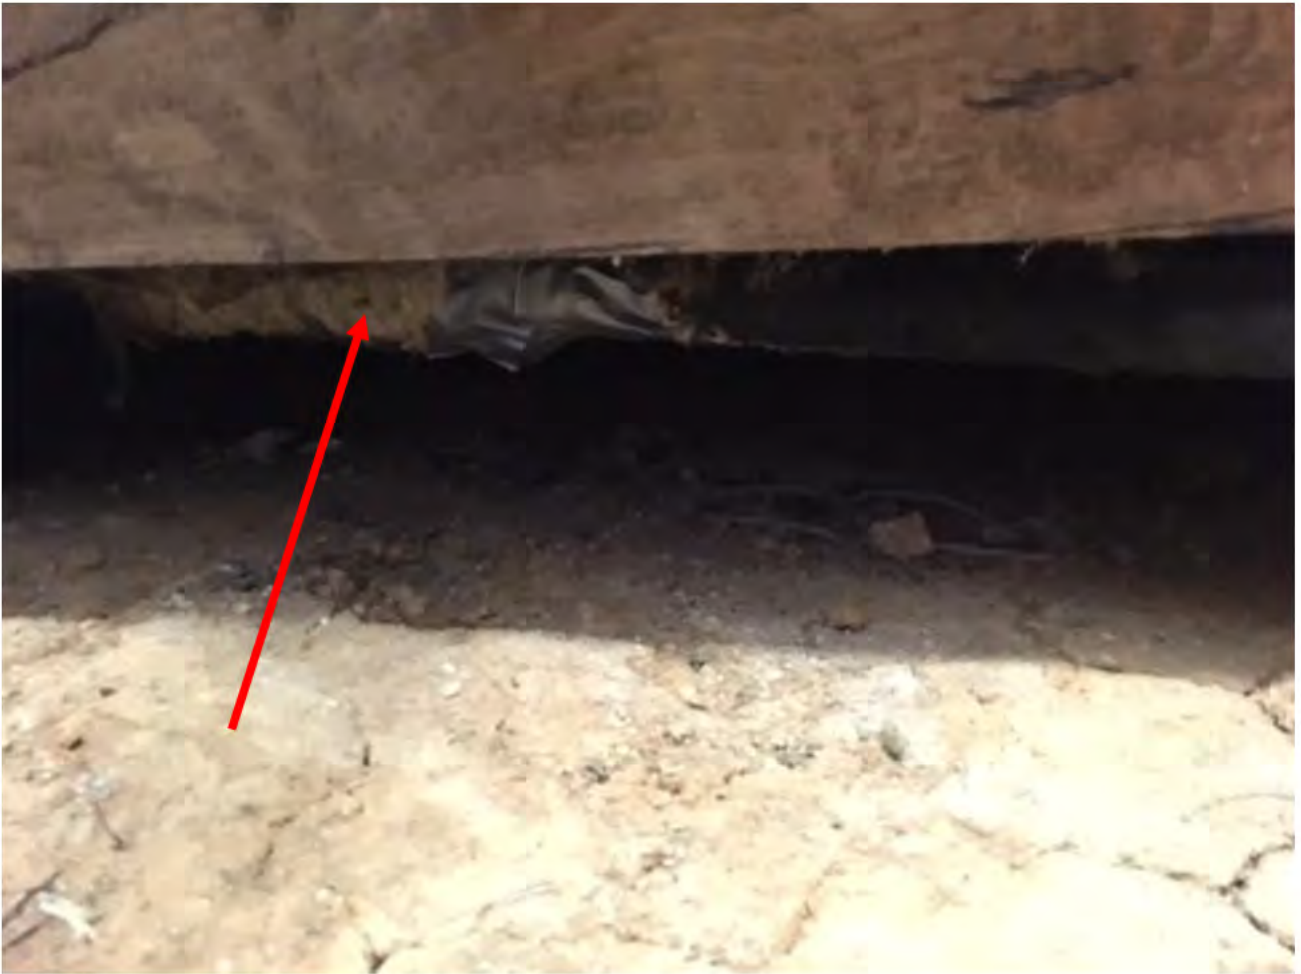
Note: lagging was only removed as far as practicable. Lagging is still present where the pipes leave the removal area. These areas have been sealed with black paint, as have the remaining cleaned hot water pipes. Great care must be taken not to disturb remaining lagging. If works are to be conducted in this area (such as reflooring) by persons other than licensed Asbestos Assessors and Removalists they must be supervised and directed by a licensed Asbestos Assessor. It must be assumed that lagged pipes are present throughout all voids in the building.

Areas of remaining lagging where pipes leave removal area

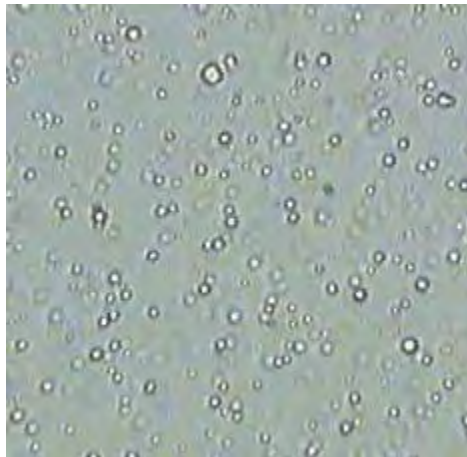
Please note that sample number 7335471-054 was too dirty to read/analyse (TDR). It was located adjacent to the entry/exit of the removal area. Although the door was closed during PVA spraying, the licensed asbestos removalists used this doorway to enter/exit the removal area so very fine PVA glue aerosol droplets were sucked into the sample head and attached to the sample filter.

Example of PVA droplets on sample filter

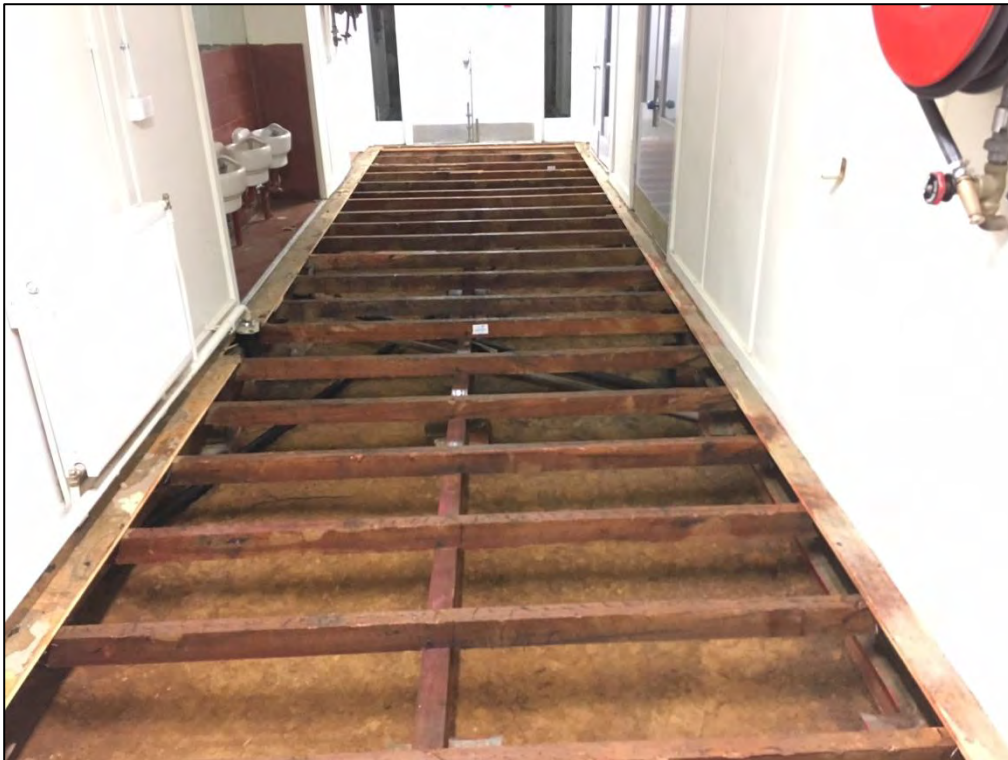
Looking East at removal area after pink PVA glue spraying

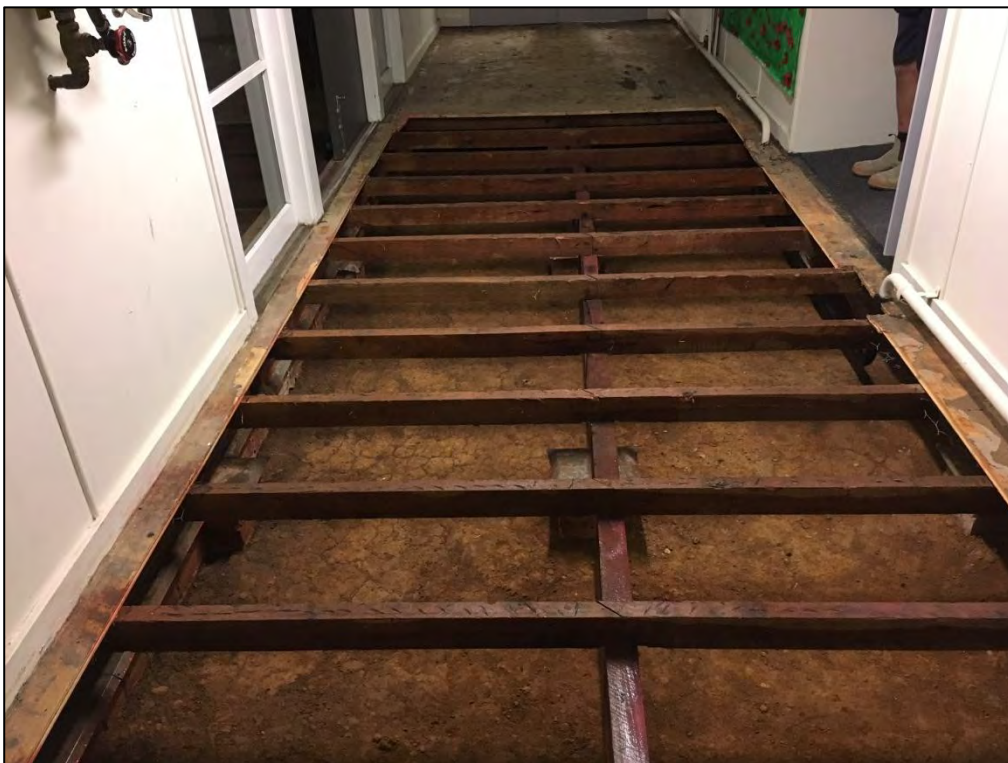
Looking West at removal area after pink PVA glue spraying

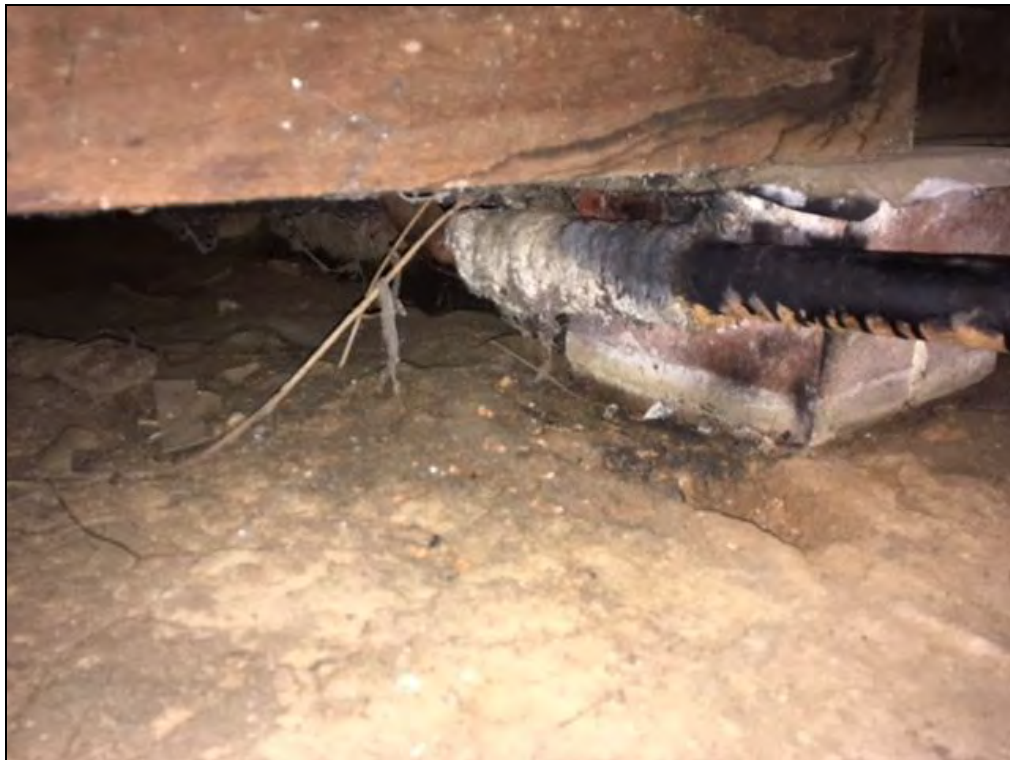
Visible lagging after black painting and before pink PVA glue spraying

Note: Lagging is still present where the pipes leave the removal area. These have been sealed with black paint and pink PVA glue. Care must be taken not to disturb remaining lagging. If works are to be conducted in this area (such as termite inspections or re-flooring) by persons other than licensed Asbestos Removalists, it is recommended that they be briefed by a licensed Asbestos Assessor.

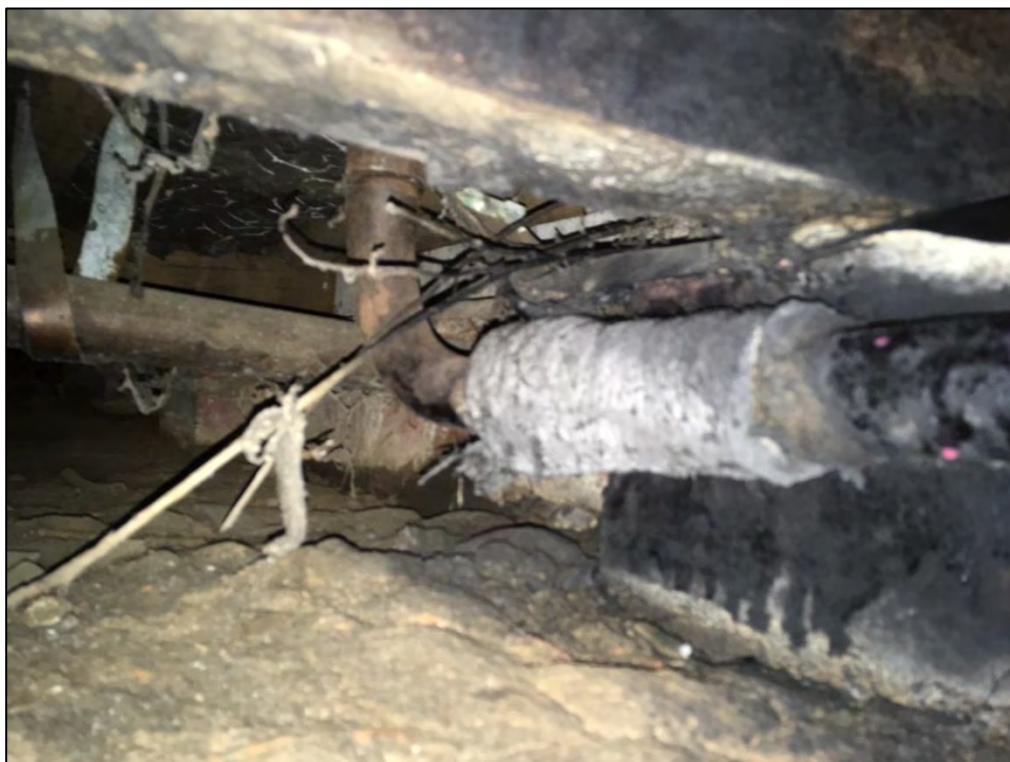
Visible lagging after black painting and after pink PVA glue spraying

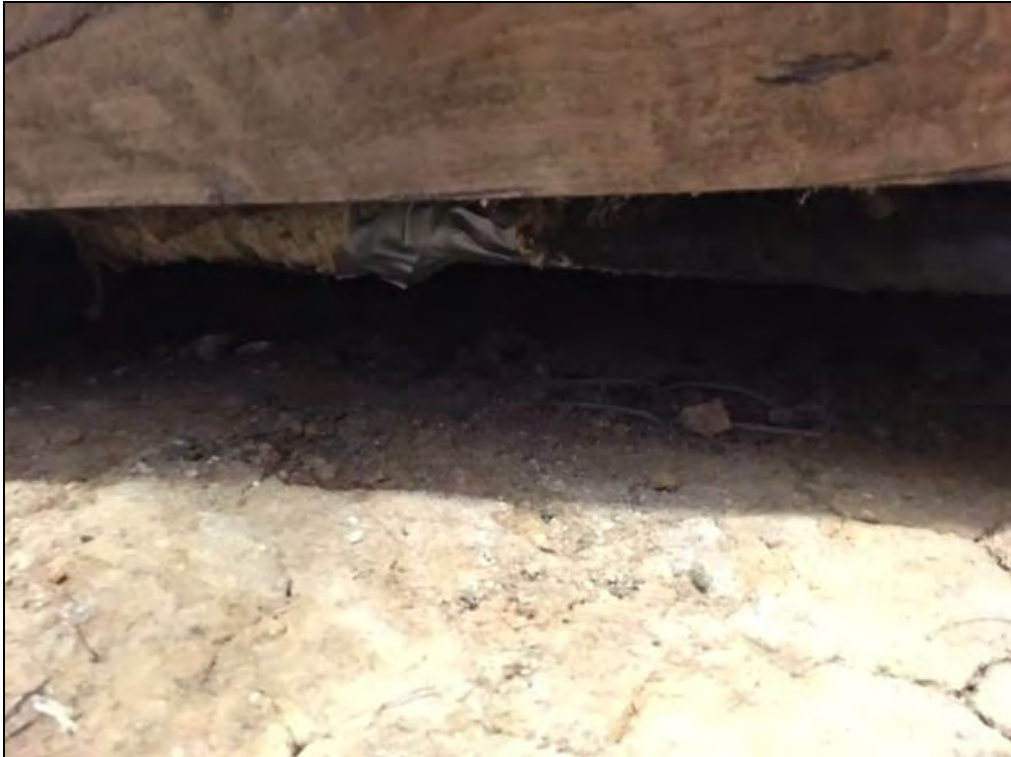
Visible lagging after black painting and before pink PVA glue spraying

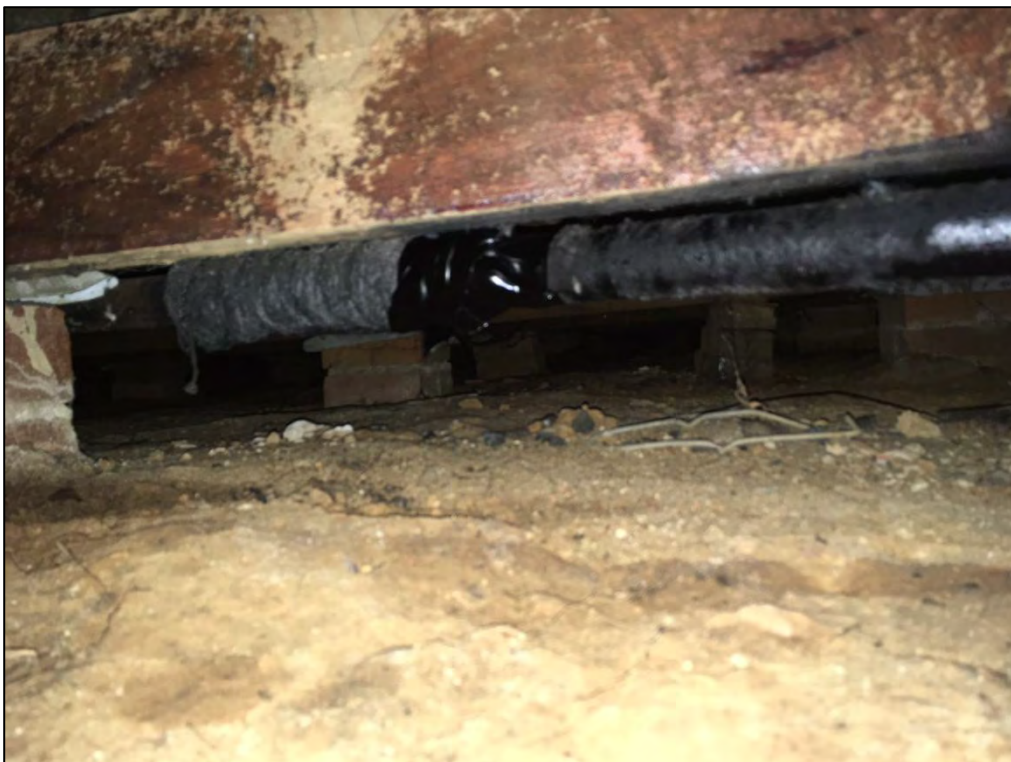
Visible lagging after black painting and after pink PVA glue spraying

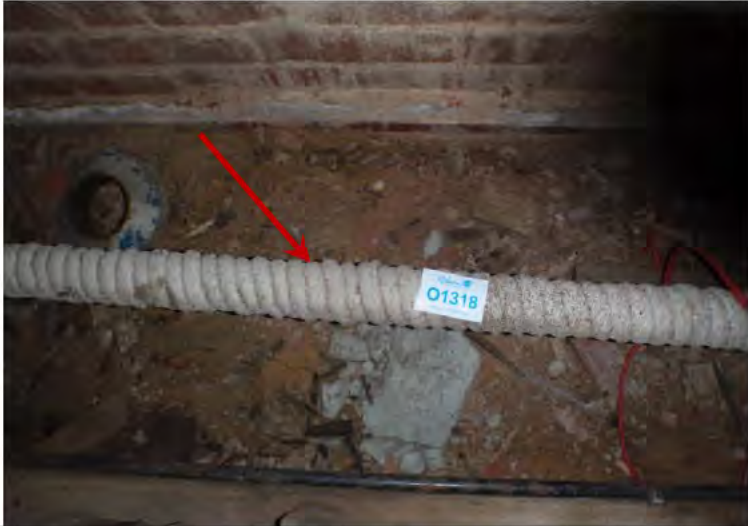
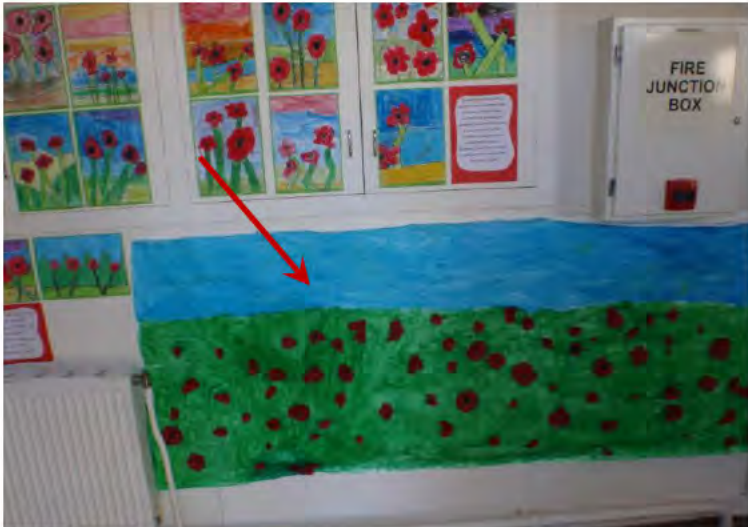
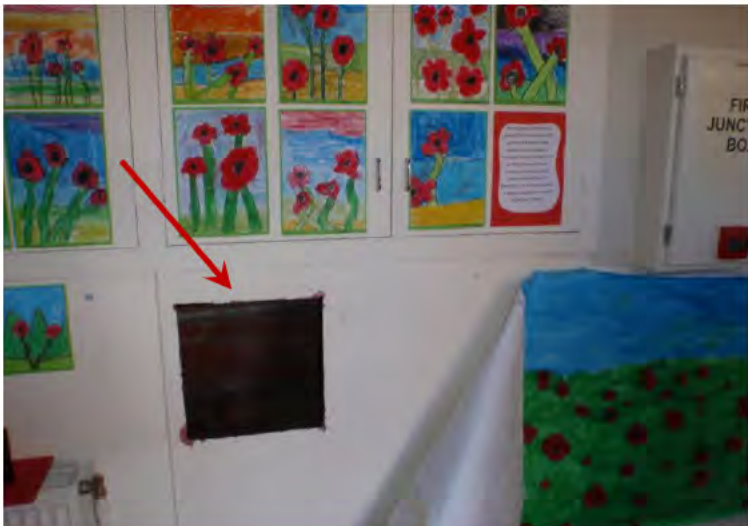
The pipe lagging insulation sampled from the hot water pipe in the wall cavity adjacent to the staff room (room 17) was found to contain chrysotile asbestos.

SAMPLE NO	LOCATION DESCRIPTION	MATERIAL	PHOTOGRAPH
O1318	Gambarri Centre and Montessori Building - Wall cavity adjacent Staff room (room 17) - Pipe lagging to hot water pipes	Pipe lagging (fibrous)

Location of access hatch to wall cavity behind children's painting in corridor adjacent the Staff room (room 17)

It is recommended that the access hatch to the wall cavity be locked and labelled. Also consideration should be given to remove the asbestos pipe lagging in the wall cavity as this area may need to be accessed for repair and maintenance works to the plumbing located in the wall cavity. All asbestos removal works must be carried out by a licensed asbestos removalist. It should also be noted that there is a no risk of exposure to staff and students due to the pipe lagging be in a wall cavity.
