Lead Paint Assessment

Yarralumla Primary School & Preschool

Robson Environmental Pty Ltd conducted a survey of lead paint in the Canteen's Pantry at Yarralumla Primary School & Preschool in Yarralumla on 22 July, 2019, on behalf of ACT Property Group.

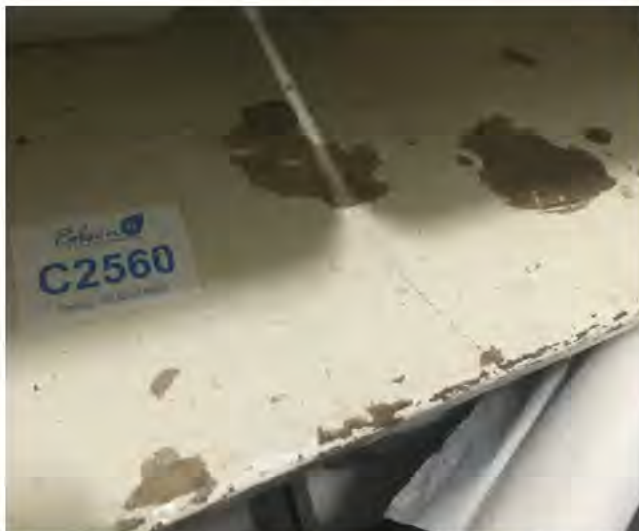
The cream coloured lead paint was present on the bench top, shelves and walls within the Canteen's pantry, as shown in Figure 1 to Figure 4. These figures show the condition of the paint to be poor, with extensive wear and chipping visible. The bench top and shelves (and the walls, though to a lesser extent) can be considered impact surfaces, as movement of items will liberate paint from the surface.

Figure 1: Pantry bench top – areas where paint has flaked chipped or worn away

Given the Poor condition of the paint, and the significant likelihood (rated as Very Likely) of exposure occurring given that the paint is:

- on a high contact surface;
- is in a food preparation area; and
- is near to areas accessed by children,

the risk presented by this lead paint is rated as High.

Given the condition of this paint, and the risk presented by its location, it is recommended that lead abatement be carried out for the lead paint in the Yarralumla Primary School Canteen Pantry. Stabilization, via over-painting or covering the paint with an encapsulant, is not appropriate in this location, either as a short term or long term management strategy, because the pantry is a high-contact food preparation area.

It is recommended that the bench top and shelves be entirely replaced, which is likely to be easier, faster and lower risk than removing the paint, and will more reliably reduce the potential for future exposures to lead in the Canteen Pantry. Removal of lead paint on walls should be carried out at the same time.

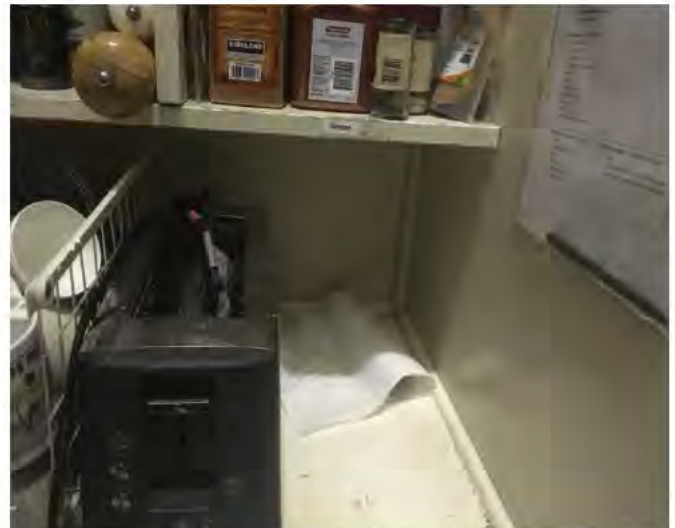
Figure 2: Cream paint on pantry bench top and walls

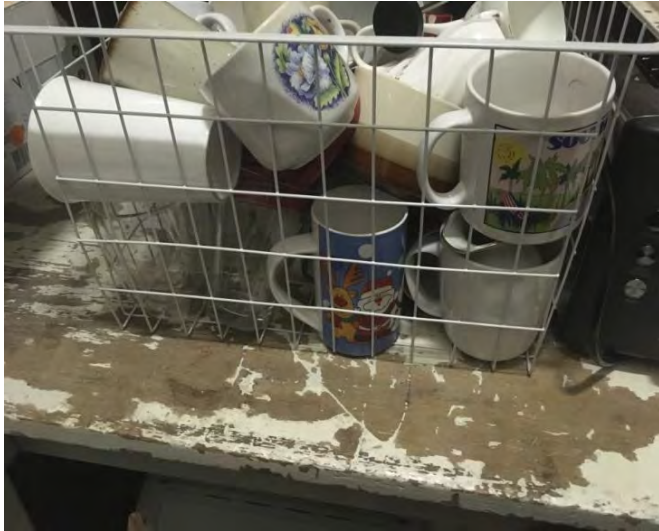
Figure 3: Pantry bench top – areas where extensive wearing of paint has occurred

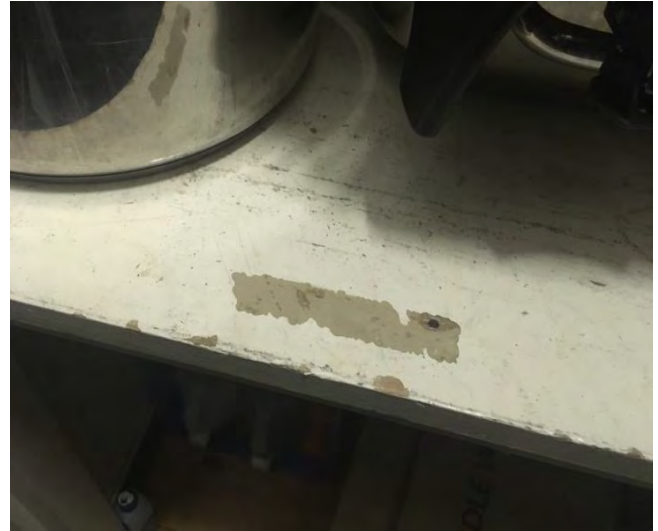
Figure 4: Pantry bench top – area where paint has flaked chipped or been worn away

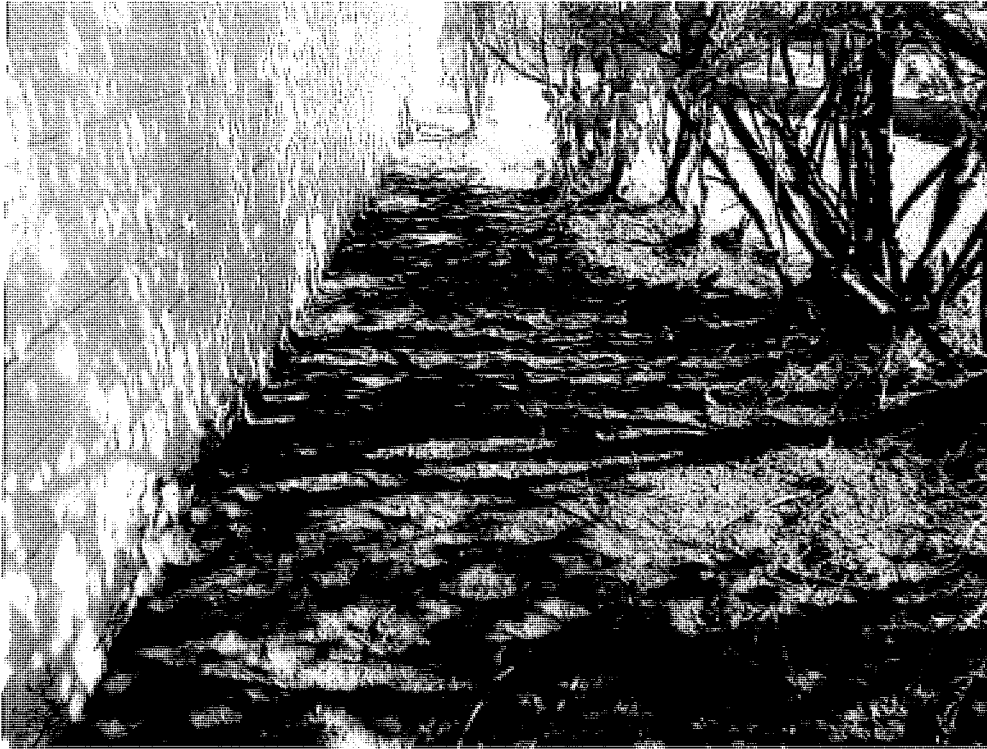
Figure 1 to 2 shown below outline the representative areas where areas of leaf litter had been removed to a satisfactory level.

Figure 1: Example of leaf litter removal works

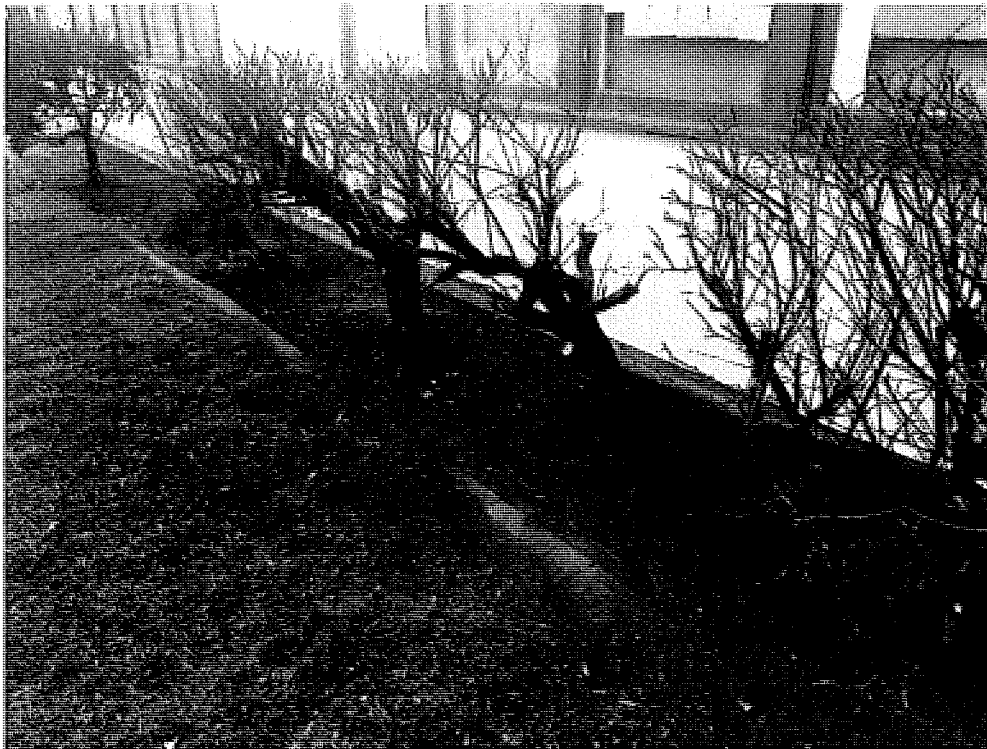
Figure 2: Example of leaf litter removal works

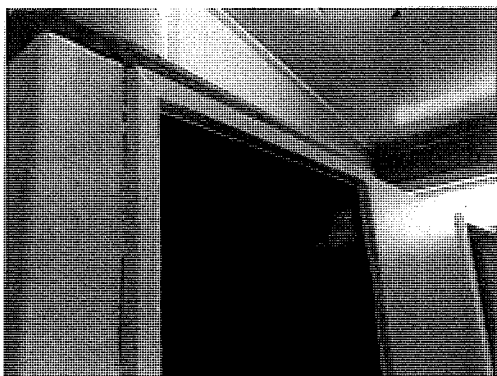
Figure 1: Door trim to WC cistern

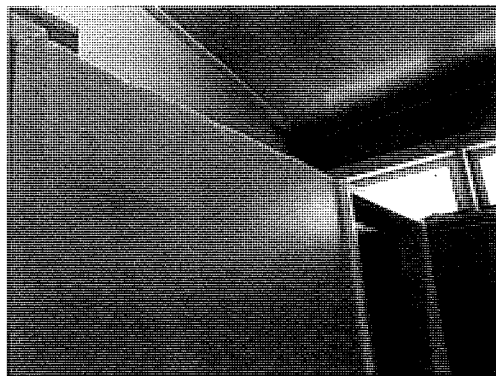
Figure 2: Sealed lead paint - wall

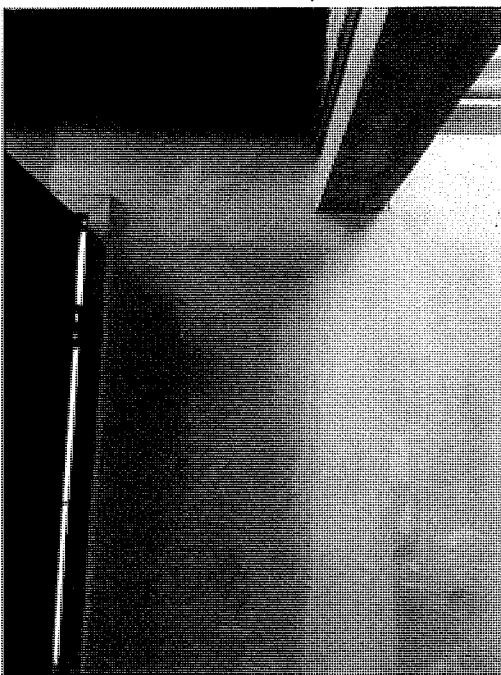
Figure 3: Sealed walls

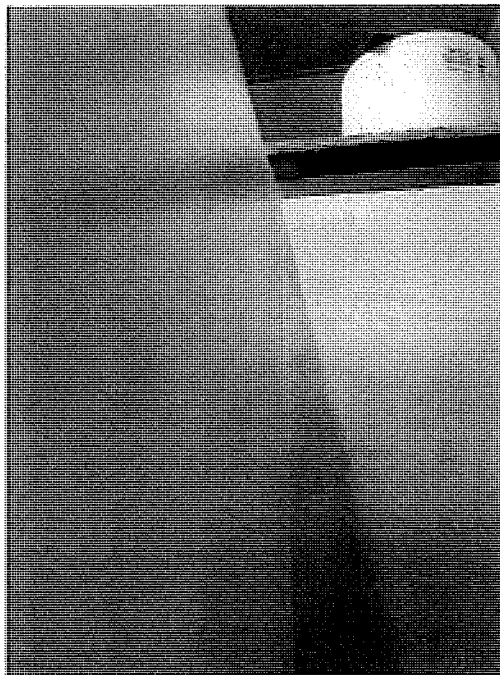
Figure 4: Sealed walls

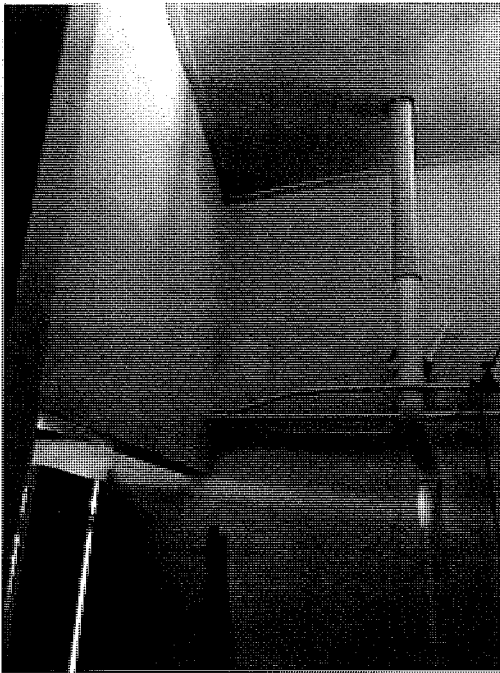
Figure 5: Sealed walls and pipes

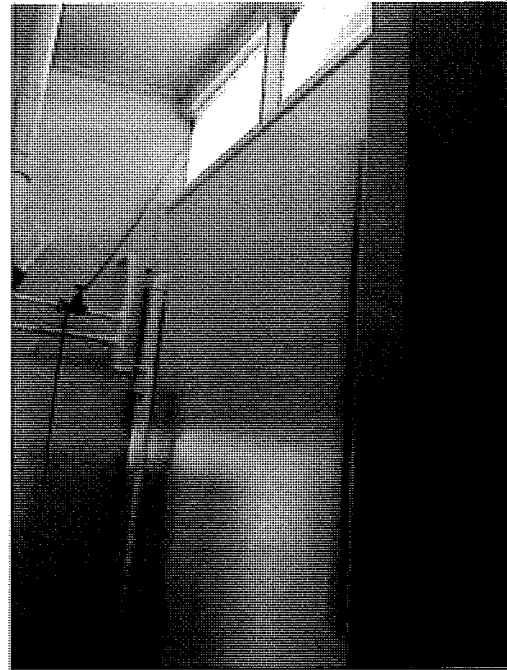
Figure 6: Sealed walls and pipes

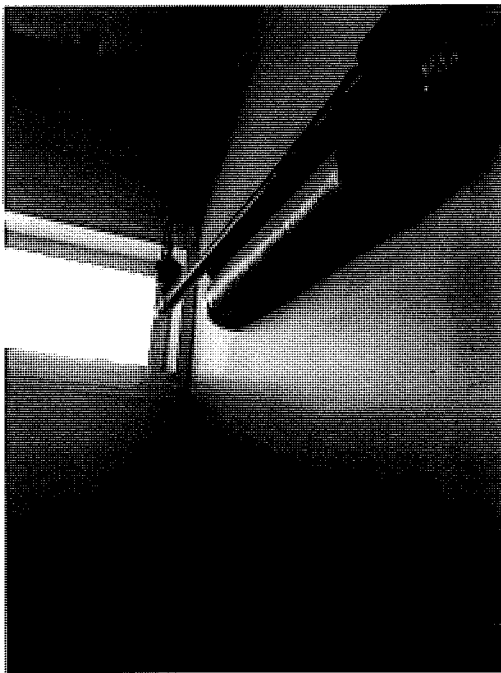
Figure 7: Sealed walls and pipe insulation

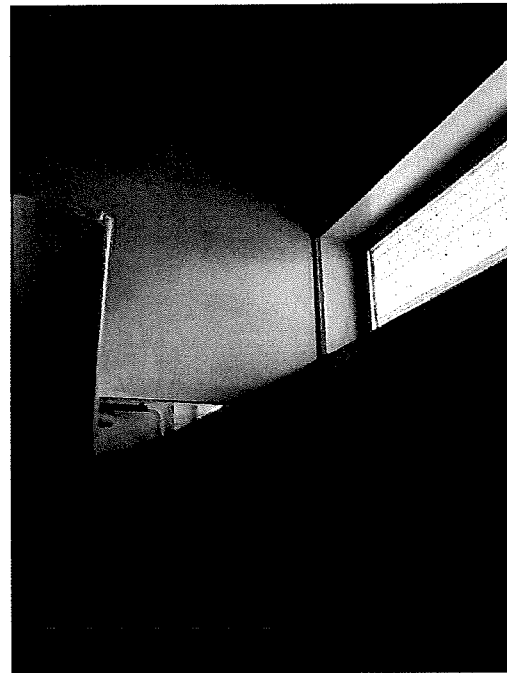
Figure 8: Sealed walls and trims

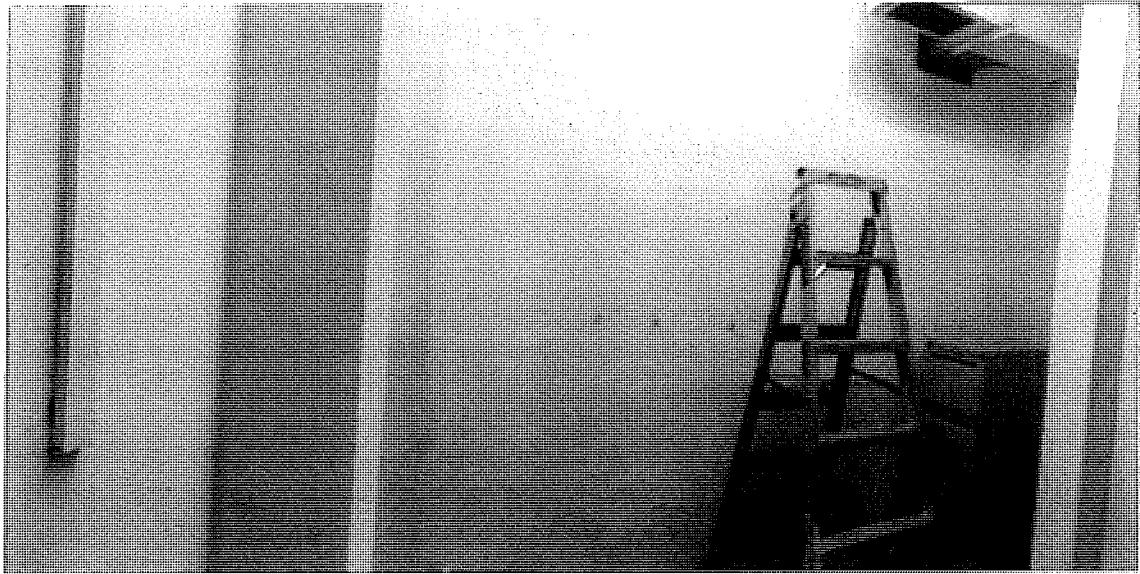
Figure 9: Sealed walls, ducting and trims
