ASBESTOS CLEARANCE CERTIFICATE INSPECTION PASS

Project/Location: Yarralumla Primary School

Job Number: 7335471

Lead Paint analysis of samples collected from proposed work areas in the Gambarri Wing at Yarralumla Primary School, Loftus Street, Yarralumla, ACT 2600 – 20 July 2017

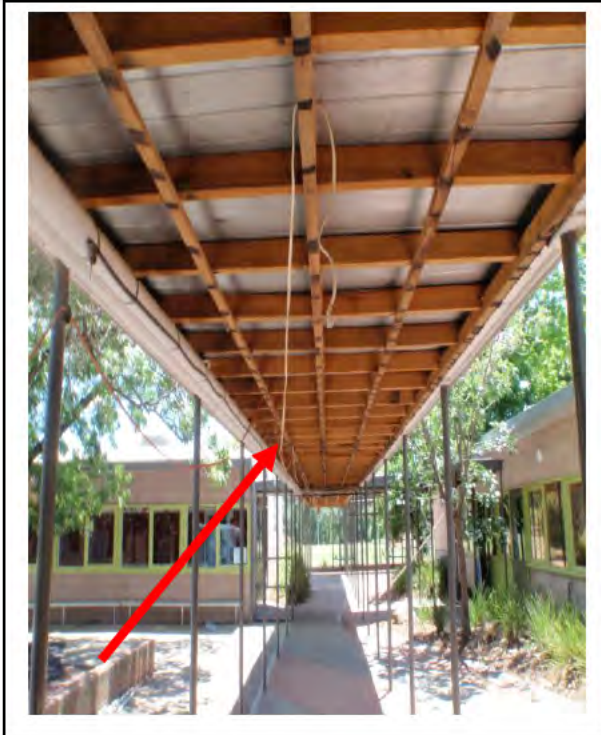
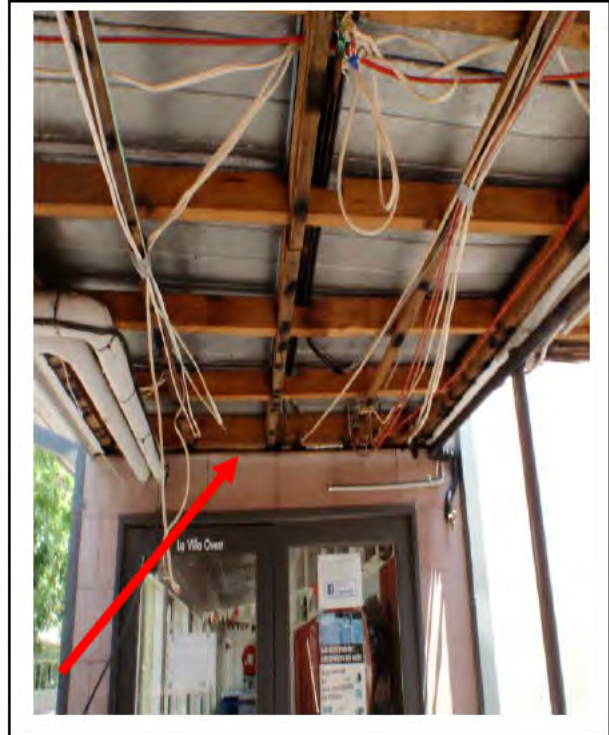
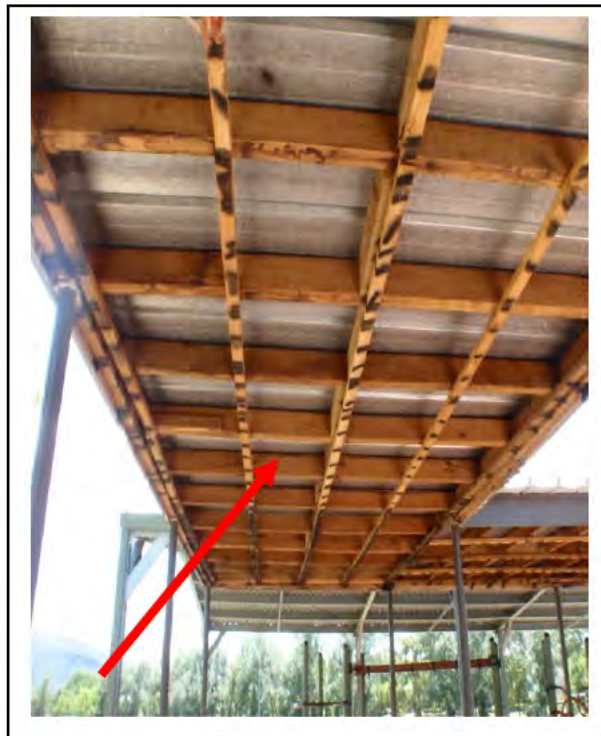
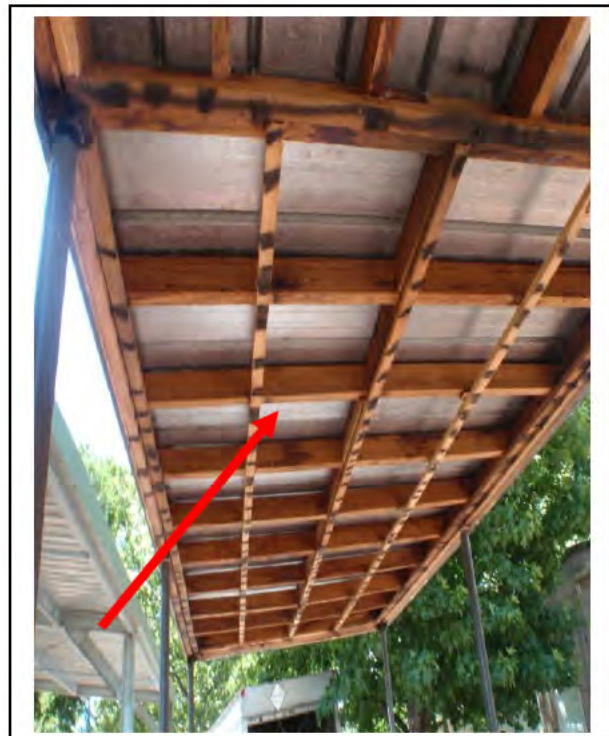
Removal of asbestos soffit sheets from covered walkway from the rear of the main building.

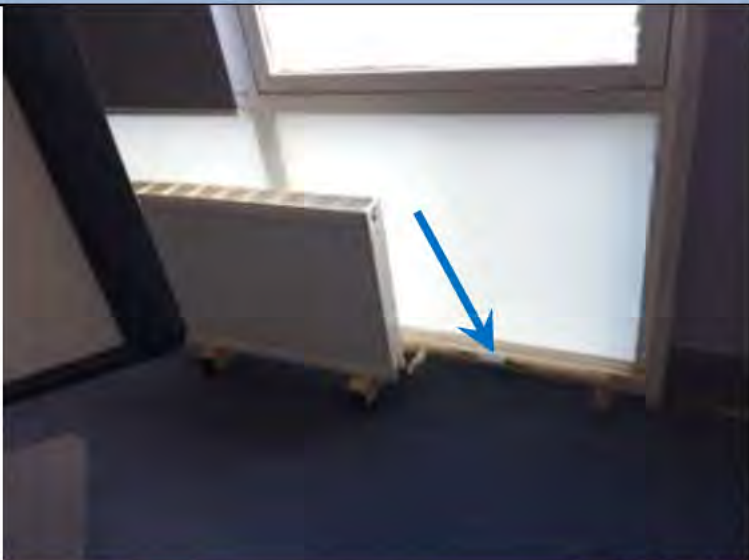
SAMPLE NO	LOCATION DESCRIPTION	PAINT COLOUR	PHOTOGRAPH
I0504 a,b,c	To radiator pipes and skirting boards	Cream

The analytical results of paint sampling from Yarralumla Primary School revealed that the white paint to the door and window frames was Lead Paint ($>1\% \text{ Pb}$). The cream paint to the radiator pipes and the skirting boards was found to be First Schedule Paint ($\geq 0.25\% \text{ Pb}$) and must be treated as lead paint (See **Appendix A** for more information on dealing with lead paint).

The cream First Schedule Paint to the radiator pipes and skirting boards is flaking in areas and must either be encapsulated with a fresh coat of paint or removed.
