ROOF CONDITION REPORT, HAWKER COLLEGE,
MURRANJI STREET, HAWKER

Prepared by [REDACTED] on the 19/04/2022
On behalf of the ACT Property Group

Background Notes: This roof report has been prepared on behalf of the ACT Property Group to investigate the current condition of the roof and help determine the location and cause of ongoing roof leaks. Hawker College has a long history of ongoing roof leaks (pers comm school).

Aim: Inspect and assess the current condition of the roof catchment. Provides options to repair.

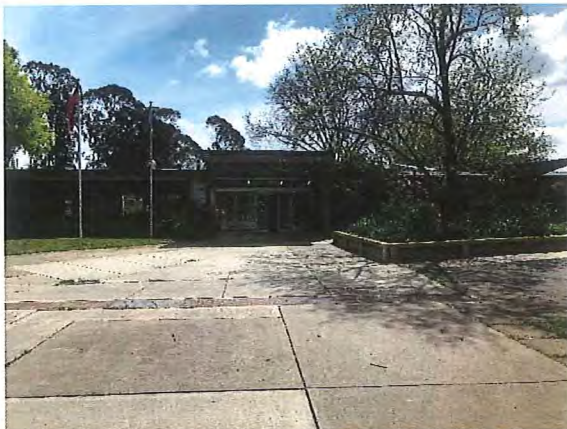
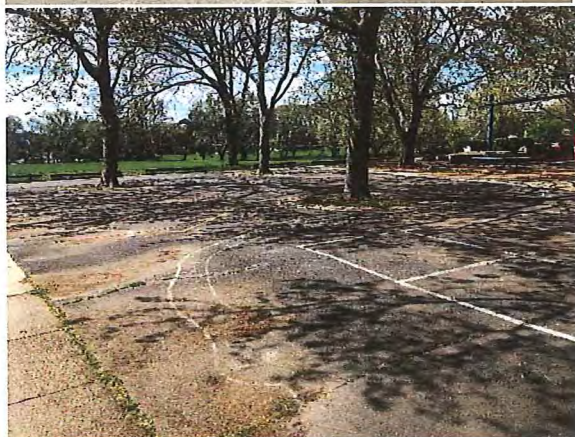
Yarralumla PS – Area 4

Problem: YPS has had works at the school concentrating on hazardous material but no allocation to update existing non lead areas. The school is looking tired with extensive trip hazards and cracking of concrete, existing gardens and garden beds require extensive work, signage is non-existent, asphalt under plane trees has significant trip hazards made particularly hazardous when trees are losing leaves. No under covered walkway to the front of the school for disabled

- New signage to front of school administration building
- Replace worn and cracked concrete and address extensive trip hazards in asphalt under the plane trees caused by tree roots.
- Replace existing garden beds with sensory garden incorporating an outdoor learning space under the trees, outdoor seating for children to eat /play without sitting on the cold/hot ground, area for natural gross motor skills play, meeting place for families and for student to play.

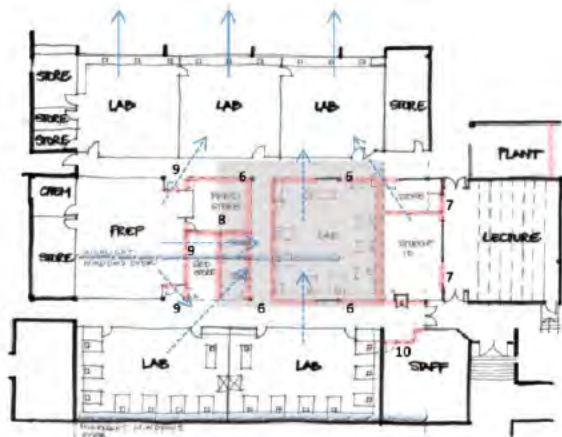
The proposal involves removal of a considerable number of solid partition walls which are largely unreplaced (see sketch below)

Since these walls are providing lateral bracing to the existing structure it will be necessary to add some bracing to the roof structure so that outer walls can be engaged to provide stability instead of the internal ones. If ceilings are to be replaced this work can be carried out from below prior to the walls being demolished. The extent of the work cannot be firmly established until a full inspection of the existing bracing is undertaken.

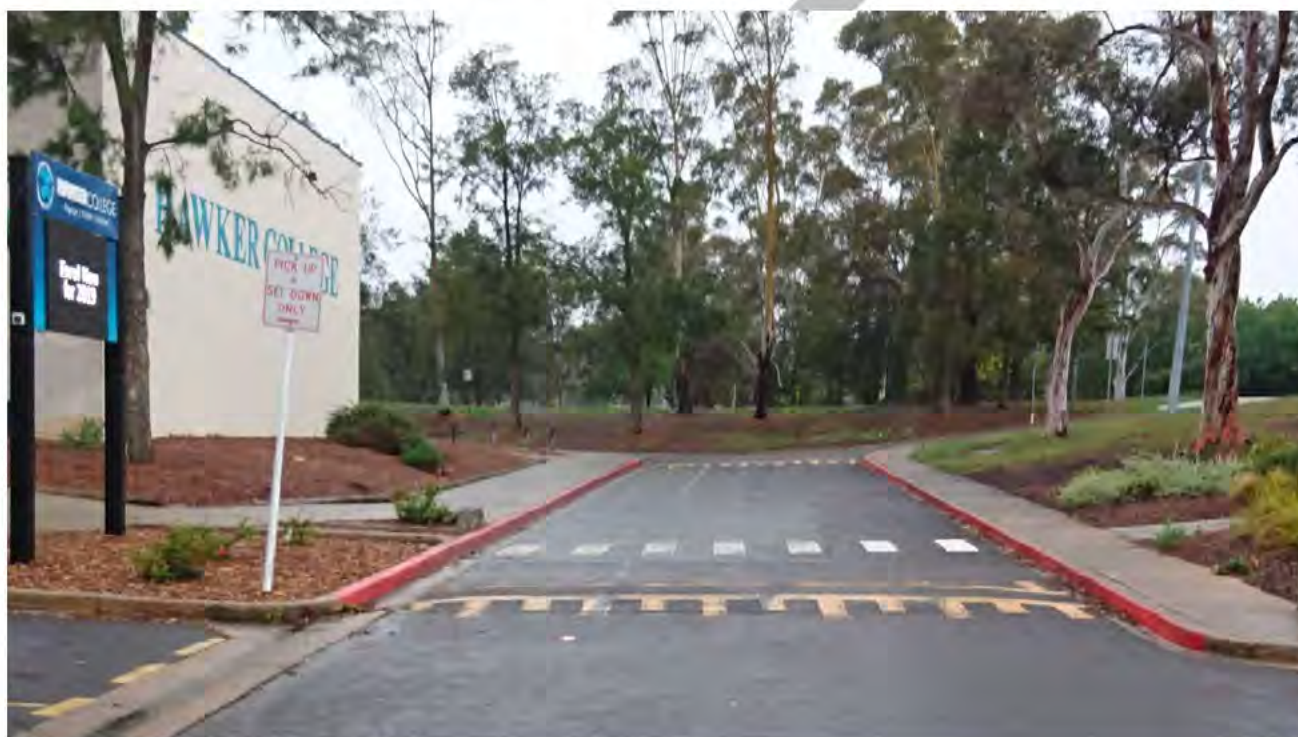
The pick up and set down area is currently unsigned except for a non-standard sign near the start of the designated area. The information provided on the non-standard sign creates some confusion over the location where vehicles are allowed to stop. Several vehicles were observed stopping at the sign rather than the designated section of the car park.

Except for the “additional” walking distance for the passengers, it is expected that drivers are stopping at the sign due to the information provided on the sign. This resulted in some vehicles stopping on the pedestrian crossing (zebra) or blocking the access to formalised 90 degree parking spaces (disability car parking spaces and staff parking spaces). Additionally, passengers were walking through the landscaped garden, one exiting passenger was observed hitting the car door on a rock when opening the door to exit the vehicle.

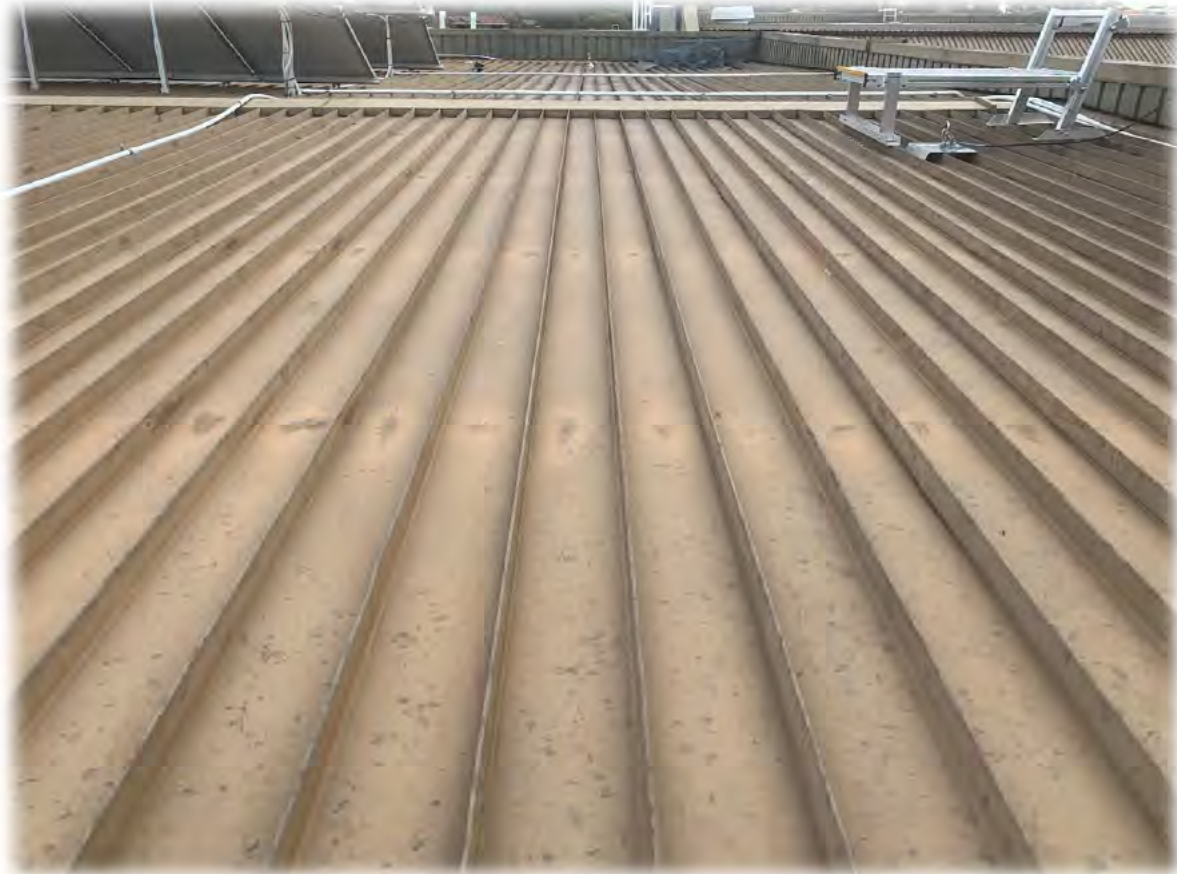
Figure 1: Metal roof cladding

Findings: The general condition of the roof cladding is fair. The age of the roof is unknown however is estimated at around 30-40 years given the type of roof cladding used (brown built klip-lok). The roof cladding in its present state exhibits few issues other than damaged ribs from foot traffic and raised ends where the roof sheets terminate and discharge into the box gutter. The base metal thickness of the roof cladding (BMT) appears without defect with little to no rust present along the roof sheets. Some sections of the roof catchment have undergone replacement due to extensions and modifications. These sections have been replaced with a klip-lok 406 style cladding as seen in figure 4.

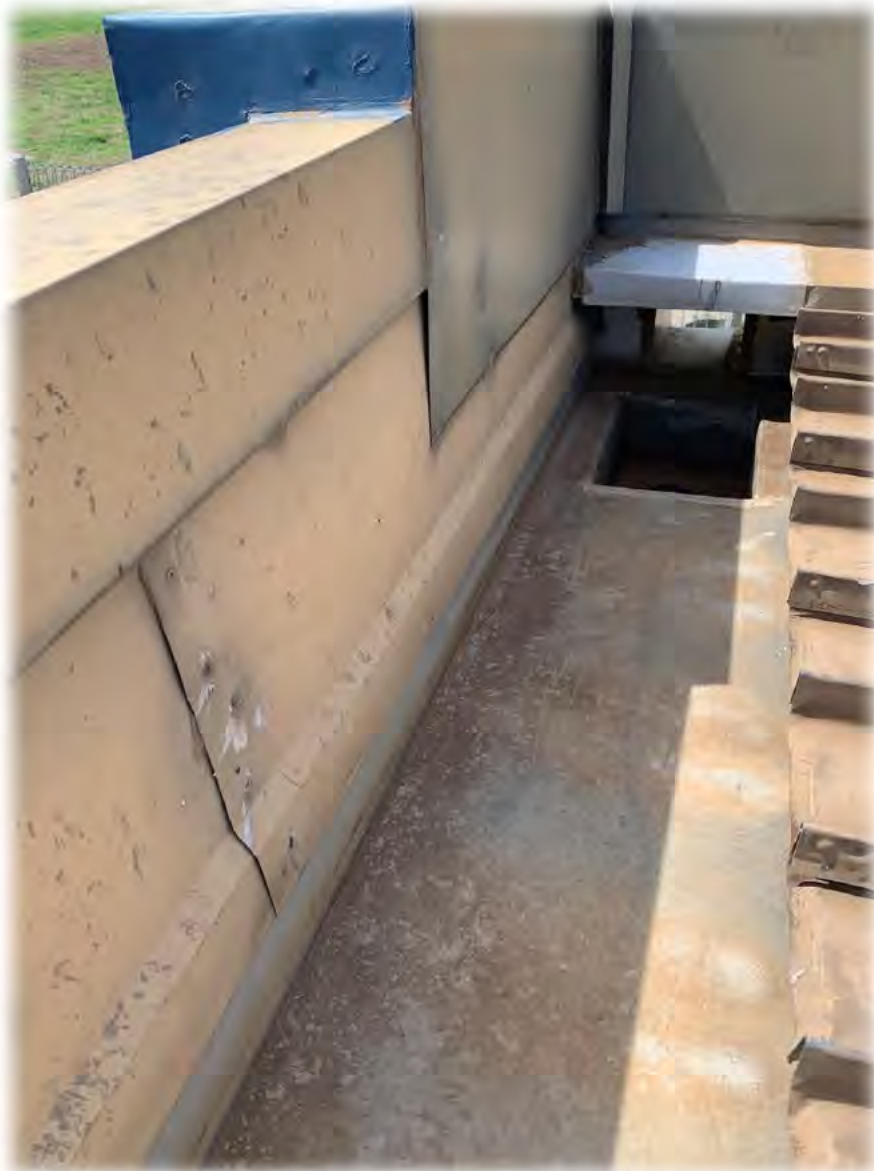
Figure 2: Typical view of box gutter

The majority of leaks associated with the installation of guttering is in large a result of poor workmanship in the original installation of the gutters. Current point source locations for leaking gutters appear to be the result of poorly sealed gutters. It appears that the majority of joints and sump and downpipe connections may have been over sealed only. It is critical and best practice to apply sealant to the overlapping joint before fixing to ensure a sound and lasting seal. Maintenance work to date appears to have only focused on over sealing.

Replacement of rusted affected galvanized gutters is recommended.

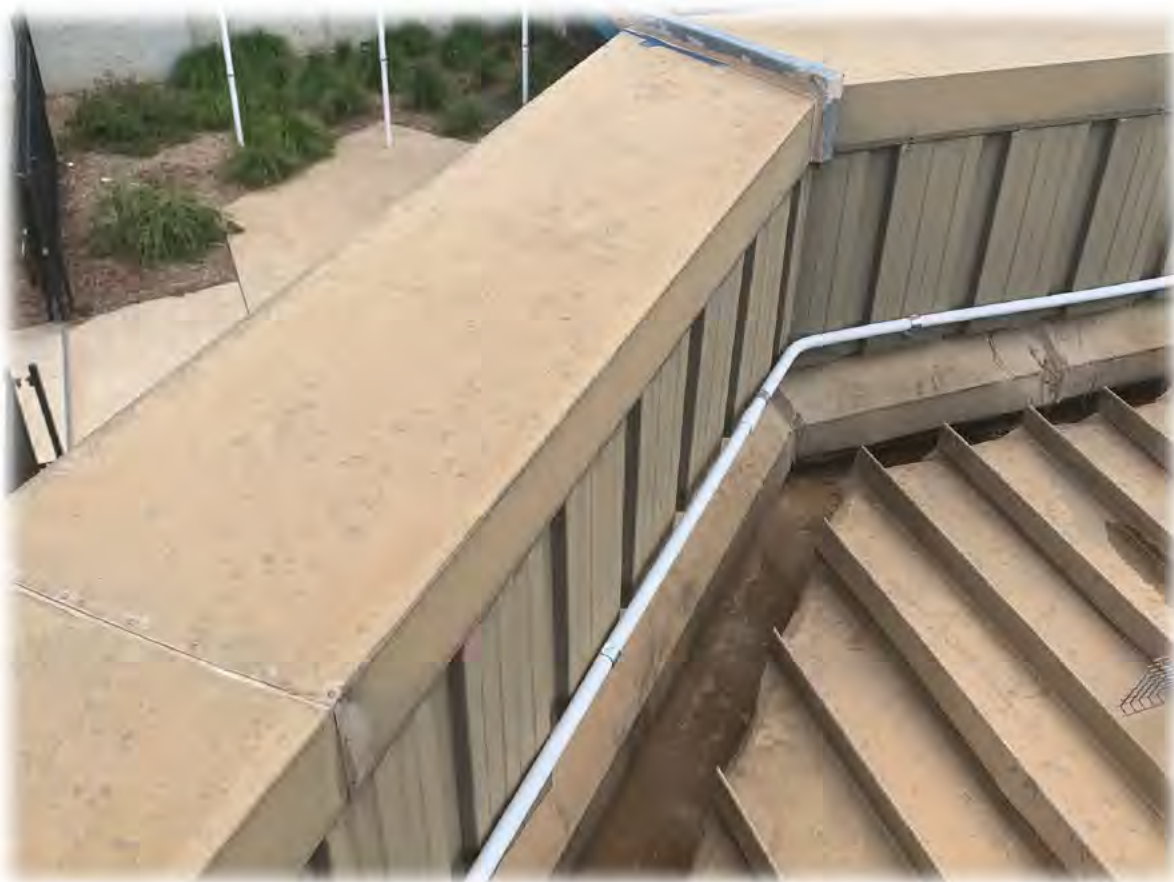
Figure 3: Parapet wall capping and wall and apron flashings

Findings: With a building of this age, it is becoming increasingly common to find that the majority of roof leaks originating from worn flashing, most commonly associated with the overlap and fixing method commonly used at the time. Over time the forces of expansion and contraction can lead to the overlapping joints becoming compromised. For example: the age of this roof was most likely built in a period of transition between galvanized metal (where joints were soft soldered and the introduction of Colourbond (painted metal) where joints are silicone sealed between the overlap and riveted not screwed. Roof examinations across a number of schools in the ACT exhibit similar faults that being that at the time silicone was not used between the overlapping joints. Silicone repairs have then been undertaken however have only applied to the top of the overlap and work as an over seal only. This type of remediation work is limited in its effectiveness over time and eventually cracks and becomes compromised. Best practice requires silicone to be applied between the joint. This creates a sandwich type effect creating a long and lasting water proof seal when coupled with correct fixing of 1/8th sized rivets fixed at no more than 25mm spacings. Ideally two runs of rivets are used in a stitching pattern to provide optimal fixing and long jeopardy.

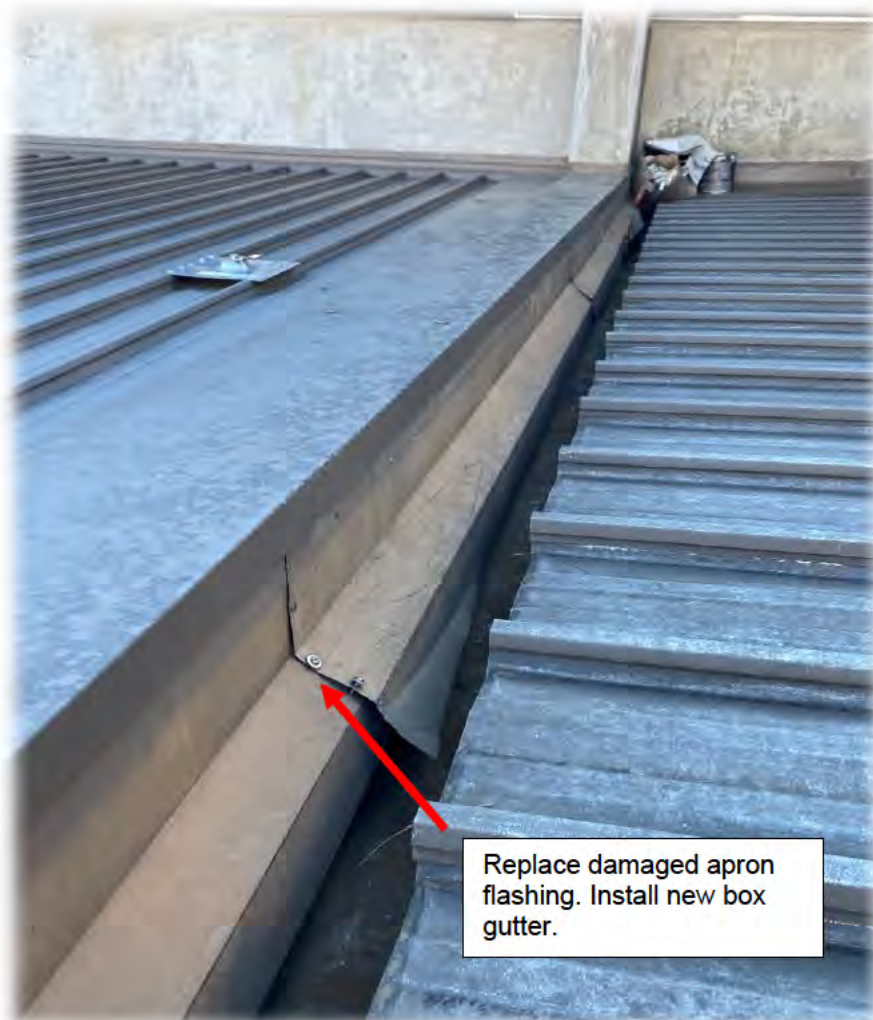
Figure 4: Damaged apron flashing

Item 1	Replace apron flashing and box gutter over office area
Item 2	Reseal dek-tites

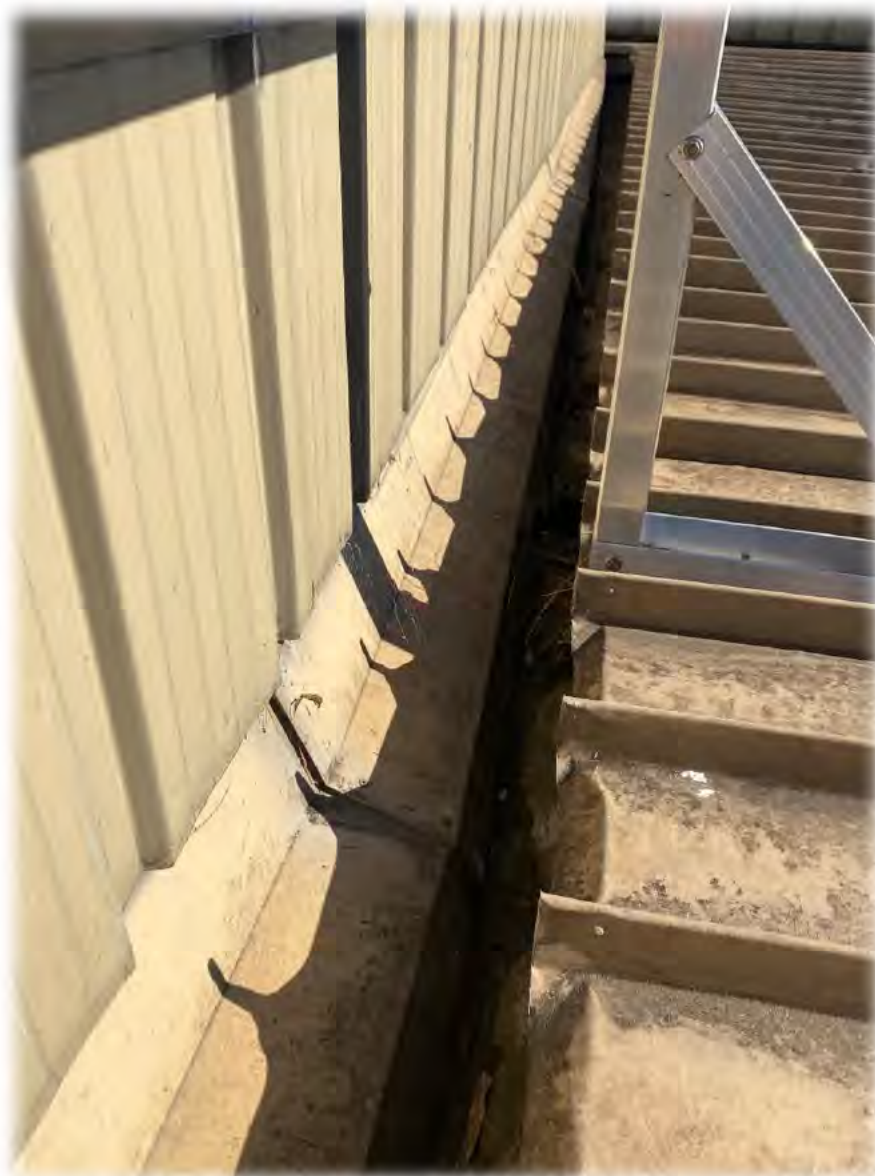
Figure 6: Gymnasium roof and perimeter box gutter showing loose and failed apron flashing

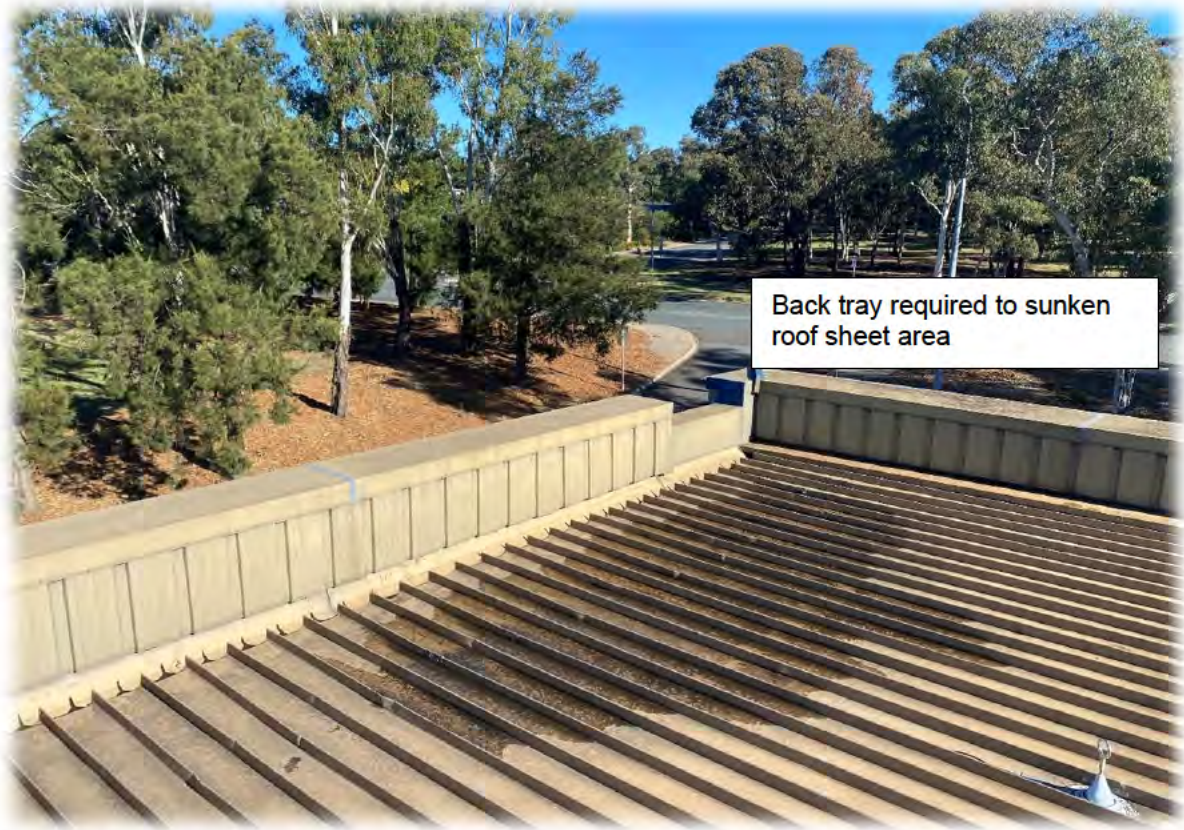
Figure 7: Pooling of water above gymnasium leak

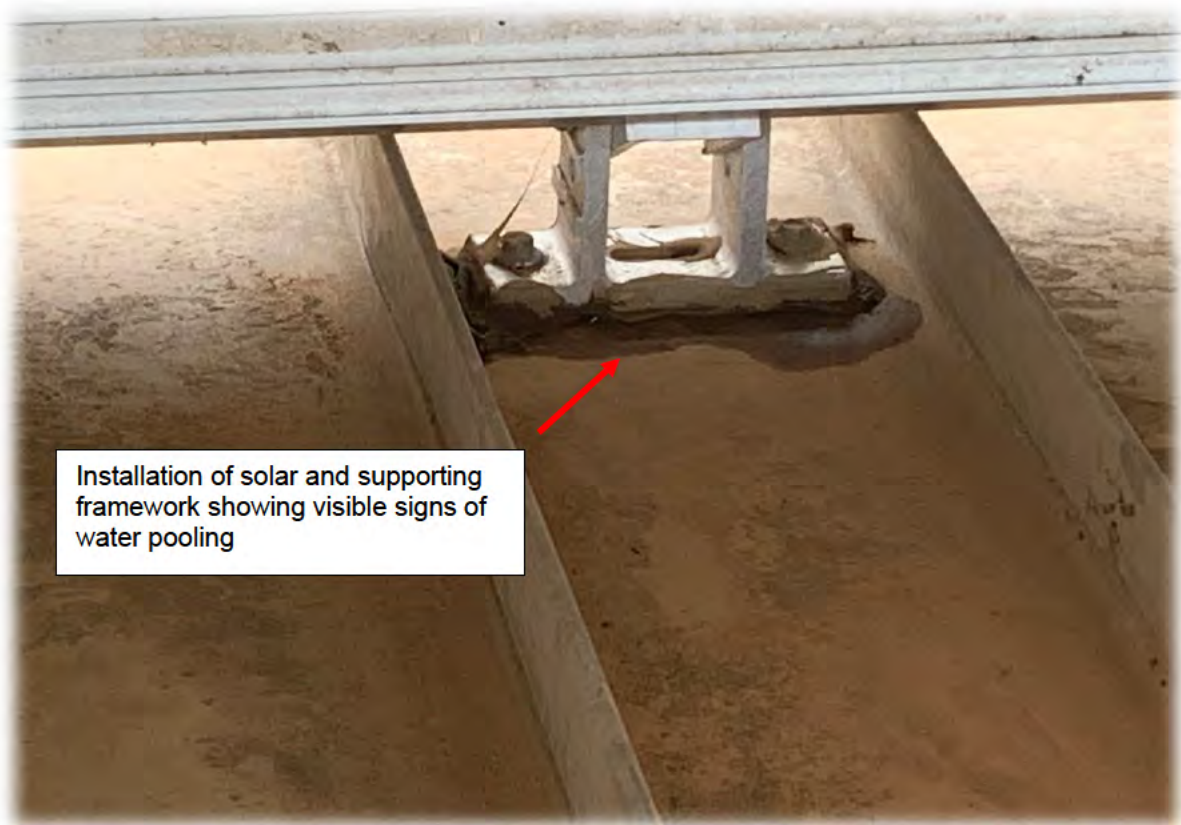
Installation of solar and supporting framework showing visible signs of water pooling

Item 5	Solar PV supports. Clean back all existing sealant to support feet. Remove existing screws. Clean and prepare surface using primer/solvent solution. Silicone seal between under side of support feet and roof sheet. Re-fix using screws. Clean away excess sealant and ensure water proof seal is maintained. <i>An alternate option is for the complete modification of the support frames by an accredited solar installer to re-engineer using the correct clamps.</i>

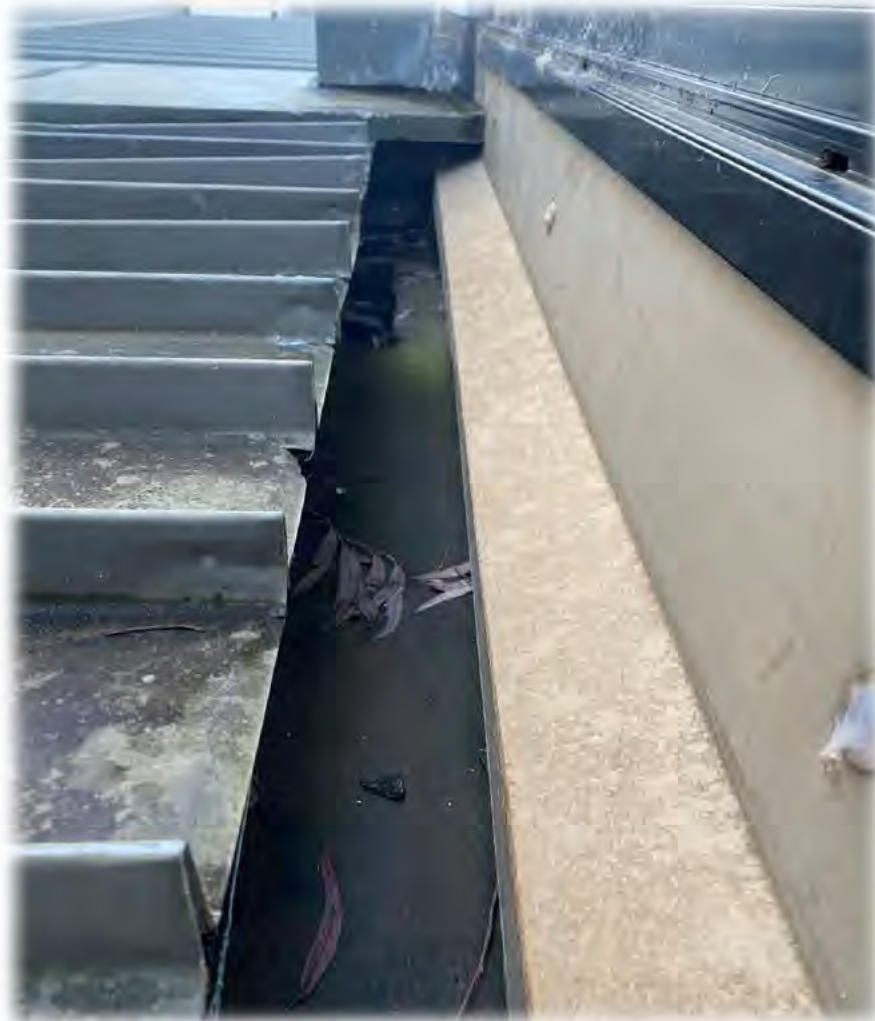
Figure 10: Box gutter located above gymnasium corridor servicing change rooms

Item 6	Clean and seal around brick column and window flashing. Replace internal box gutters (approximately 18 lineal meters).
Item 7	Clean blockage and gutters. Install additional larger over flows to gutter.

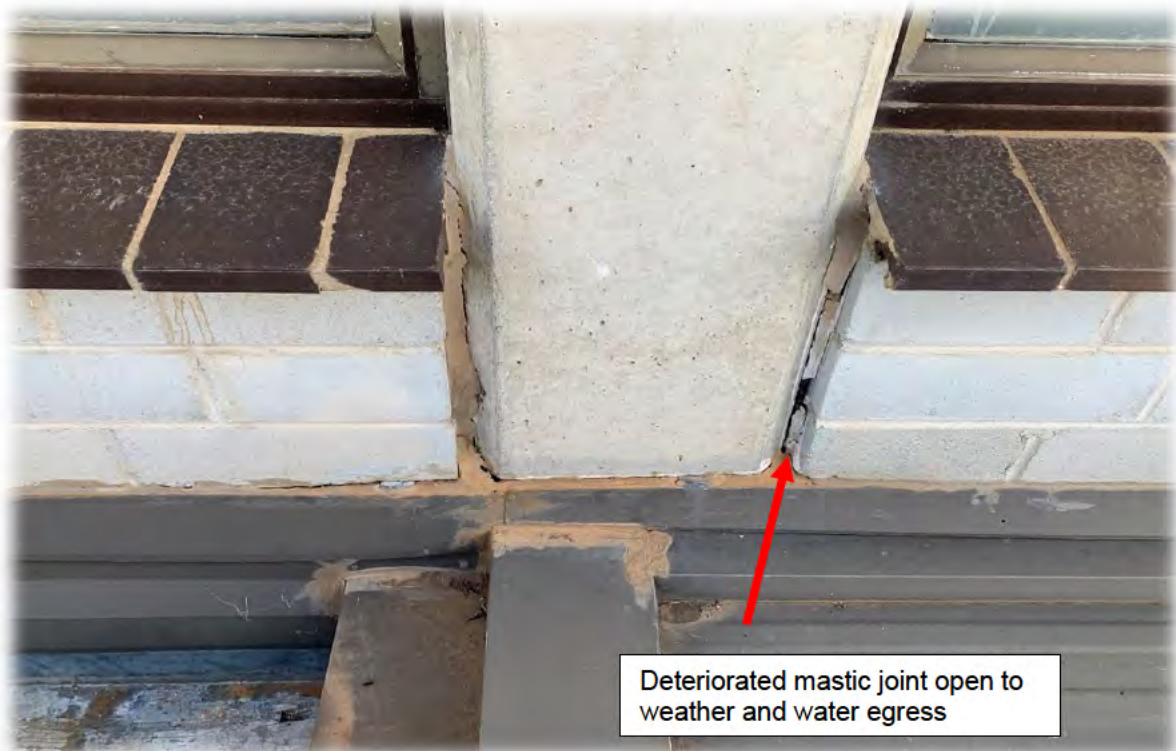
Figure 16: Deteriorated mastic seal along concrete wall joint

Item 9	Install large back tray to extend over damage roof sheet section in front of window.
Item 10	Replace rusted box gutters along wall edge.
Item 11	Reseal concrete joints using suitable mastic sealant.

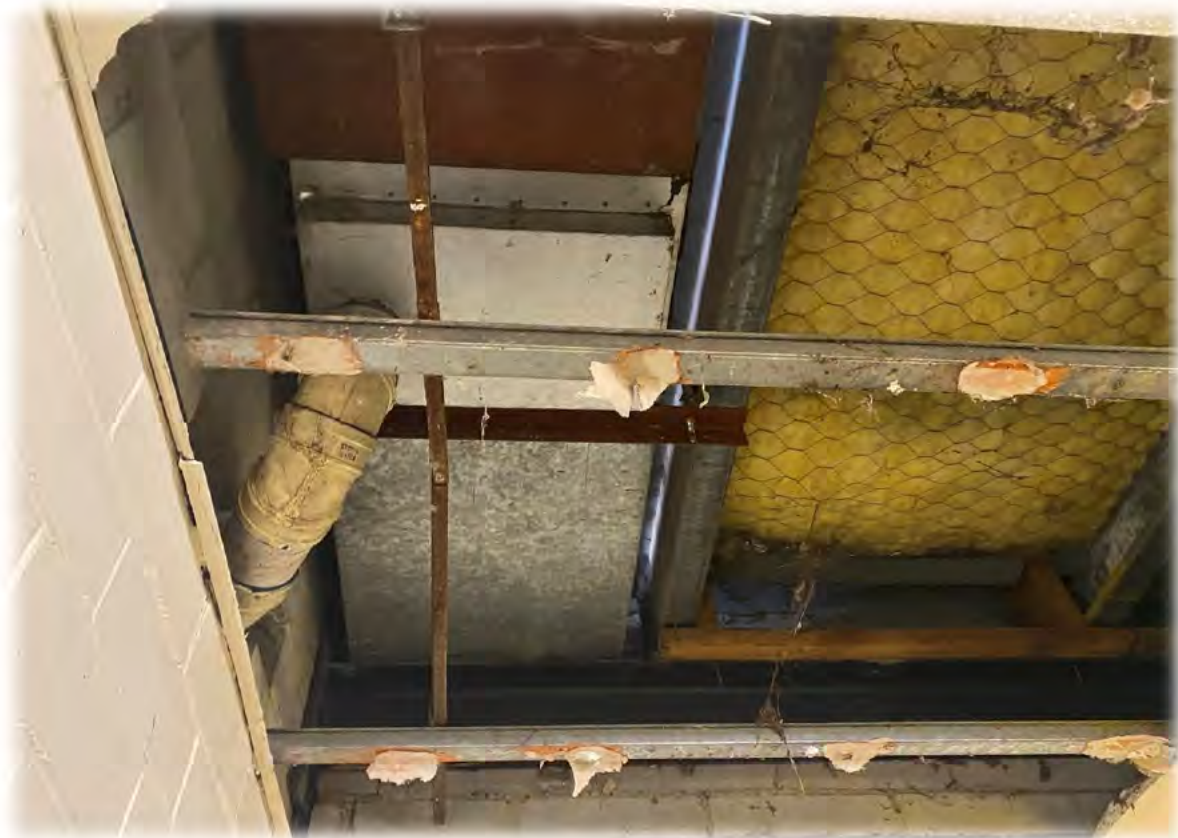
Figure 17: Ceiling leak in woodwork technology plant room

Item 12	Carry out work to repair box gutter sump and downpipe connection. Further inspect area, evaluate and make good as required.
---------	---

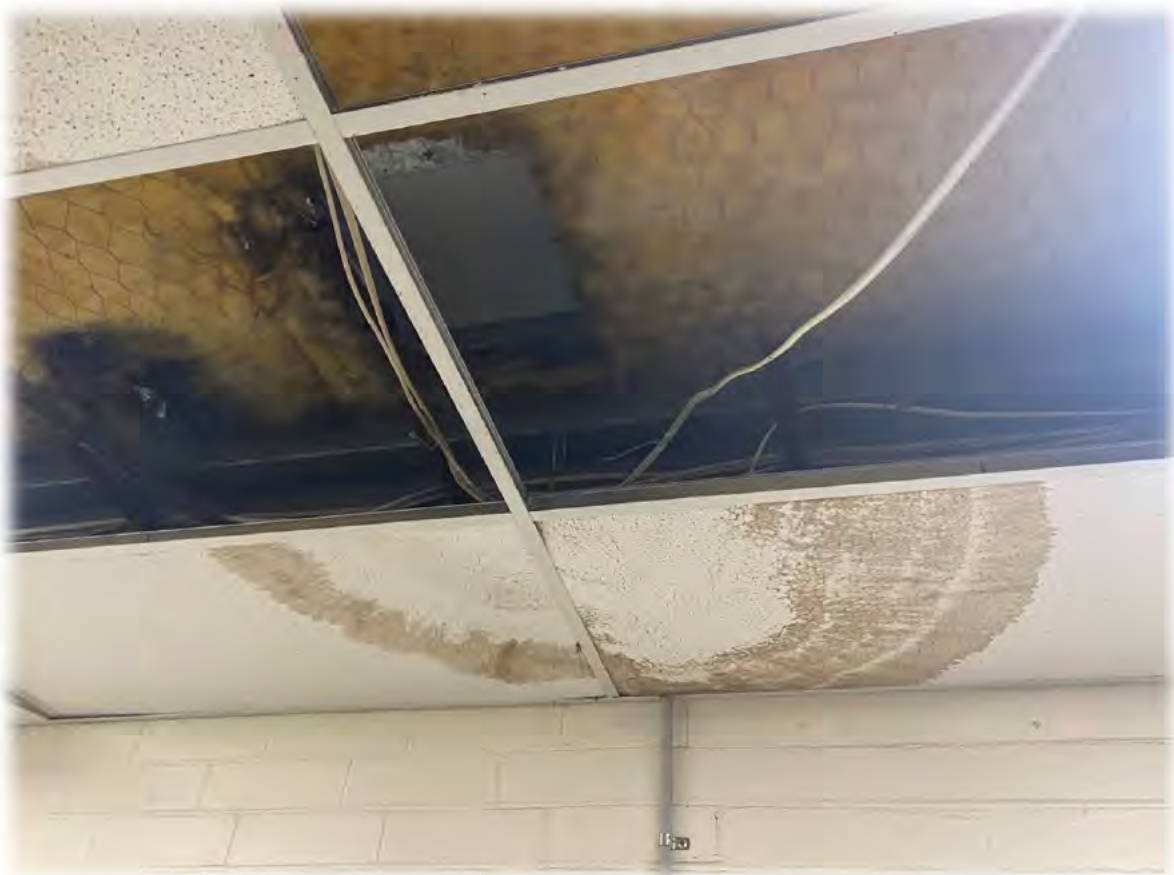
Figure 20: Damaged ceiling due to roof leak

Item 14	Remove old penetration and patch roof using colourbond metal.
---------	---

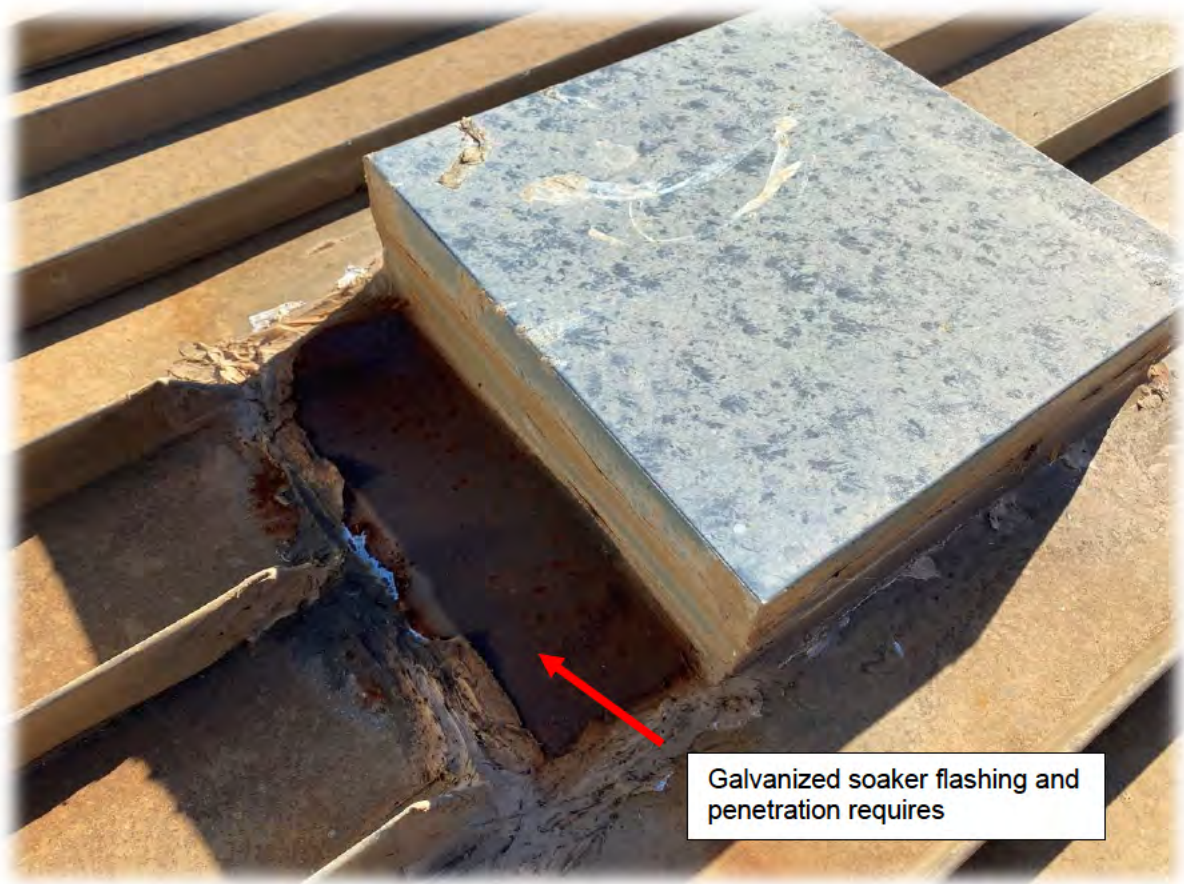
Figure 21: Redundant penetration

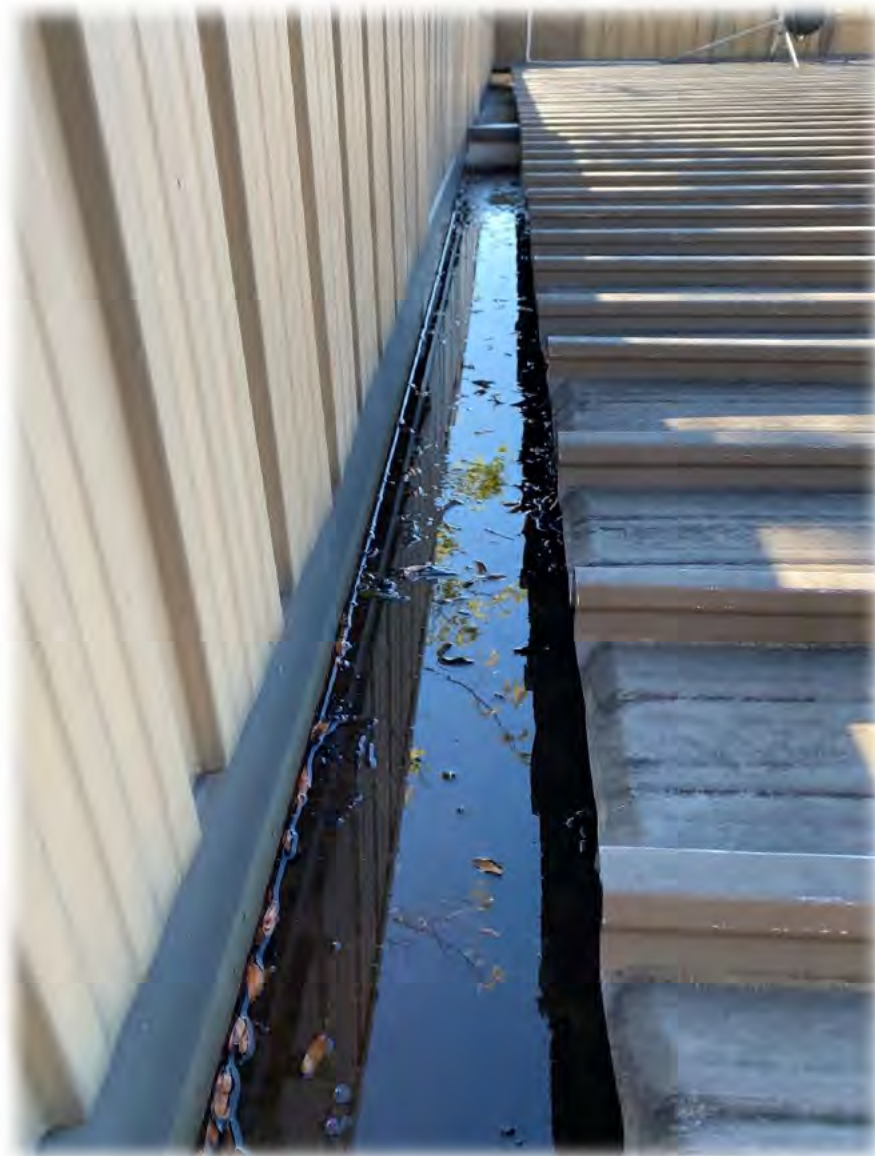
Figure 24: Flooded box gutter

Item 15	Replace box gutter. Correct gradient of gutter support.
Item 16	Modify satellite supports. Repair and patch roof fixing penetrations.

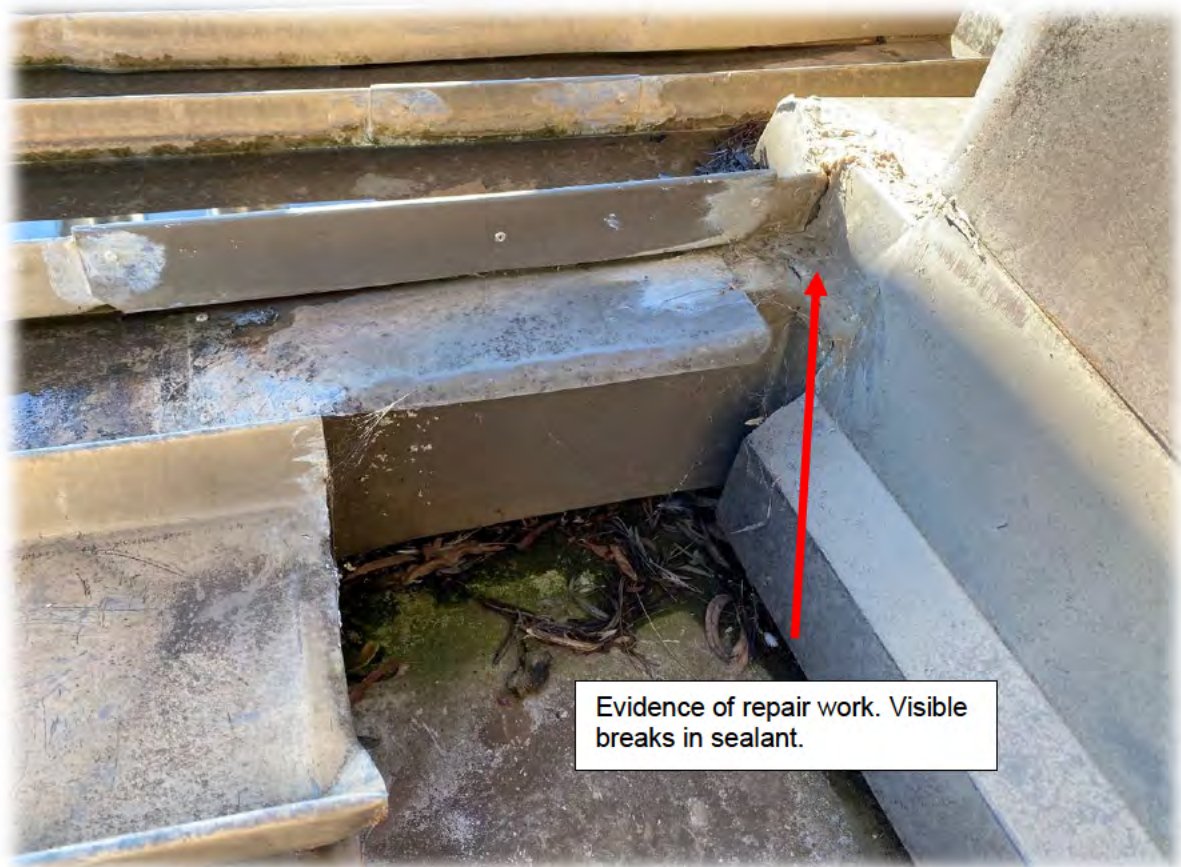
Evidence of repair work. Visible breaks in sealant.

Item 26	Further investigate box gutters.
---------	----------------------------------
