**From:** [Byrne, Evan](#)  
**To:** [Hunter, Stuart](#)  
**Cc:** [Ebner, Joanne](#); [Wickham, Ilona](#); [Schaidreiter, Robert](#)  
**Subject:** Fwd: Yarralumla Preschool - Lead in soil testing [SEC=UNCLASSIFIED]  
**Date:** Wednesday, 17 July 2019 3:40:59 PM  
**Attachments:** [image002.png](#)  
[image003.png](#)  
[image004.png](#)  
[image005.jpg](#)  
[SE195362\\_After School Care Building\\_PM\\_ANALYTICALREPORT.pdf](#)

Robson Environmental Pty. Ltd. (Robson) undertook a visual lead clearance assessment following lead paint removal work conducted at the Yarralumla Primary Gambarri Preschool Building on Wednesday 17 July 2019.

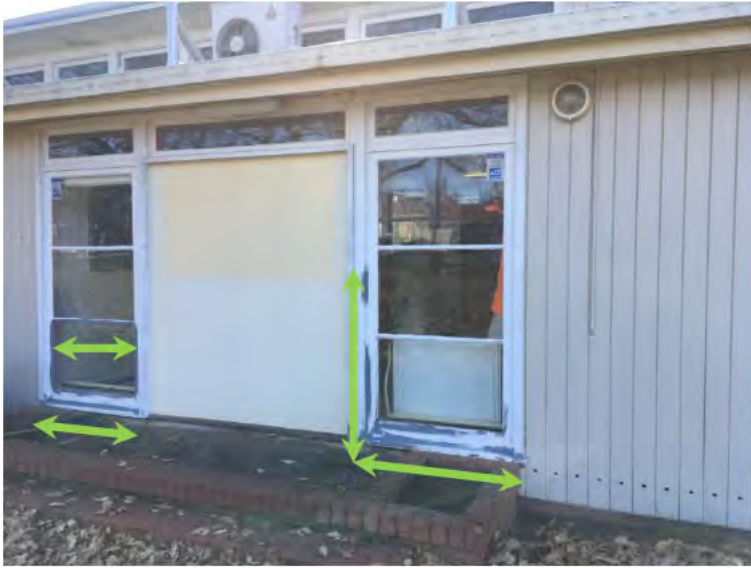
Surfaces which had lead paint removed appeared to have been stripped sufficiently. However it should be noted that lead paint still remains to the structural surfaces. Encapsulation with new weatherproof paint of these surfaces has been organised. Figure 1 to Figure 2 below outline the representative areas where areas of flaking and peeling the lead paint had been removed to allow workers to safely apply a new coat of paint. Figure 7 to Figure 12 below outline the removal of lead paint debris from top surfaces of the surrounding soil surfaces.

Figure 1: Exterior surfaces after removal of flaking and peeling lead paint

1. Workers conducting the repainting works should wear appropriate respiratory protection during the application of new paint, to provide protection against lead concentrations that are still adhered on to surfaces.
2. Workers should practice good personal hygiene practices following repainting works, including washing hands and face following completion of the works and prior to eating, drinking or smoking.

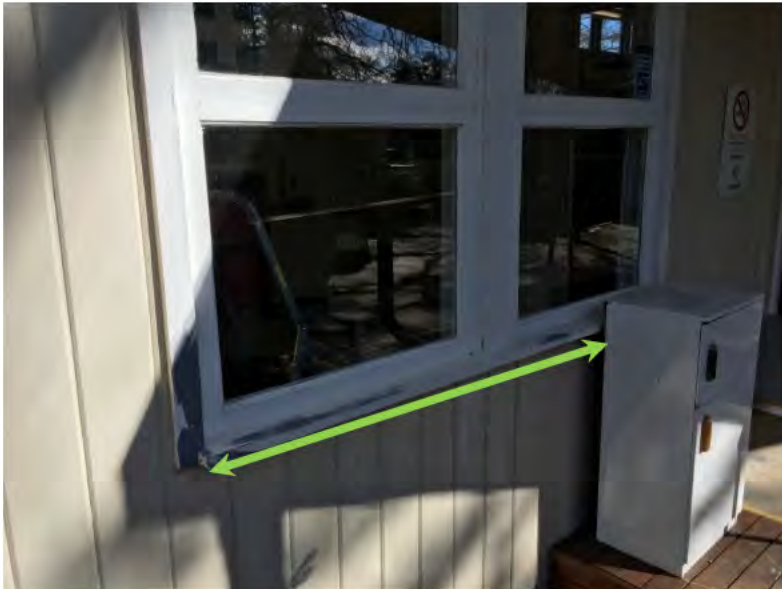
Figure 2: Exterior surfaces after removal of flaking and peeling lead paint

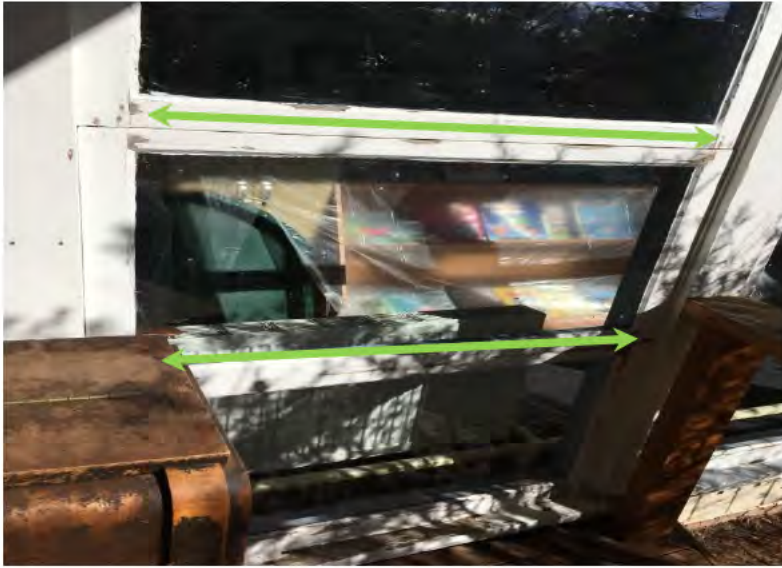
Figure 3 Exterior surfaces after removal of flaking and peeling lead paint

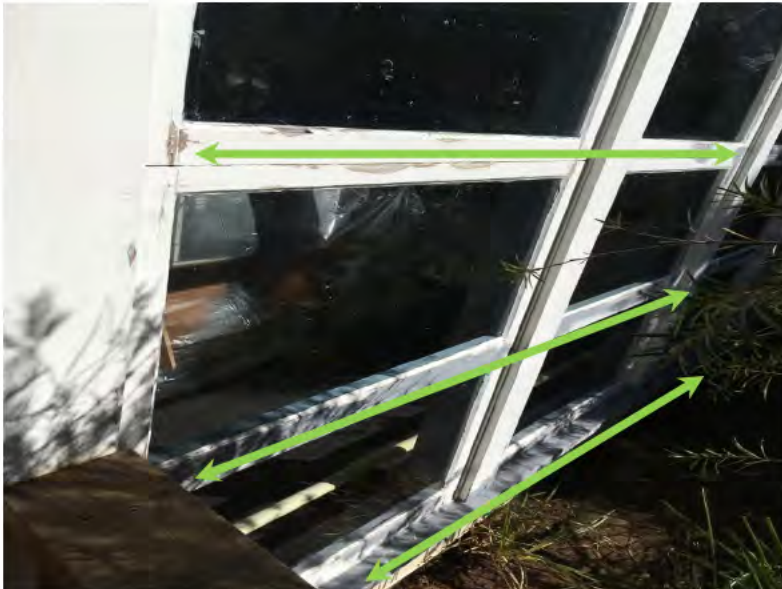
Figure 4: Exterior surfaces after removal of flaking and peeling lead paint

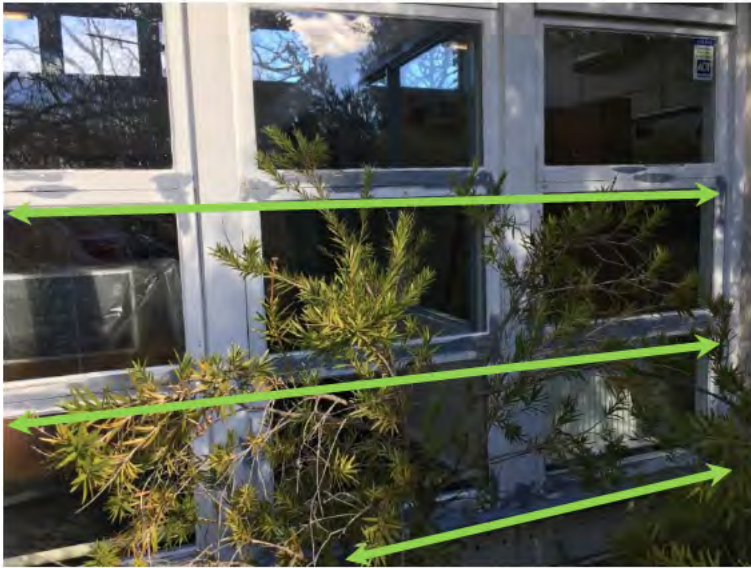
Figure 5: Exterior surfaces after removal of flaking and peeling lead paint

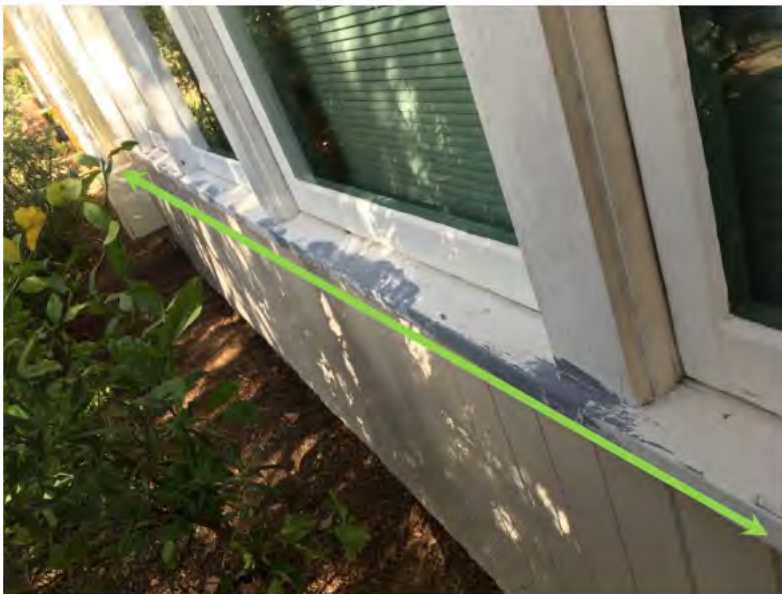
Figure 6: Exterior surfaces after removal of flaking and peeling lead paint

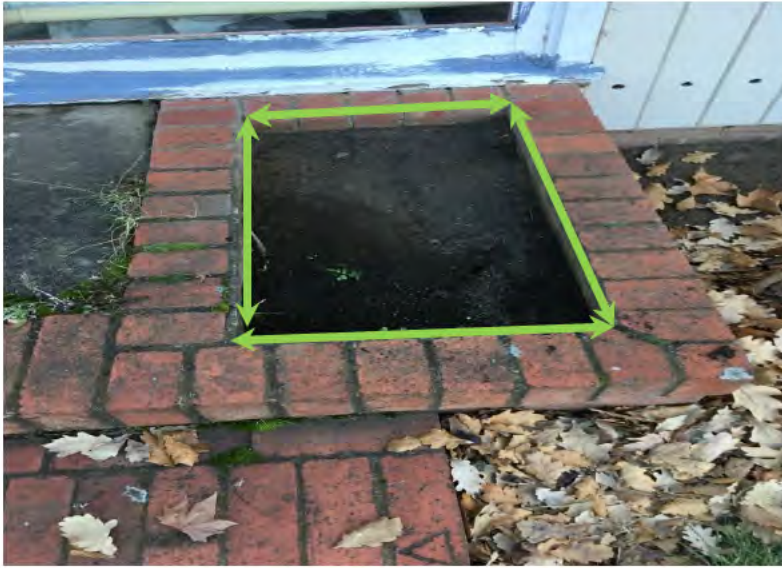
Figure 7: Exterior surrounding soil surfaces after removal of lead paint debris

The lead paint clearance assessment undertaken at the Yarralumla Primary Gambarri Preschool Building on Wednesday 17 July 2019 found that the lead paint removal works to be satisfactory, as that there was no visual sign of flaking lead paint remaining on surfaces. It is recommended that all of the leaf litter from around the perimeter of the Gambarri Preschool building be removed as there were lead paint fragments found throughout.

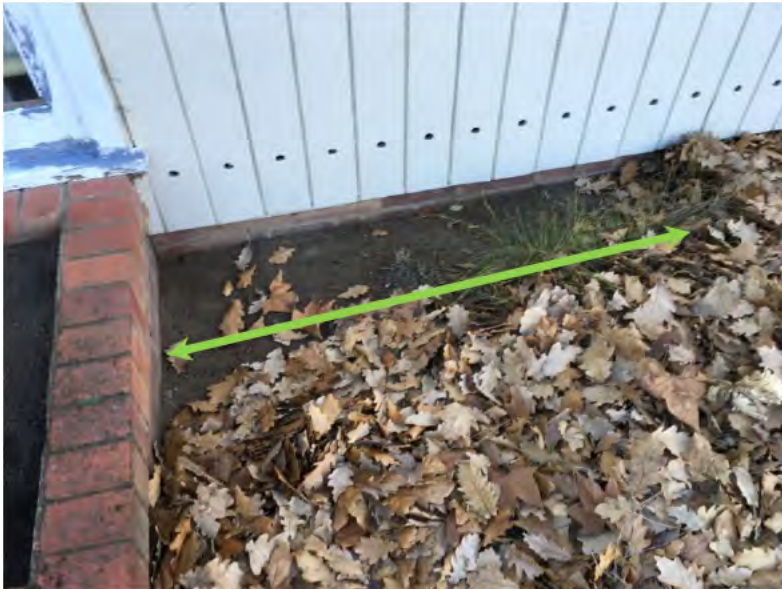
Figure 8: Exterior surrounding soil surfaces after removal of lead paint debris

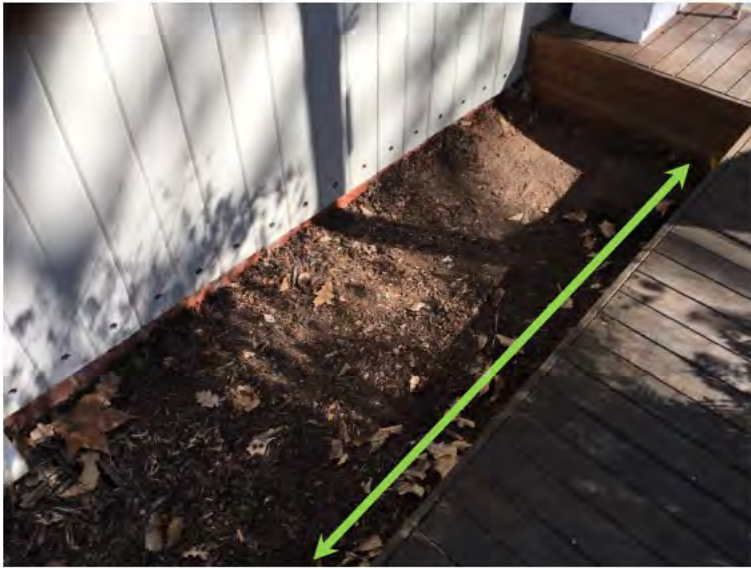
Figure 9: Exterior surrounding soil surfaces after removal of lead paint debris

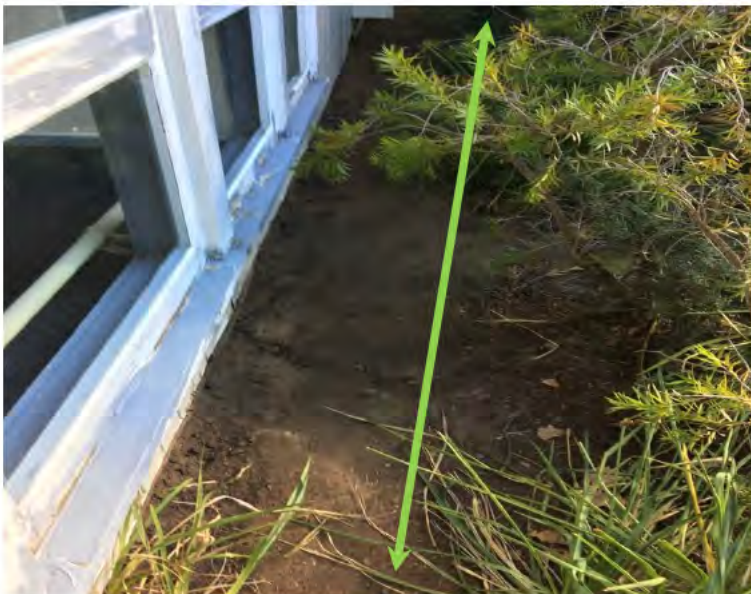
Figure 10: Exterior surrounding soil surfaces after removal of lead paint debris

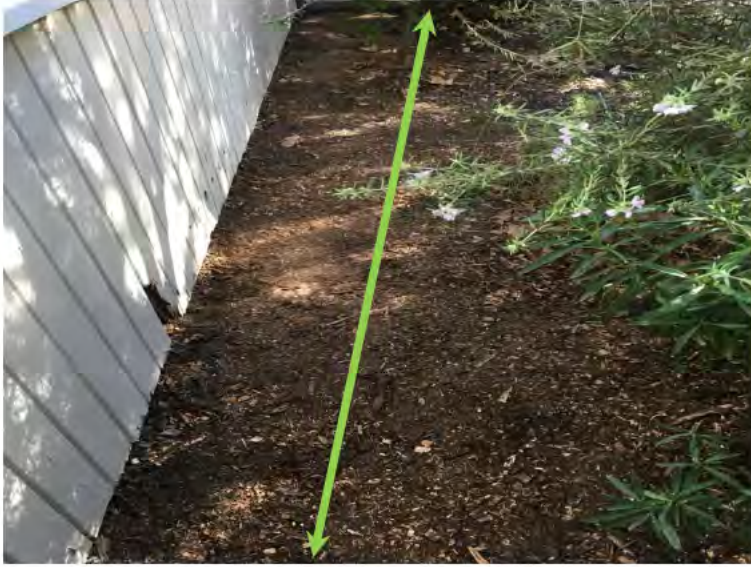
Figure 11: Exterior surrounding soil surfaces after removal of lead paint debris

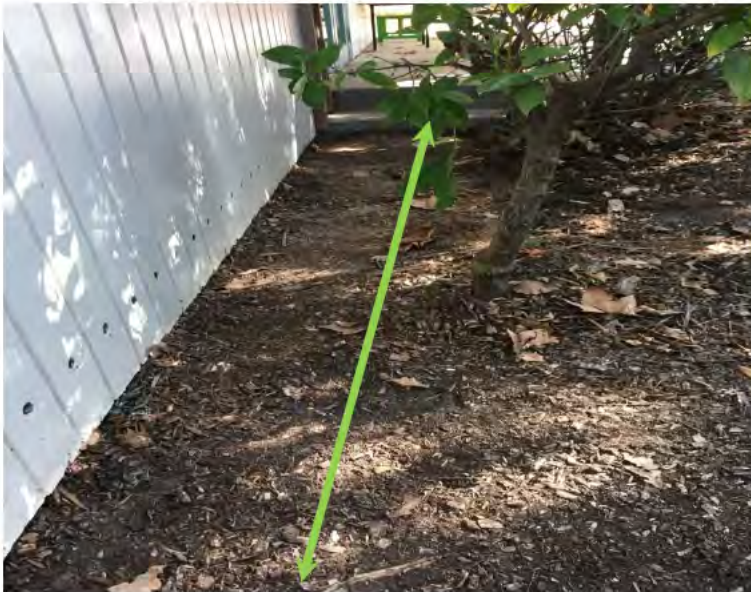
Figure 12: Exterior surrounding soil surfaces after removal of lead paint debris

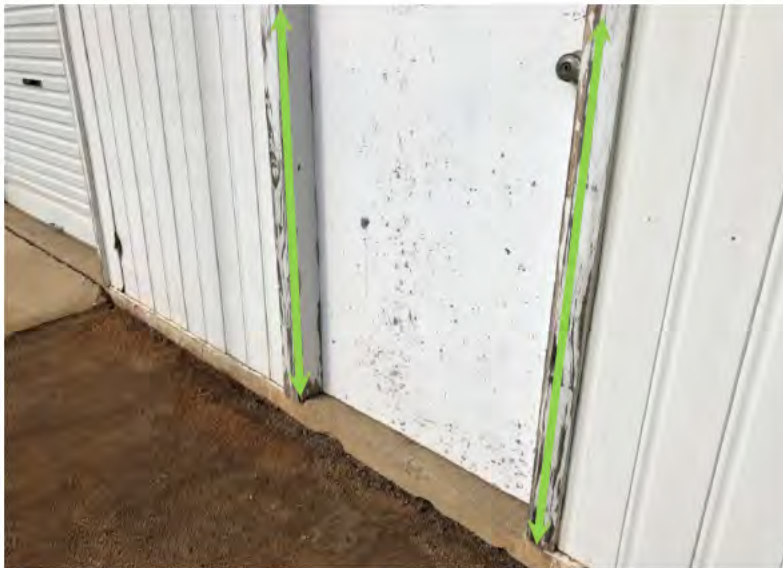
Surfaces which had lead paint removed appeared to have been stripped sufficiently. However it should be noted that lead paint still remains to the structural surfaces. Encapsulation with new weatherproof paint of these surfaces has been organised. Figure 1 and Figure 2 below outline the representative areas where areas of flaking and peeling the lead paint had been removed to allow

Figure 1: Exterior surfaces after removal of flaking and peeling lead paint

1. Workers conducting the repainting works should wear appropriate respiratory protection during the application of new paint, to provide protection against lead concentrations that are still adhered on to surfaces.
2. Workers should practice good personal hygiene practices following repainting works, including washing hands and face following completion of the works and prior to eating, drinking or smoking.

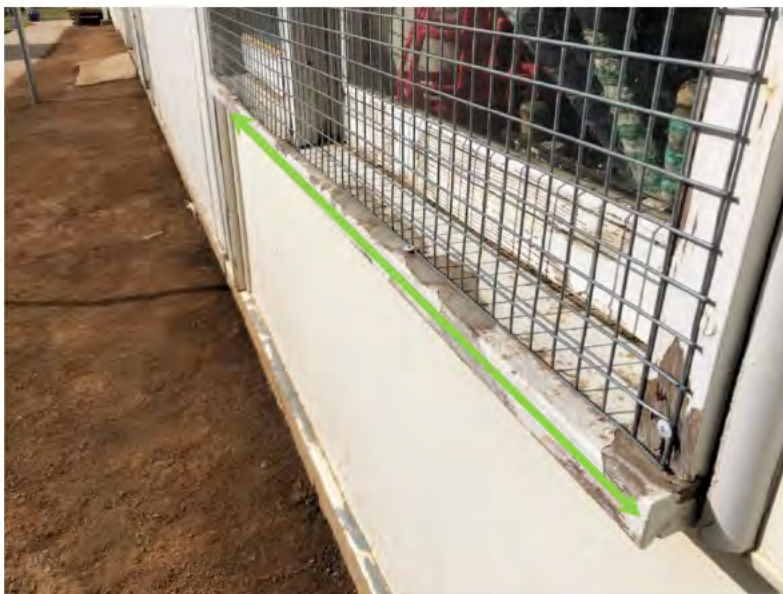
Figure 2: Exterior surfaces after removal of flaking and peeling lead paint

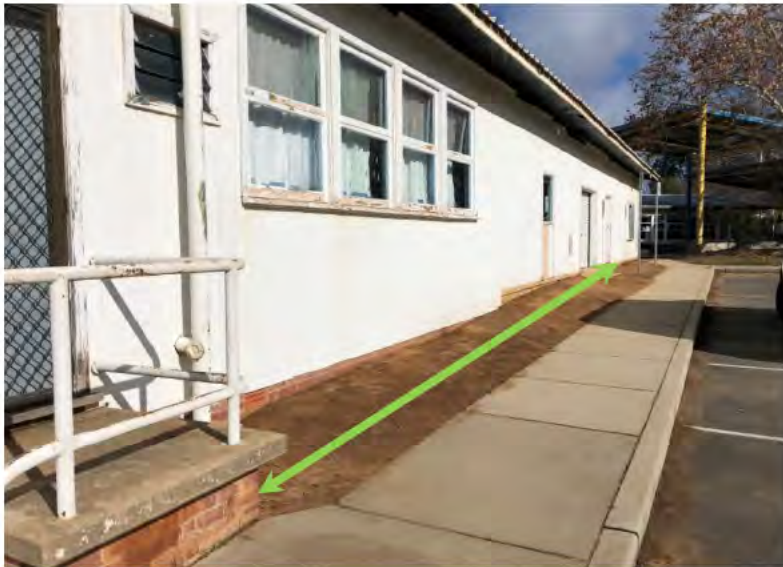
workers to safely apply a new coat of paint. Figure 3 and Figure 4 below outline the removal of lead paint debris from surrounding soil surfaces

Figure 3: Exterior surrounding soil surfaces after removal of lead paint debris

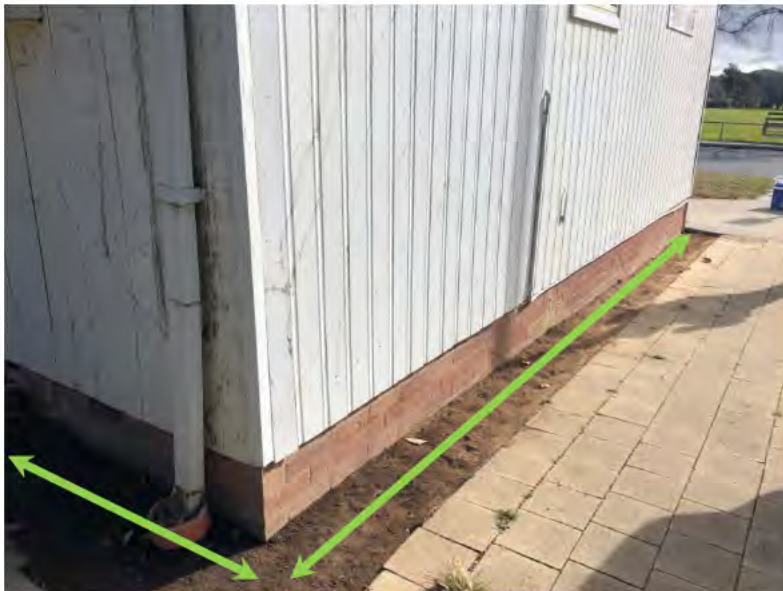
Figure 4: Exterior surrounding soil surfaces after removal of lead paint debris

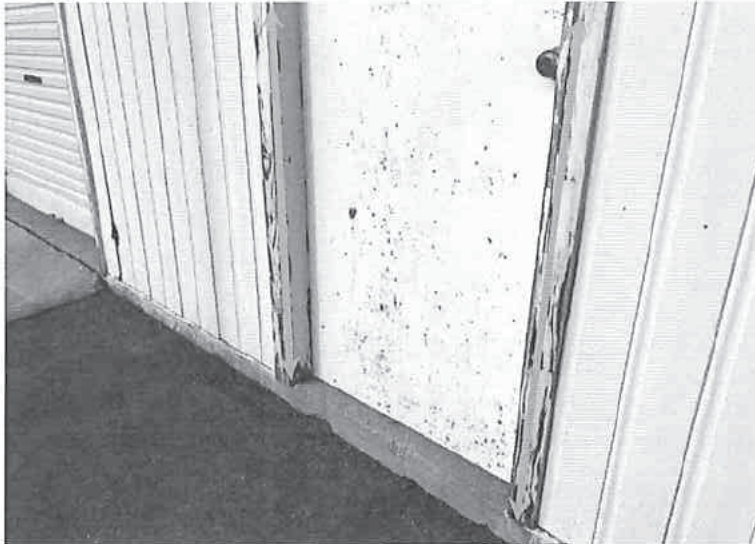
Surfaces which had lead paint removed appeared to have been stripped sufficiently. However it should be noted that lead paint still remains to the structural surfaces. Encapsulation with new weatherproof paint of these surfaces has been organised. Figure 1 and Figure 2 below outline the representative areas where areas of flaking and peeling the lead paint had been removed to allow

Figure 1: Exterior surfaces after removal of flaking and peeling lead paint

1. Workers conducting the repainting works should wear appropriate respiratory protection during the application of new paint, to provide protection against lead concentrations that are still adhered on to surfaces.
2. Workers should practice good personal hygiene practices following repainting works, including washing hands and face following completion of the works and prior to eating, drinking or smoking.

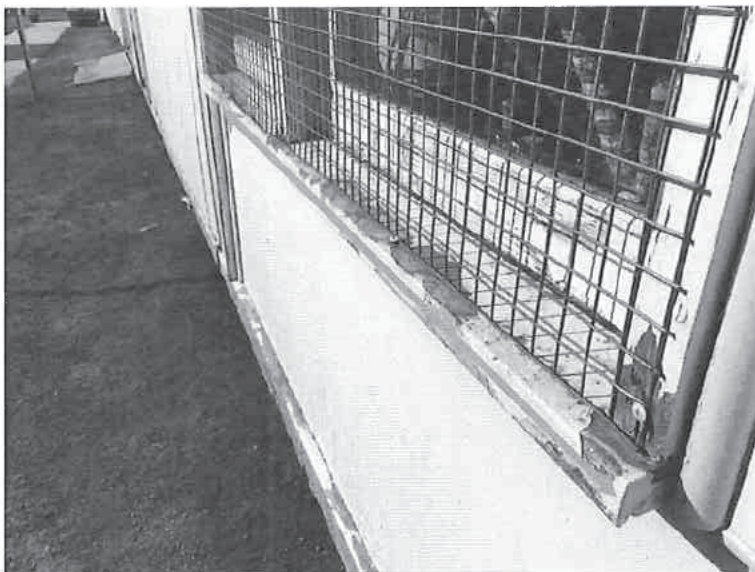
Figure 2: Exterior surfaces after removal of flaking and peeling lead paint

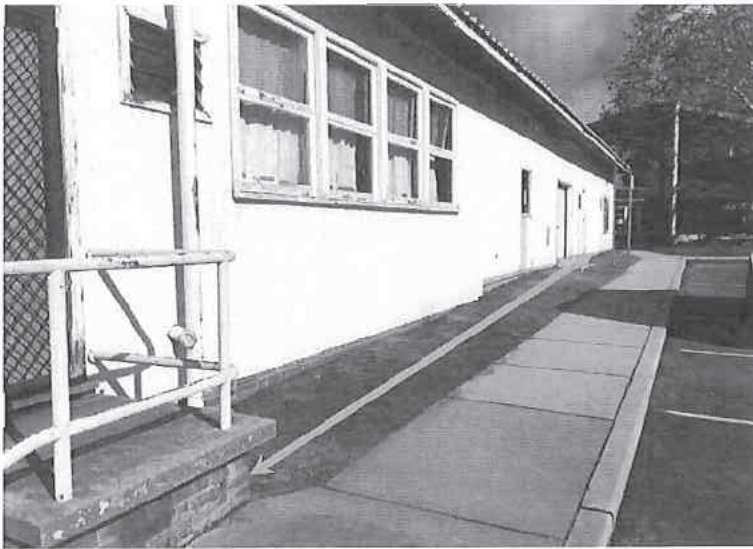
workers to safely apply a new coat of paint. Figure 3 and Figure 4 below outline the removal of lead paint debris from surrounding soil surfaces

Figure 3: Exterior surrounding soil surfaces after removal of lead paint debris

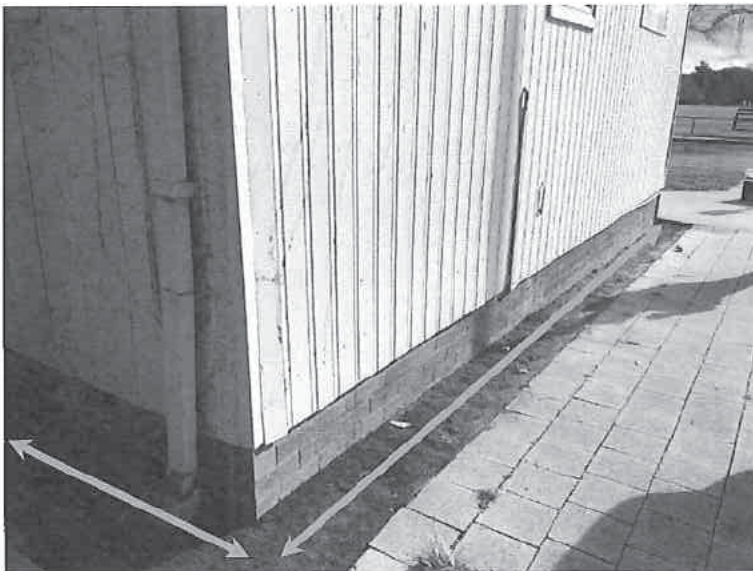
Figure 4: Exterior surrounding soil surfaces after removal of lead paint debris
