Re: Analysis of the sprayed coating debris on top of pinboards of the 1st floor Class room 7.15 (Tracker location 015), Staff room 7.A.1 (Tracker location 011) and Class room 7.6 (Tracker location 023) on 03 February 2021 at Hawker College 51 Murrarji Street Hawker 2614

Removal of light fixtures to ceilings with attached ACM sprayed coating within room 7.4 (TL013) and the Learning Hub (TL017) at Hawker College – on 3 March 2021.

Lead Paint Assessment

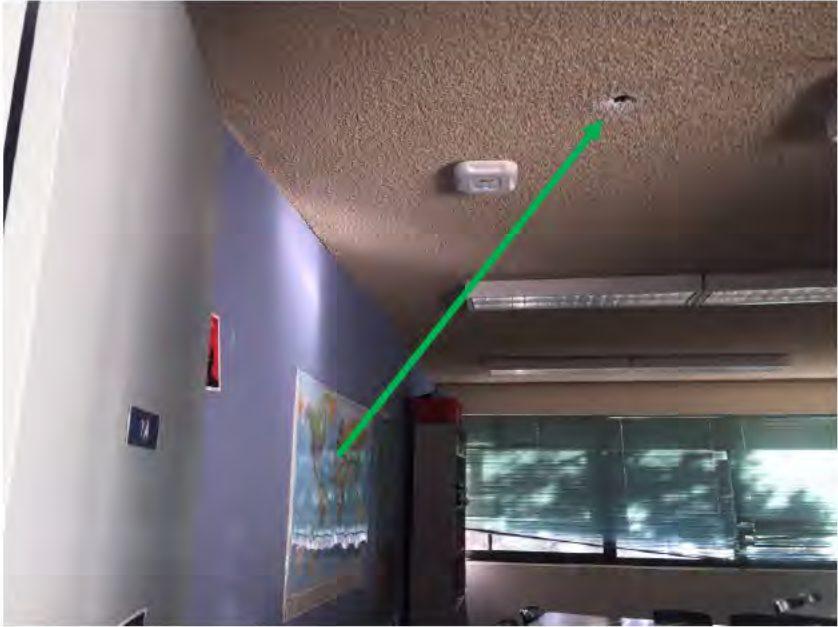
PHOTO NO	LOCATION DESCRIPTION	MATERIAL	PHOTOGRAPH
1	Room 7.4 (TL013) following removal	sprayed coating

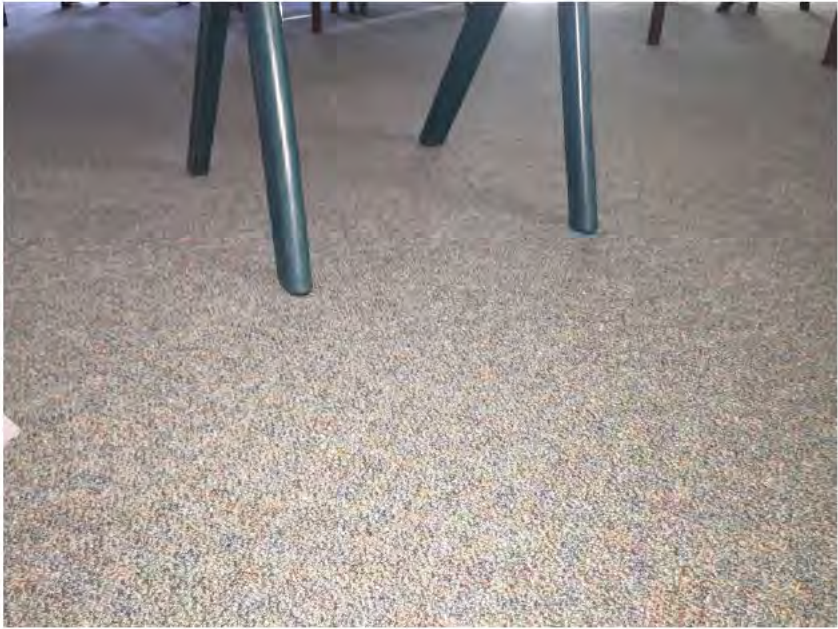
2	Room 7.4 (TL013) following removal	sprayed coating

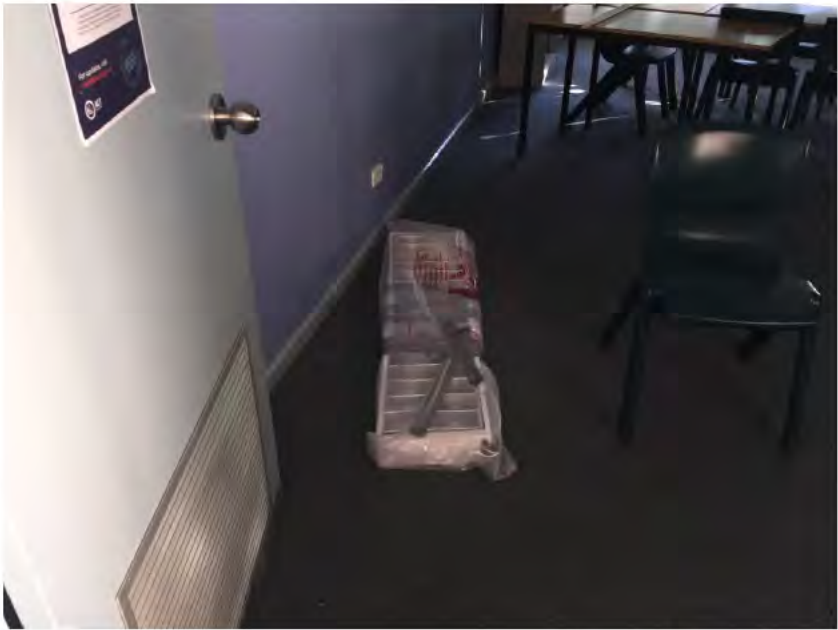
PHOTO NO	LOCATION DESCRIPTION	MATERIAL	PHOTOGRAPH
3	Room 7.4 (TL013) following removal	sprayed coating

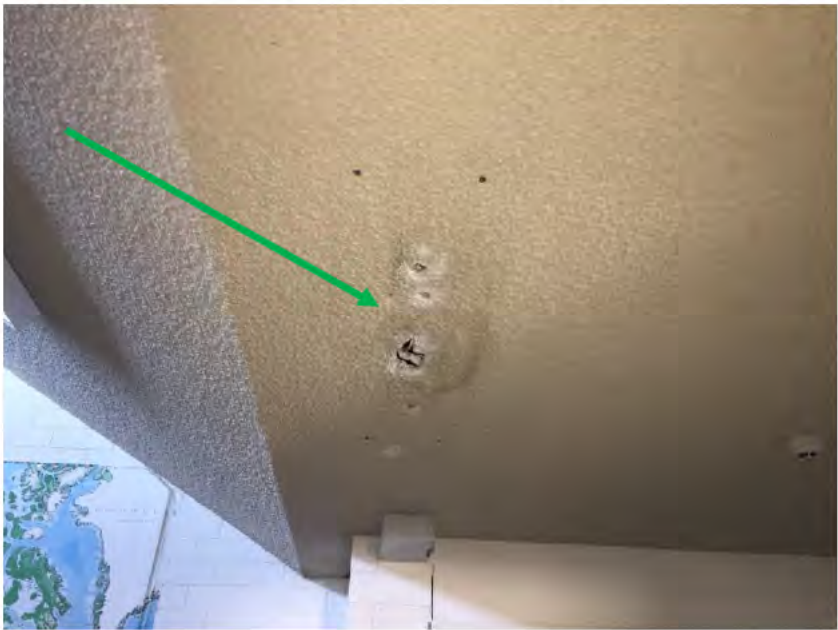
4	Learning Hub (TL017) following removal	sprayed coating

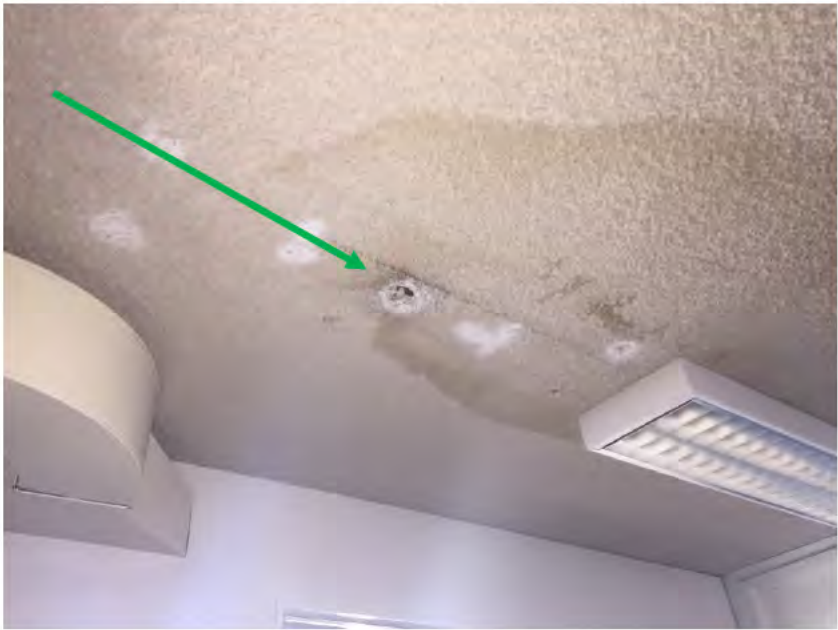
PHOTO NO	LOCATION DESCRIPTION	MATERIAL	PHOTOGRAPH
5	Learning Hub (TL017) following removal	sprayed coating

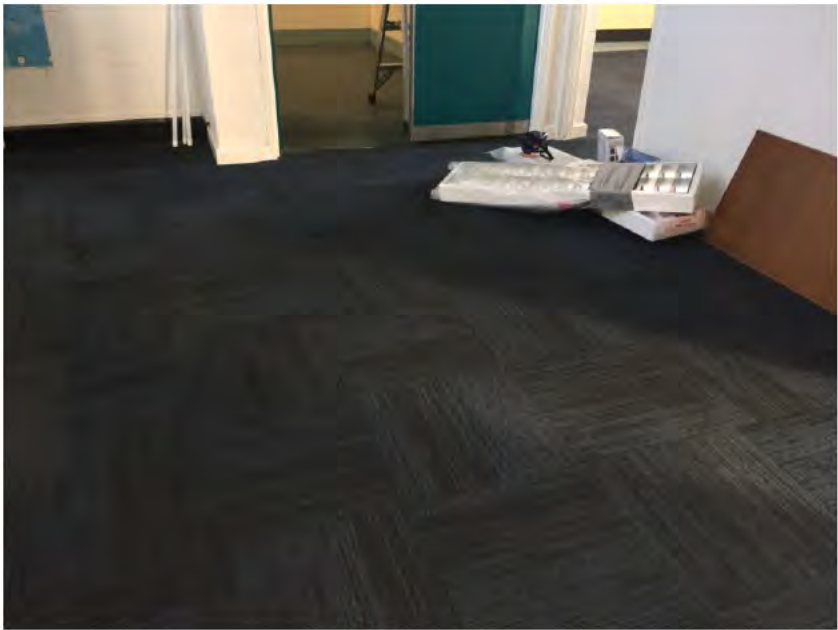
6	Learning Hub (TL017) following removal	sprayed coating

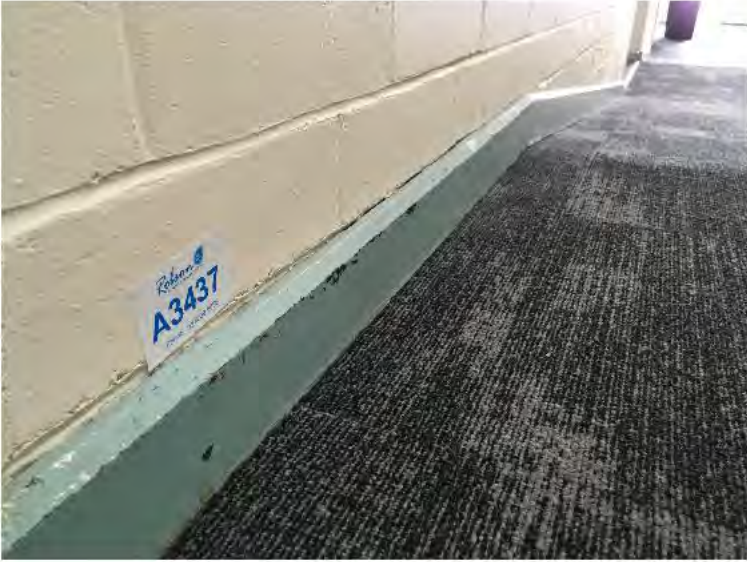
Sample Number	Location Description	Material	Photographs
A3437	Ground floor hallway outside Tracker room 128 - to skirting board	Surface debris

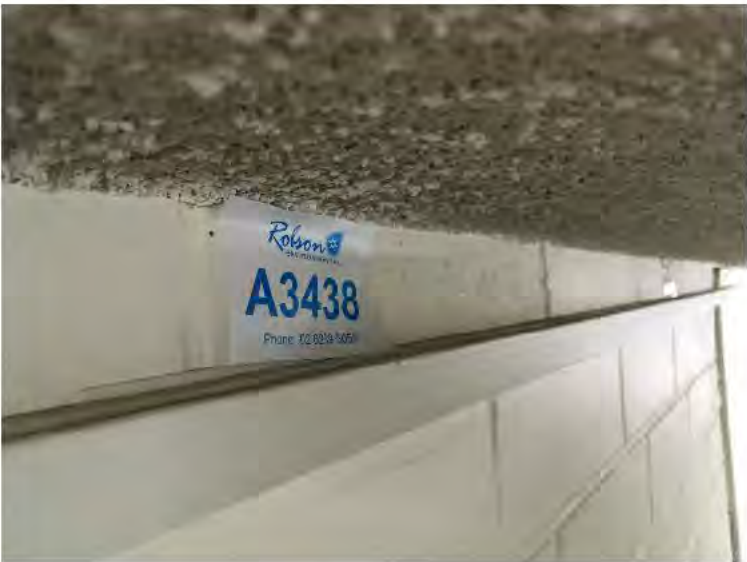
A3438	Ground floor hallway outside Tracker room 128 - top of electrical conduit (south)	Surface debris

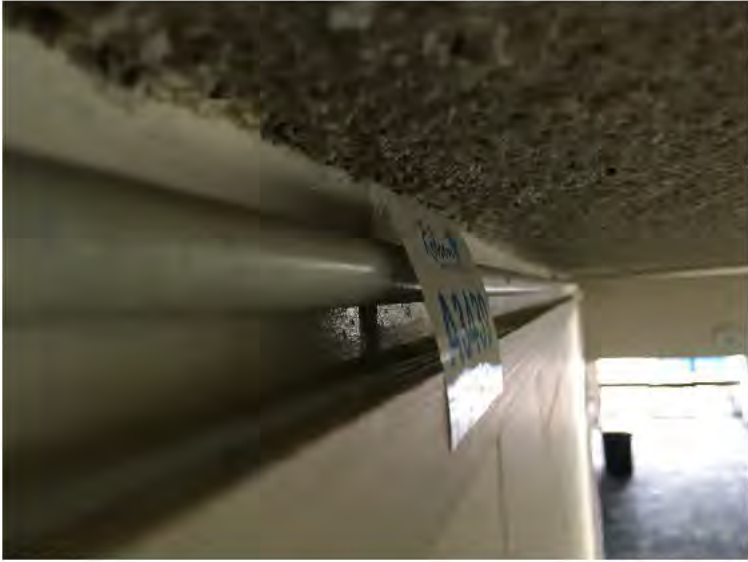
Sample Number	Location Description	Material	Photographs
A3439	Ground floor hallway outside Tracker room 128 - top of electrical conduit (north)	Surface debris

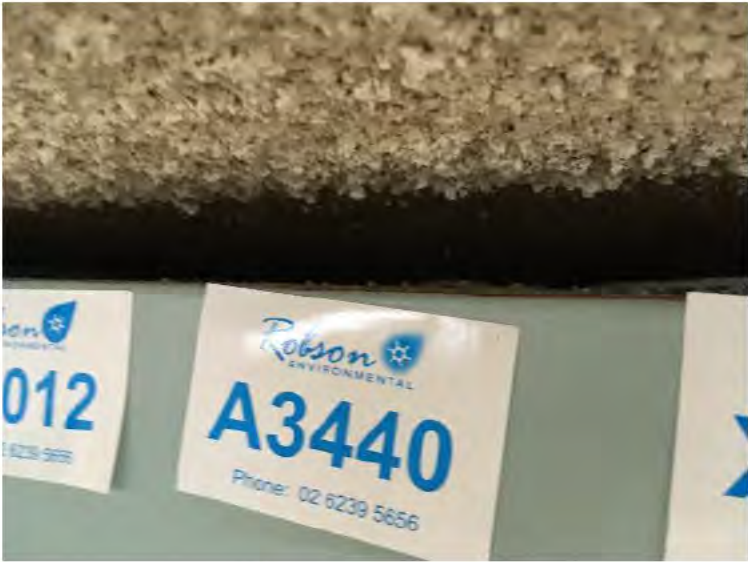
All the surface debris samples from the 1st floor room 7.M.1 (030) and the Ground floor hallway outside Tracker room 128 were found to be non-asbestos. Sprayed coating debris was identified to the top of the duct work and to the carpet adjacent skirting boards in the 1st floor Room 7.M.1 (Tracker location 030). It is recommended that a licensed Asbestos Removalist is engaged to clean up the debris.

A3440	1st floor Room 7.M.1 (Tracker location 030) - above duct work	Surface debris

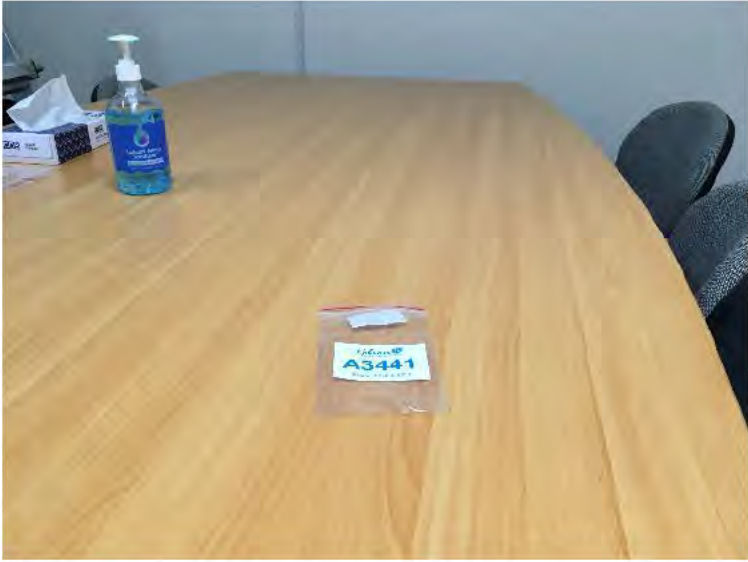
Sample Number	Location Description	Material	Photographs
A3441	1st floor Room 7.M.1 (Tracker location 030) - top of meeting table	Surface debris

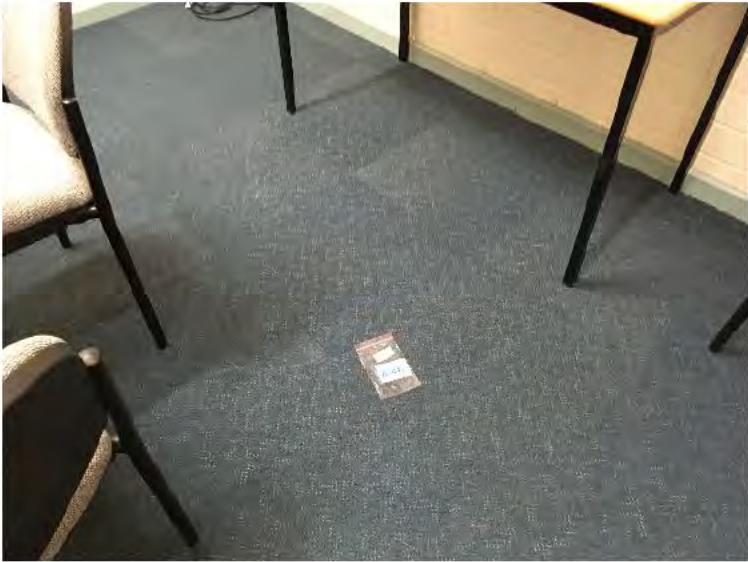
A3442	1st floor Room 7.M.1 (Tracker location 030) - to carpet floor	Surface debris

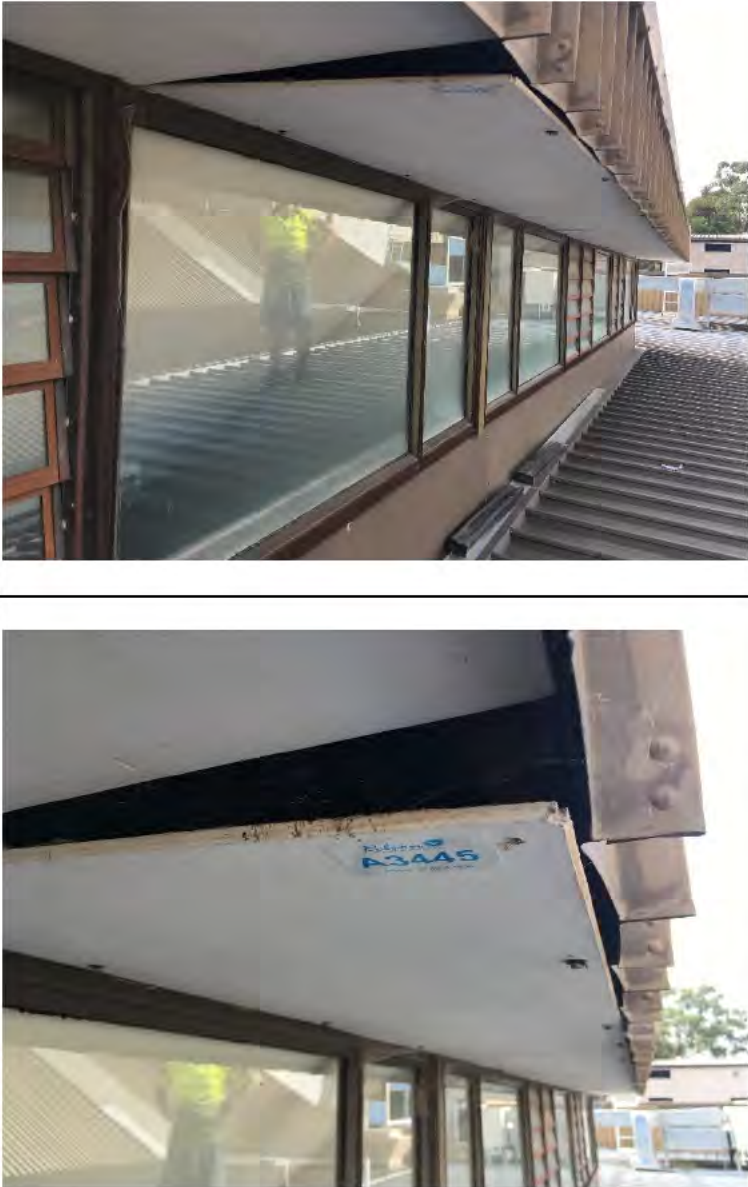
The asbestos containing eave soffit was not found to be securely attached to the roof structure. It is recommended that a licensed Asbestos Removalist either reattaches the end of the eave soffit or removes the entire panel as asbestos waste. It should be presumed that all eave soffits contain asbestos.

Sample Number	Location Description	Material	Photographs
A3445	Exterior Science Lab – eave soffit above central roof	Sheet

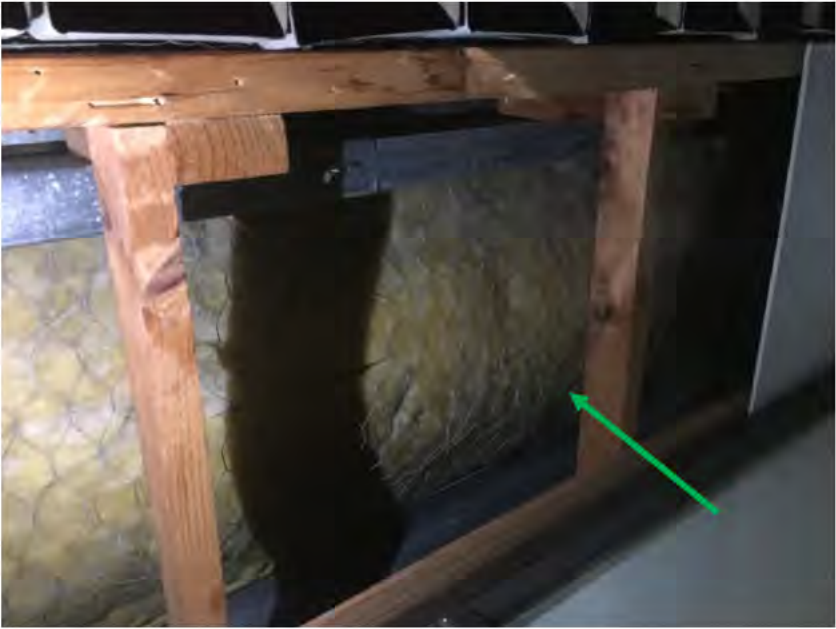
2	Central roof of the Science lab – Specified section only	Sheet

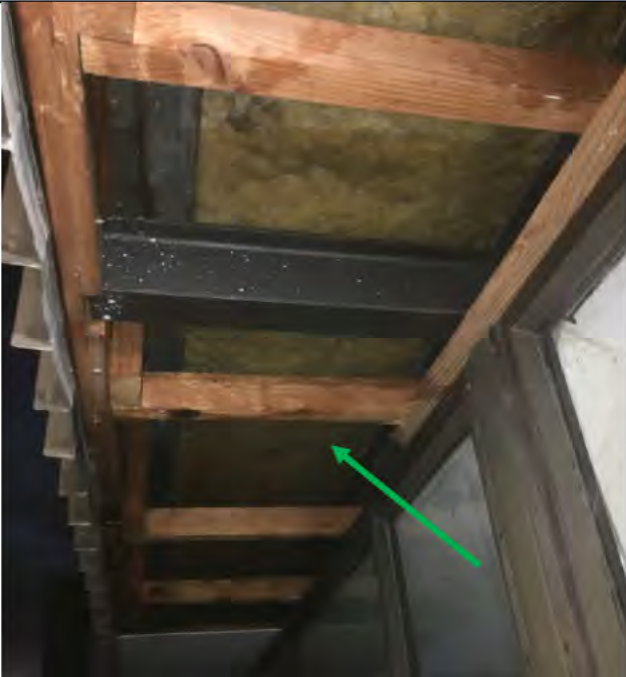
PHOTO NO	LOCATION DESCRIPTION	MATERIAL	PHOTOGRAPH
3	Central roof of the Science lab – Specified section only	Sheet

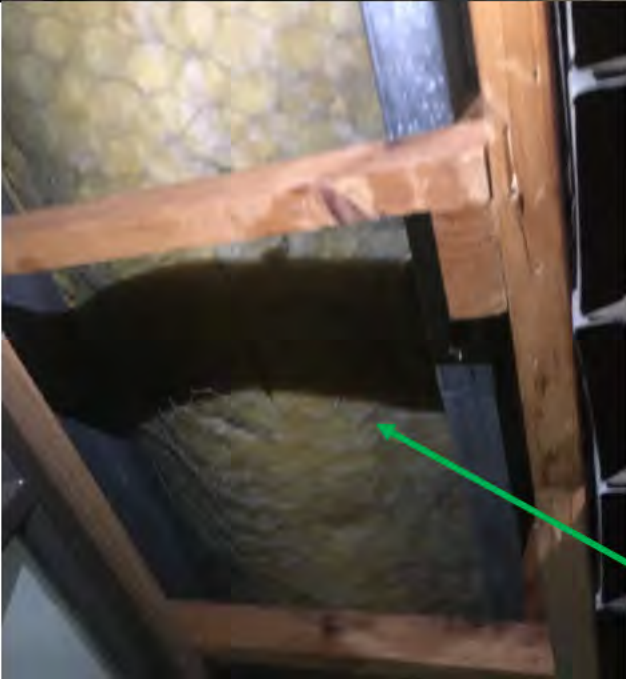
4	Central roof of the Science lab – Specified section only	Sheet

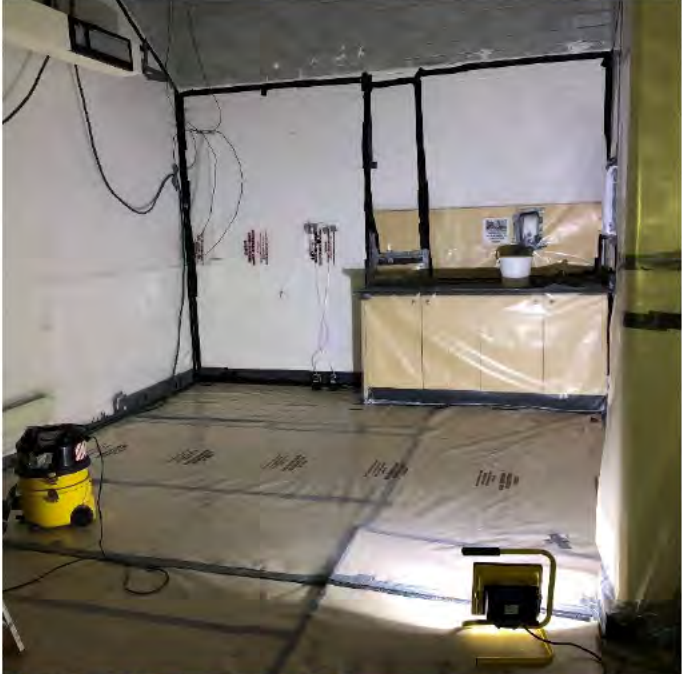
PHOTO NO	LOCATION DESCRIPTION	MATERIAL	PHOTOGRAPH
1	Removal area in TL019	Sprayed coatings

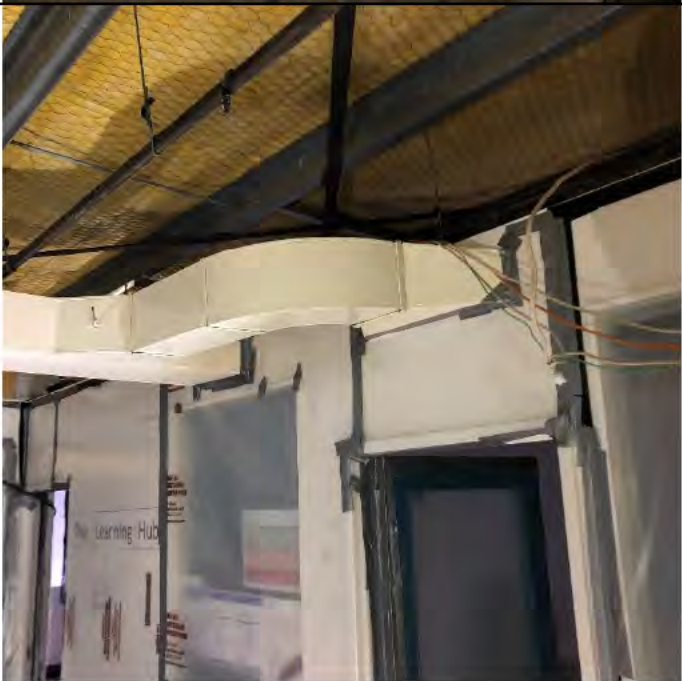
2	Example of removed ceiling in TL017 in to TL020	Sprayed coatings

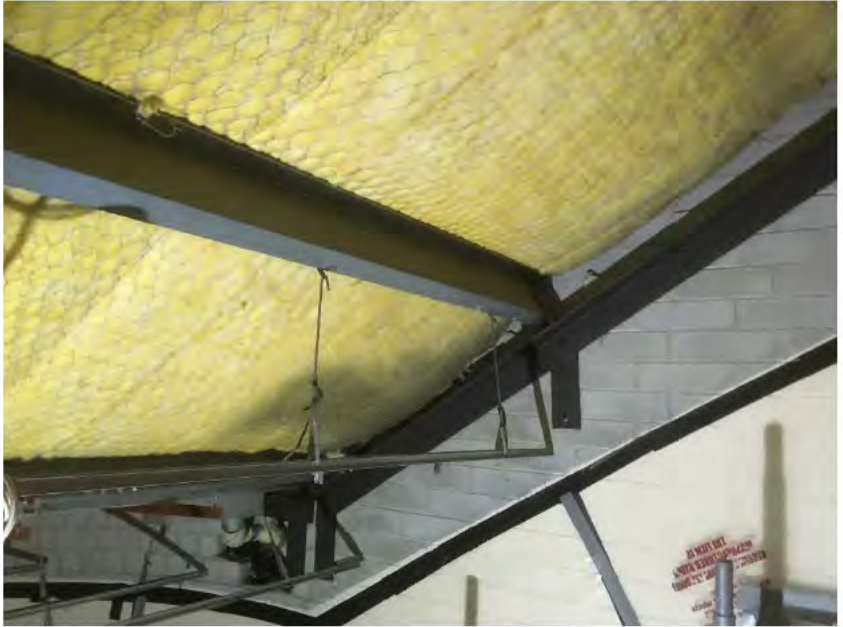
PHOTO NO	LOCATION DESCRIPTION	MATERIAL	PHOTOGRAPH
1	Top of West Stairwell Tracker Location 007	Ceiling structure after removal works

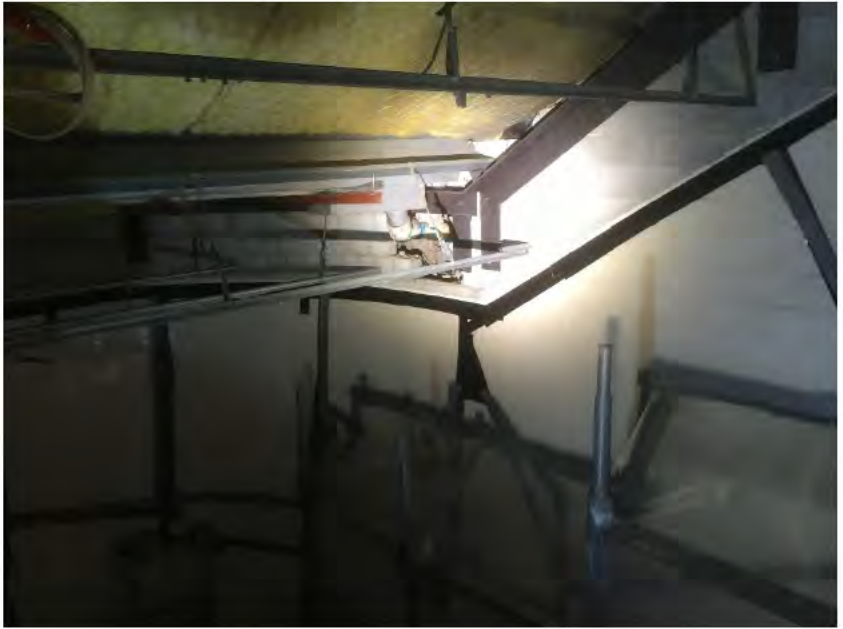
2	Top of West Stairwell Tracker Location 007	Ceiling structure after removal works

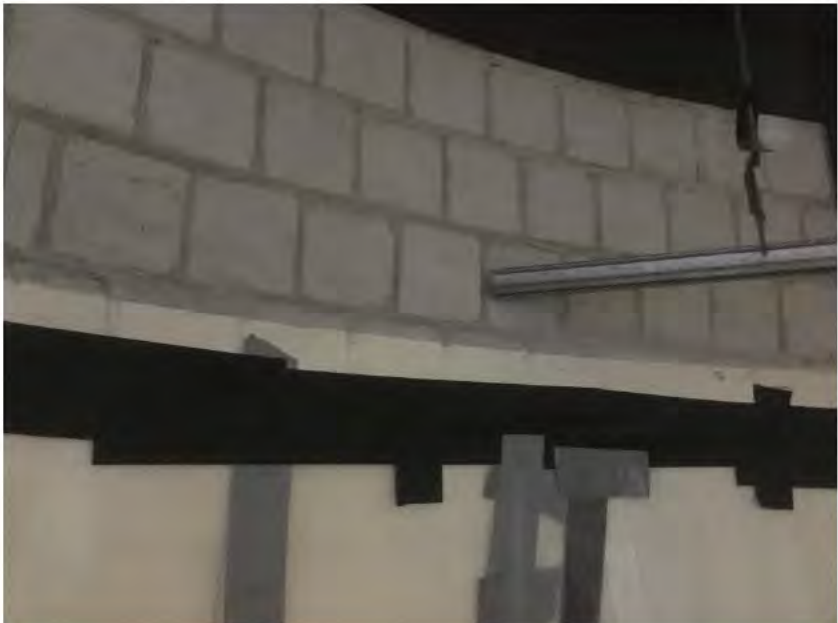
PHOTO NO	LOCATION DESCRIPTION	MATERIAL	PHOTOGRAPH
3	Top of West Stairwell Tracker Location 007	Ceiling structure after removal works

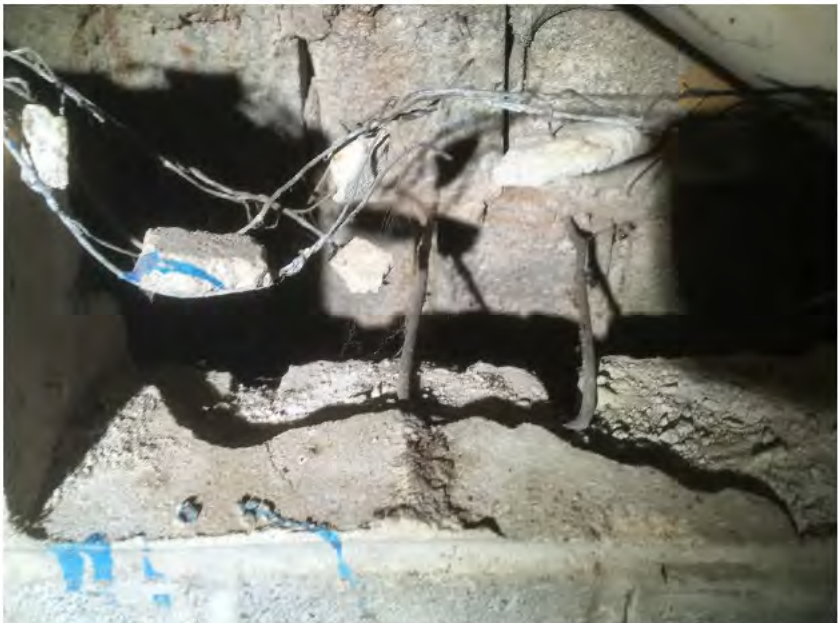
4	Top of West Stairwell Tracker Location 007	Brickwork through-hole for PVC pipe after removal works

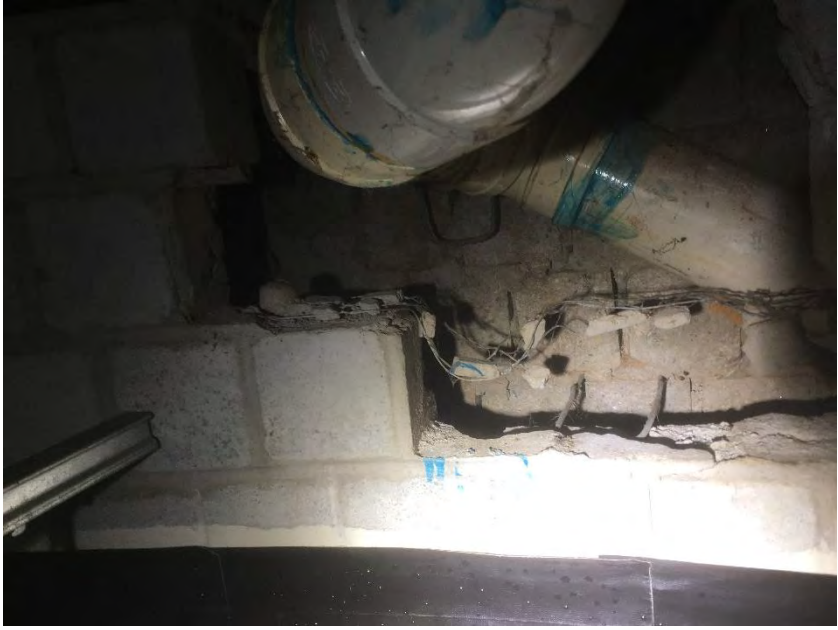
5	Top of West Stairwell Tracker Location 007	Brickwork through-hole for PVC pipe after removal works

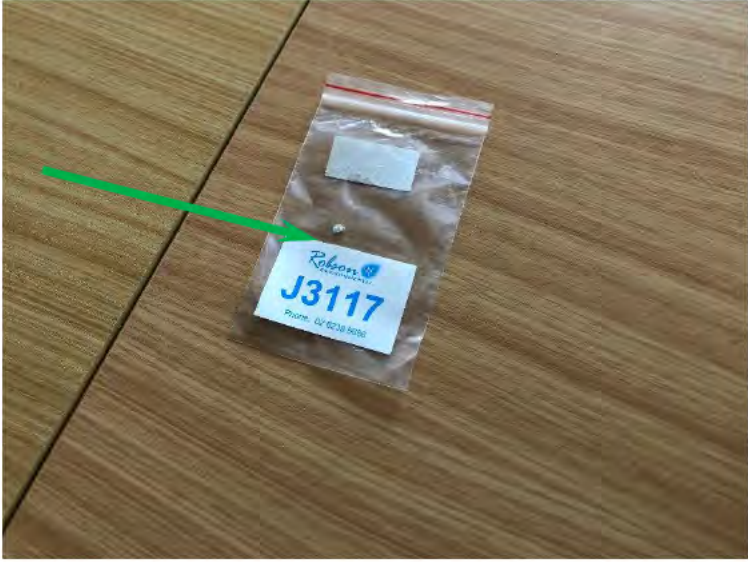
Sample Number	Location Description	Material	Photographs
J3117	1st floor A.T. Location 25 (Room 7.8) central desk	Surface debris

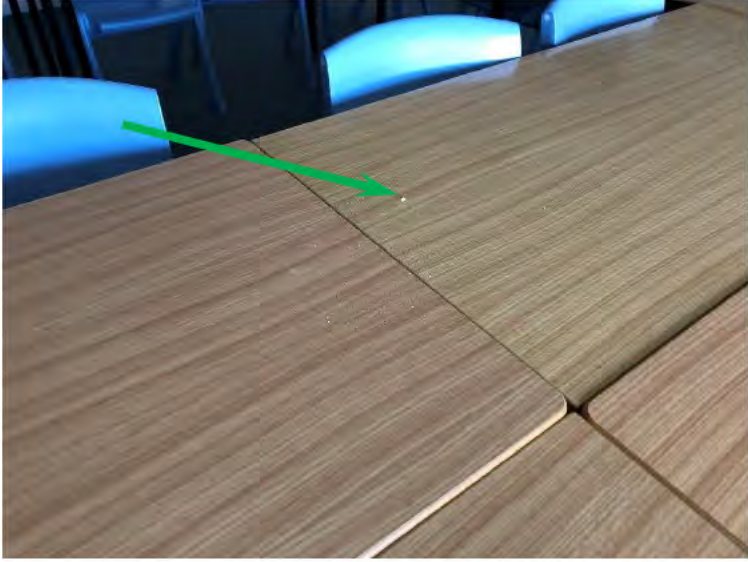
J3117	1st floor A.T. Location 25 (Room 7.8) central desk	Surface debris

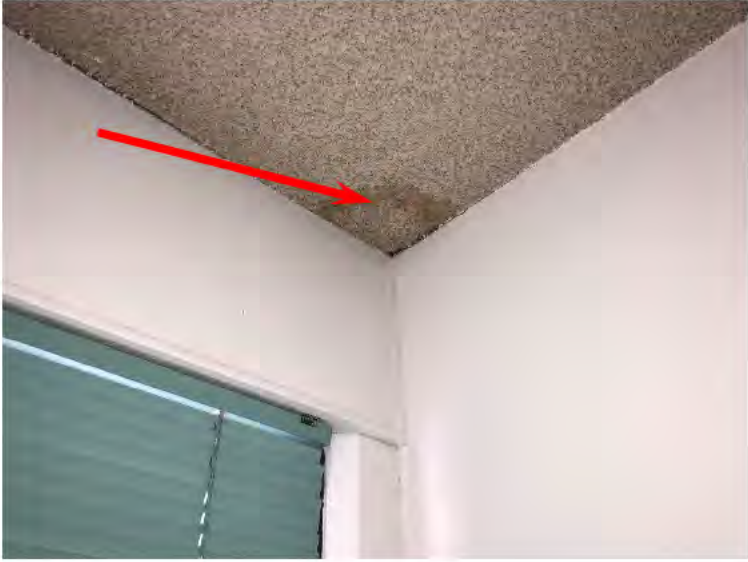
Sample Number	Location Description	Material	Photographs
J3118	1st floor A.T. Location 25 (Room 7.8) north east corner	Water damaged sprayed coating

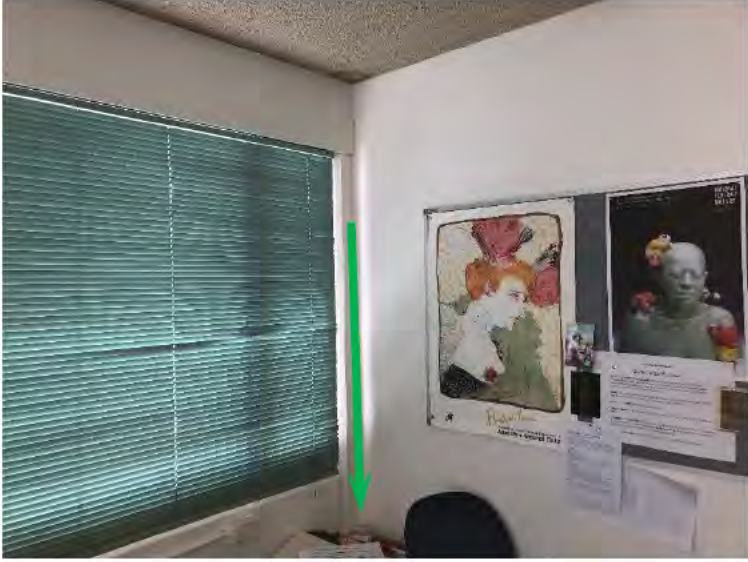
J3118	1st floor A.T. Location 25 (Room 7.8) north east corner	Surface debris

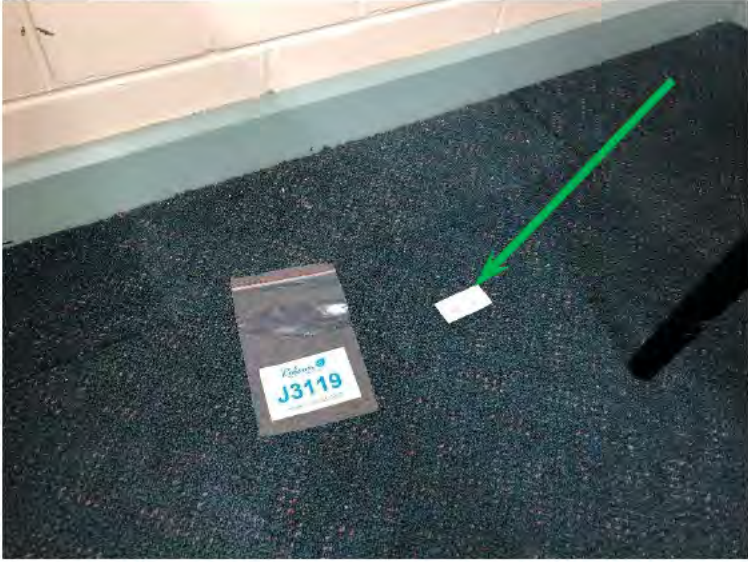
Sample Number	Location Description	Material	Photographs
J3119	1st floor A.T. Location 30 (Room 7.M.1) south west corner carpet	Surface debris

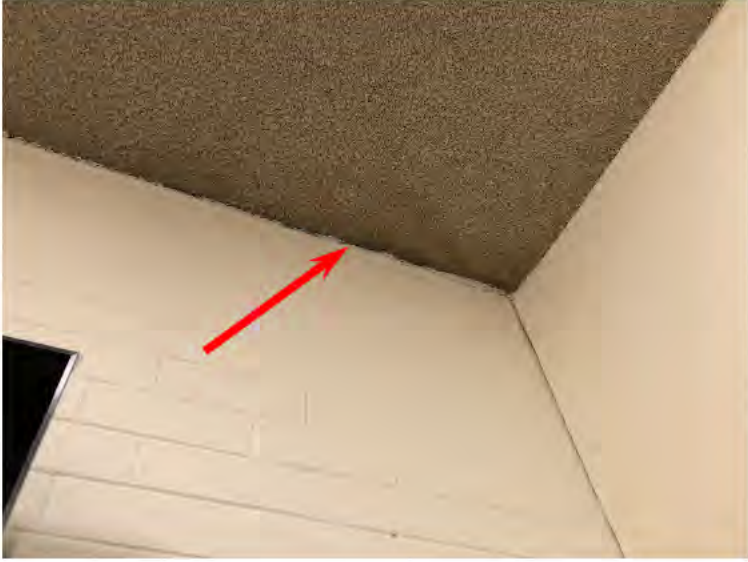
J3119	1st floor A.T. Location 30 (Room 7.M.1) south west corner carpet	Water damaged sprayed coating

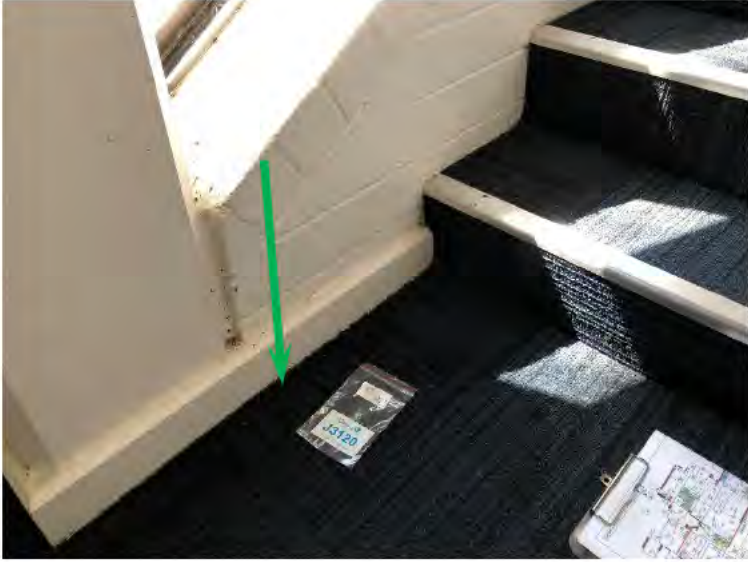
Sample Number	Location Description	Material	Photographs
J3120	Ground floor north west exit to library between flights of stairs	Surface debris

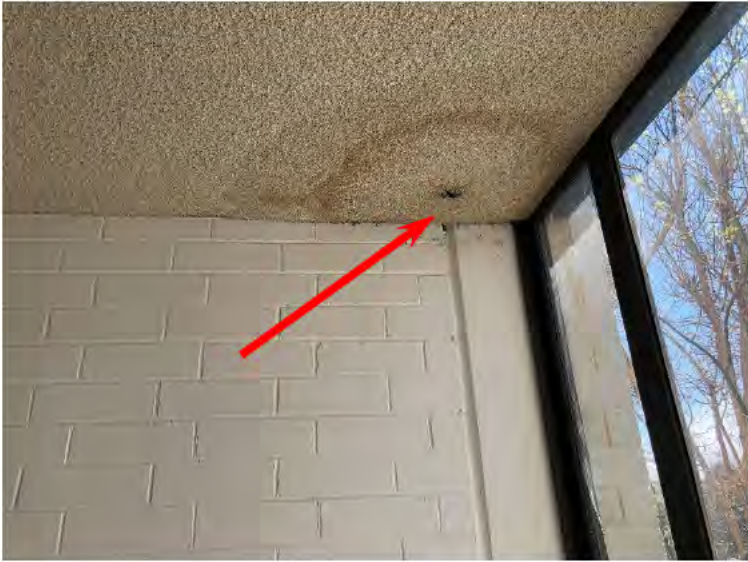
J3120	Ground floor north west exit to library between flights of stairs	Water damaged sprayed coating)

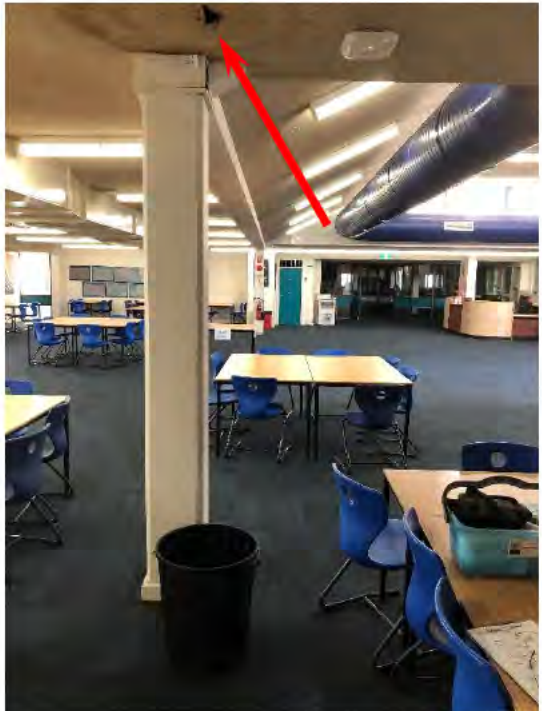
Sample Number	Location Description	Material	Photographs
1	Ground floor Library north eastern area adjacent column looking south	Water damaged sprayed coating

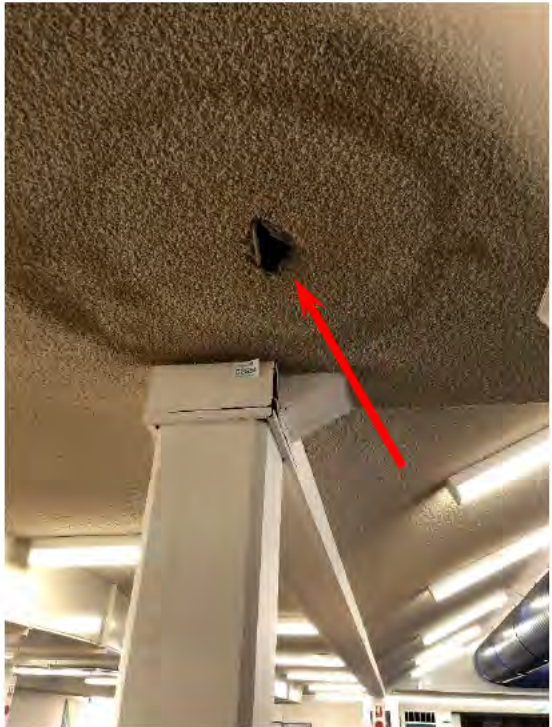
2	Ground floor Library north eastern area adjacent column	Water damaged sprayed coating

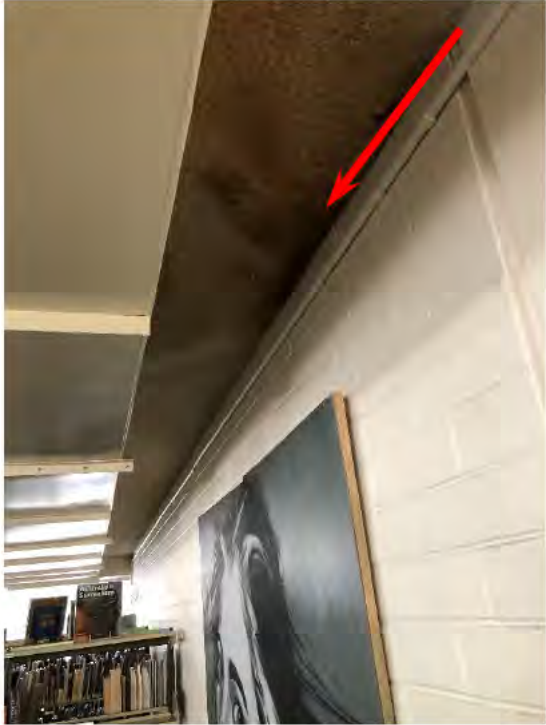
Sample Number	Location Description	Material	Photographs
3	Ground floor Library north eastern column between northern wall and the air-conditioning ducting	Water damaged sprayed coating

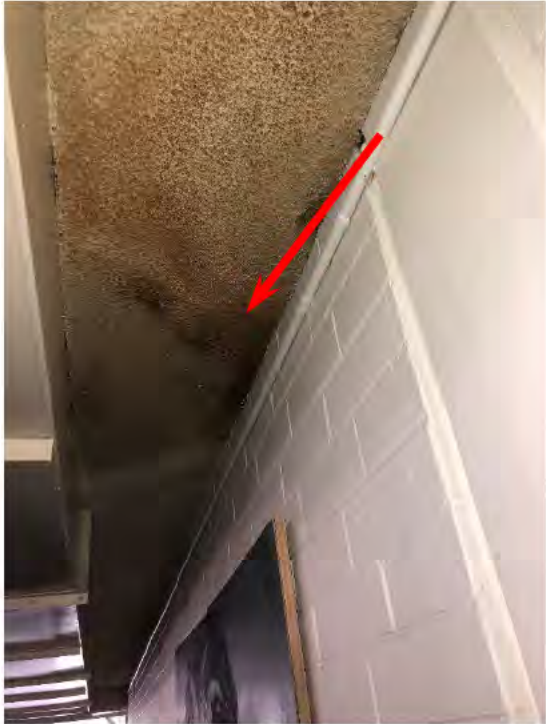
4	Ground floor Library north eastern column between northern wall and the air-conditioning ducting	Water damaged sprayed coating

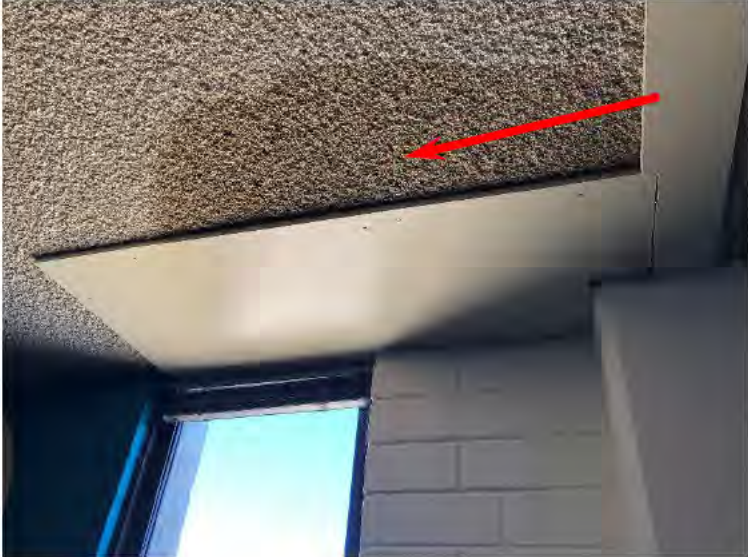
Sample Number	Location Description	Material	Photographs
5	Mezzanine Level perimeter wall central area	Water damaged sprayed coating

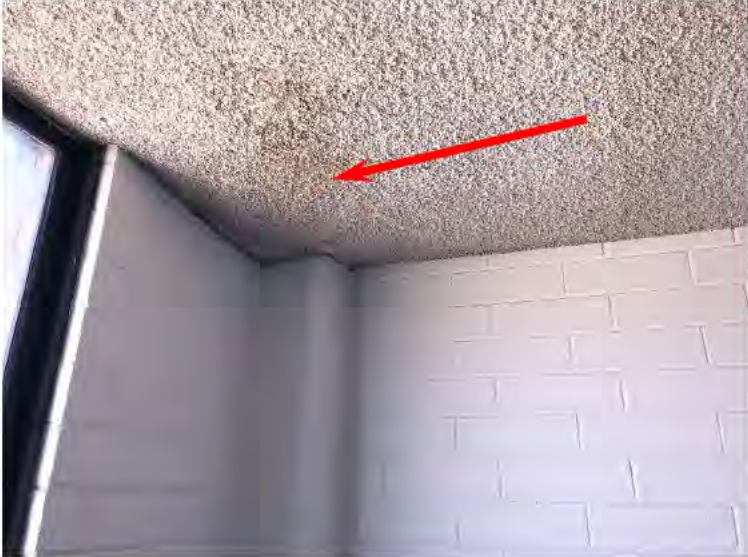
6	Mezzanine Level perimeter wall north western corner	Water damaged sprayed coating

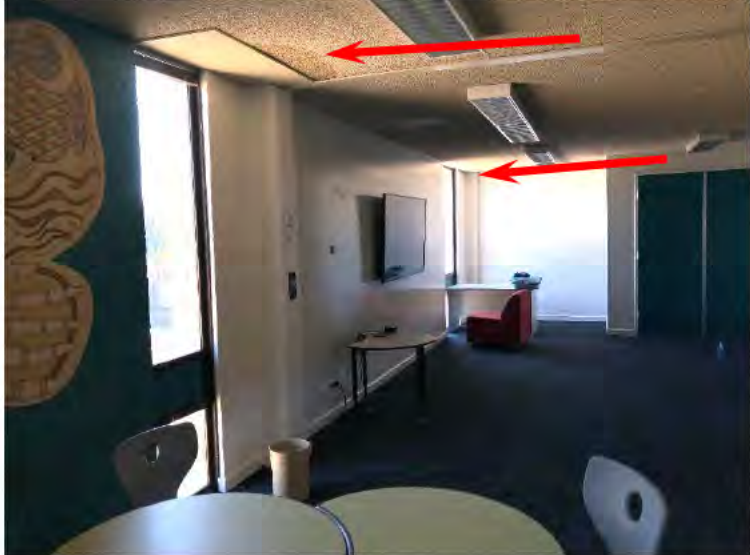
Sample Number	Location Description	Material	Photographs
7	Mezzanine Level perimeter wall central area (photograph 5) and north western corner (photograph 6)	Water damaged sprayed coating

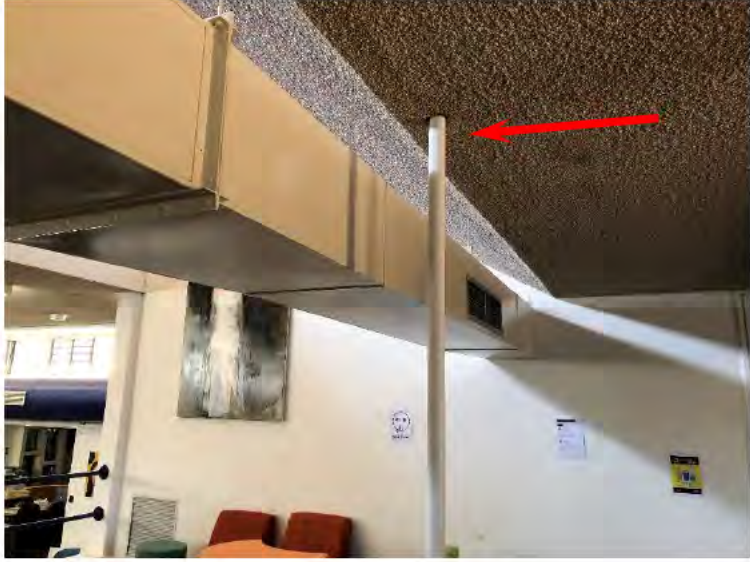
8	Mezzanine Level central area pipe through ceiling where impact on pipe could disturb sprayed coating	Water damaged sprayed coating

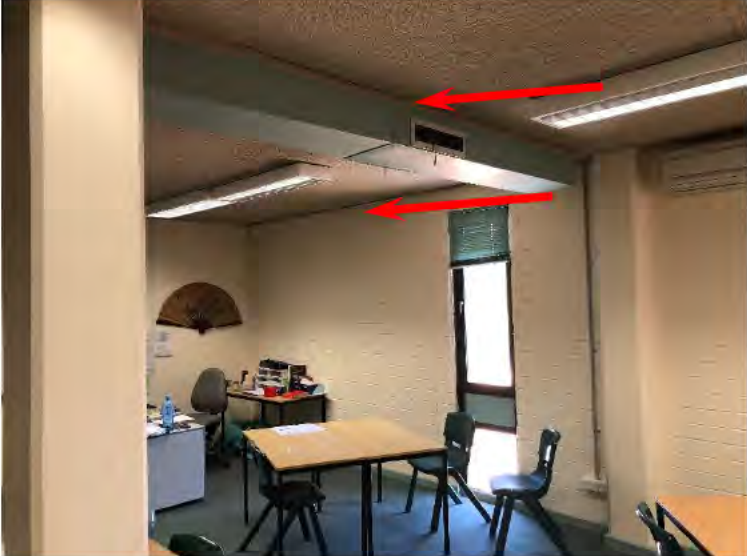
Sample Number	Location Description	Material	Photographs
9	First floor Room 7.5 air conditioning duct vibration concern against sprayed coating and gap to perimeter wall	Sprayed coating

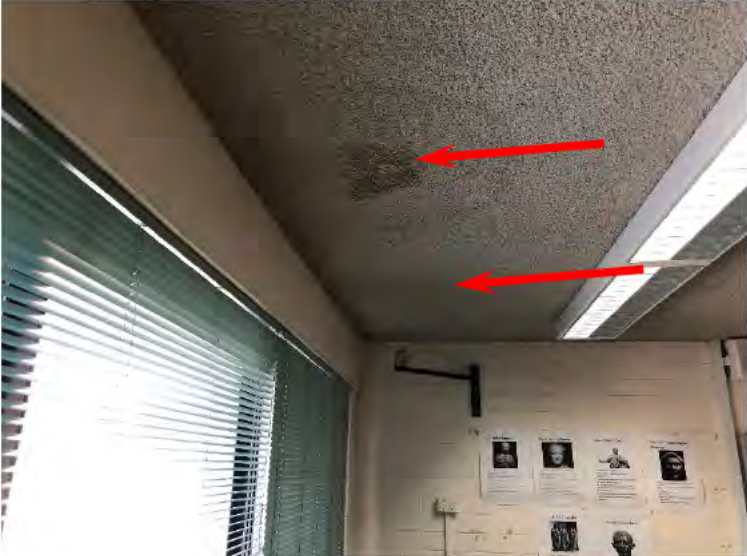
10	First floor Room 7.4 ceiling areas	Water damaged sprayed coating

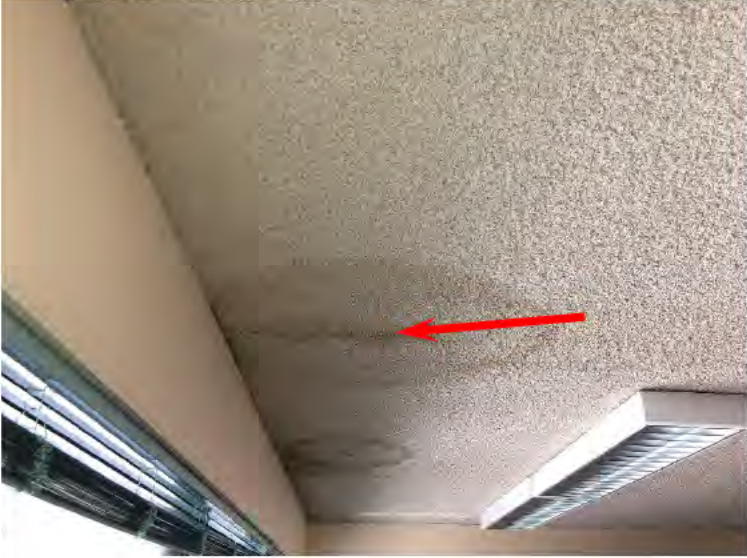
Sample Number	Location Description	Material	Photographs
11	First floor Room 7.7 ceiling areas	Water damaged sprayed coating

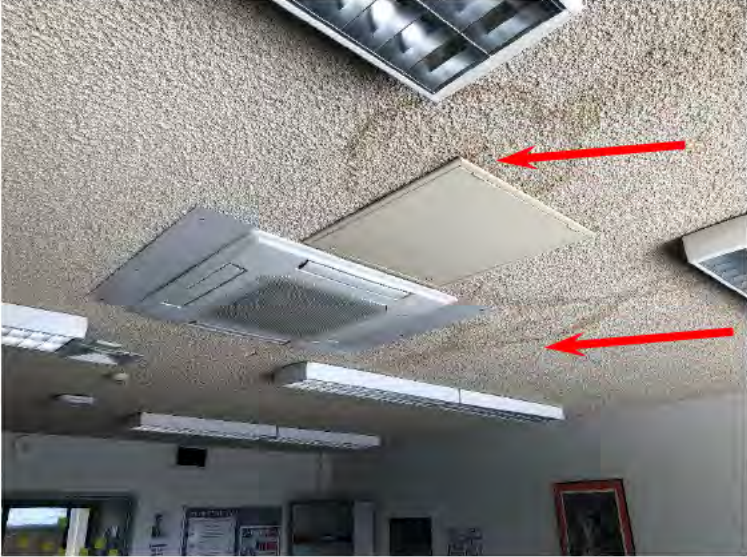
12	First floor Room 7.8 ceiling areas	Water damaged sprayed coating

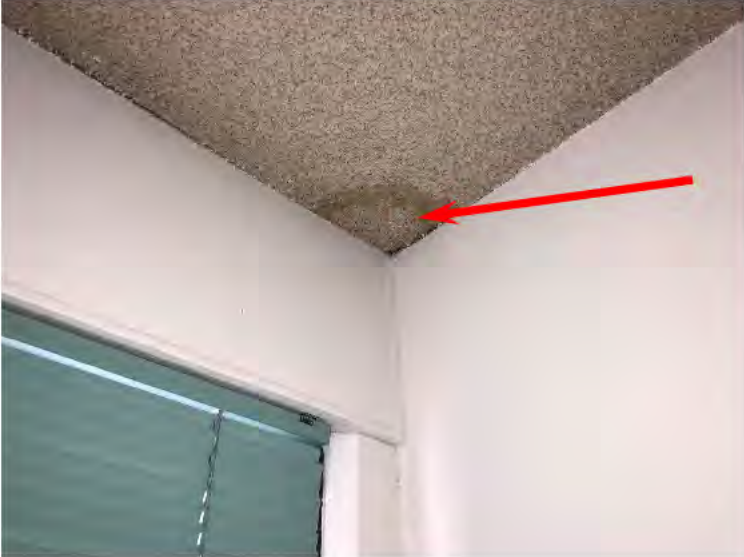
Sample Number	Location Description	Material	Photographs
13	First floor Room 7.8 north east corner of ceiling	Water damaged sprayed coating

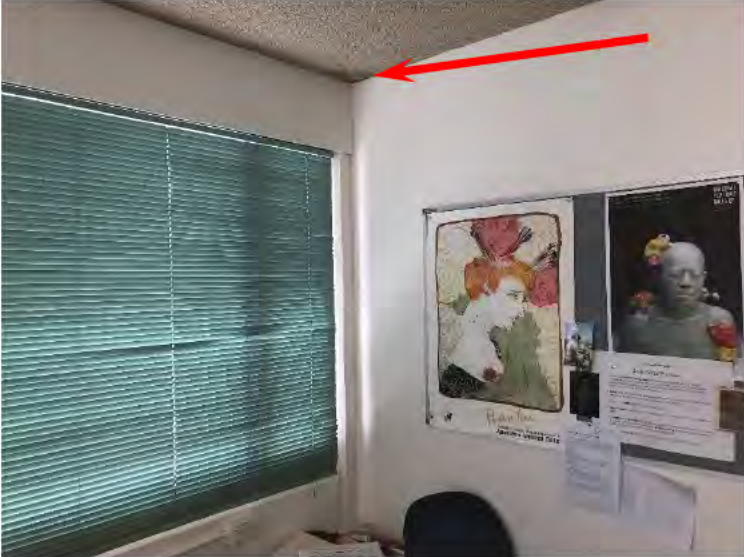
14	First floor Room 7.8 debris (asbestos free) on floor below north east corner of ceiling	Water damaged sprayed coating

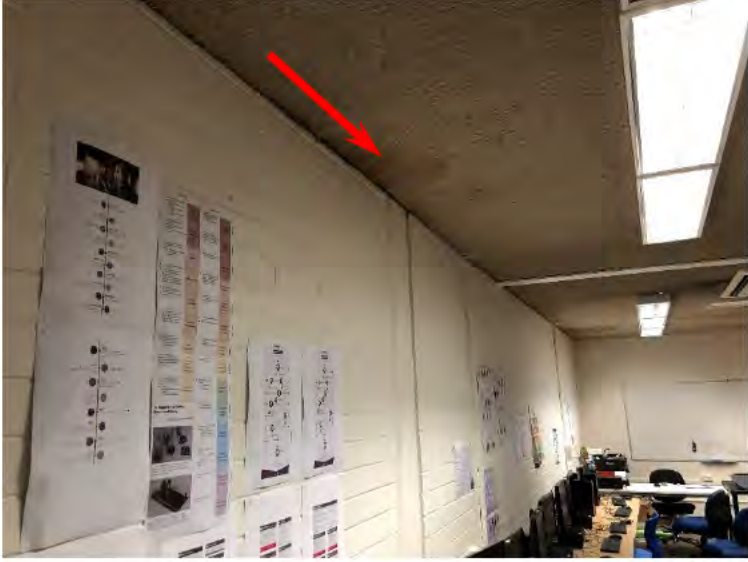
Sample Number	Location Description	Material	Photographs
15	First floor Room 7.14 eastern wall ceiling areas – looking southwards	Water damaged sprayed coating

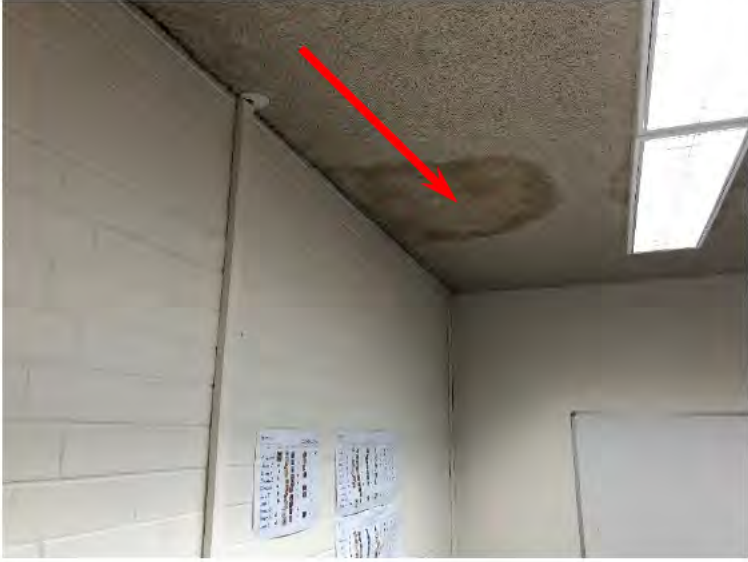
16	First floor Room 7.14 eastern wall ceiling areas – southern end	Water damaged sprayed coating
