Re: Analysis of the sprayed coating debris on top of pinboards of the 1st floor Class room 7.15 (Tracker location 015), Staff room 7.A.1 (Tracker location 011) and Class room 7.6 (Tracker location 023) on 03 February 2021 at Hawker College 51 Murrarji Street Hawker 2614

Removal of light fixtures to ceilings with attached ACM sprayed coating within room 7.4 (TL013) and the Learning Hub (TL017) at Hawker College – on 3 March 2021.

Lead Paint Assessment

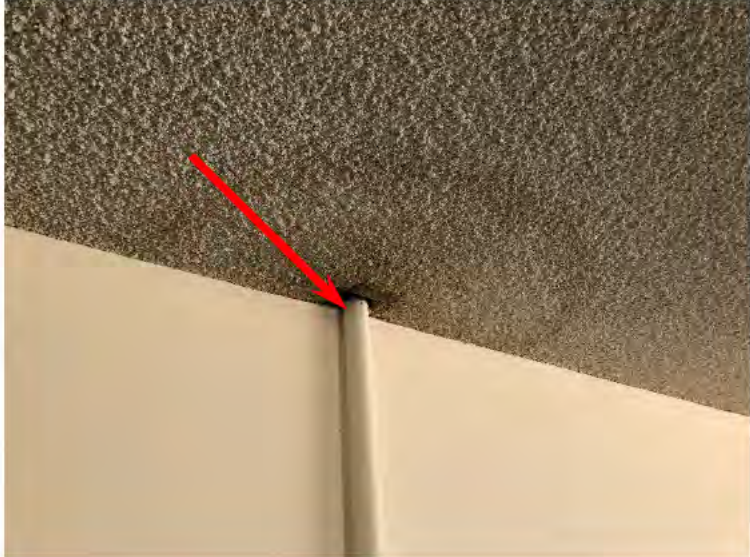
Sample Number	Location Description	Material	Photographs
17	First floor Staff Common Room north wall adjacent entry	Water damaged sprayed coating

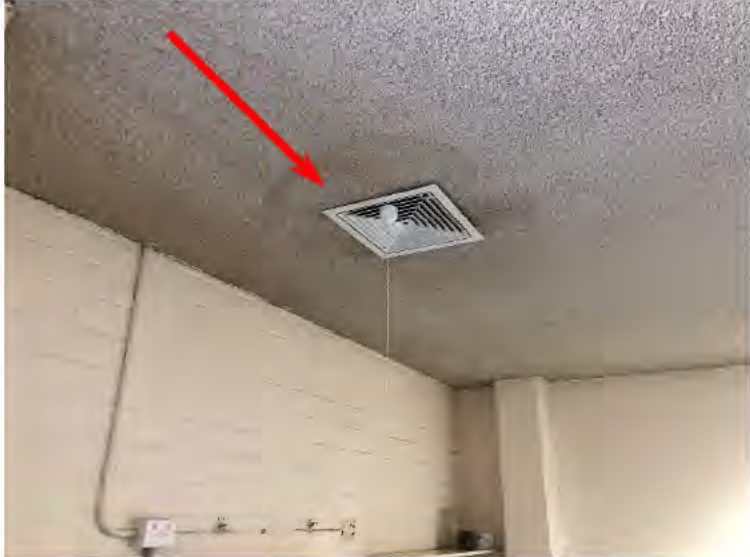
18	First floor Staff Common Room south eastern area above sink	Water damaged sprayed coating

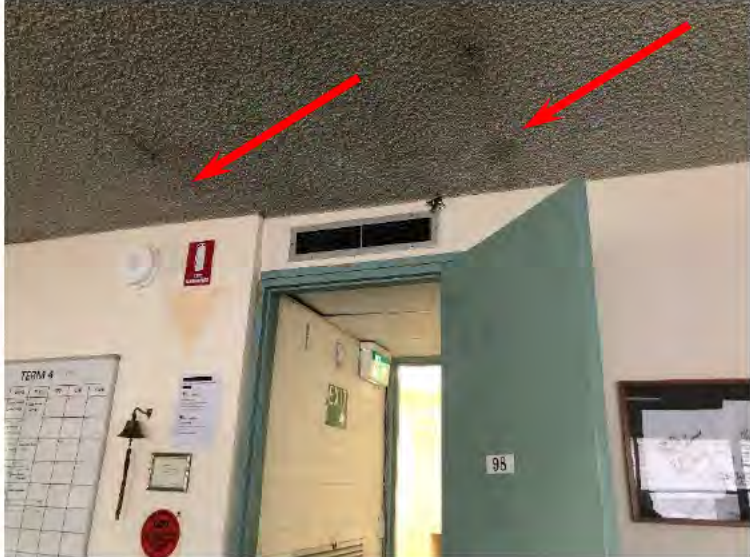
Sample Number	Location Description	Material	Photographs
19	First floor Staff Common Room 98 central western ceiling areas	Water damaged sprayed coating

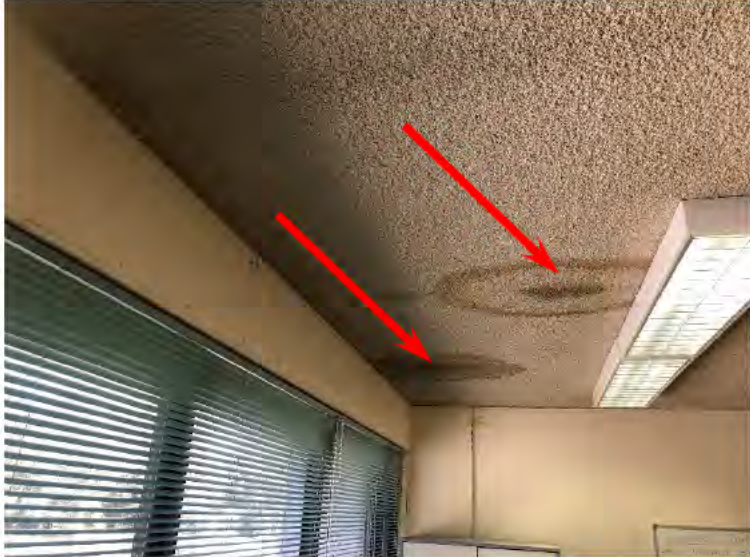
20	First floor Room 7.1 perimeter wall south western ceiling areas	Water damaged sprayed coating

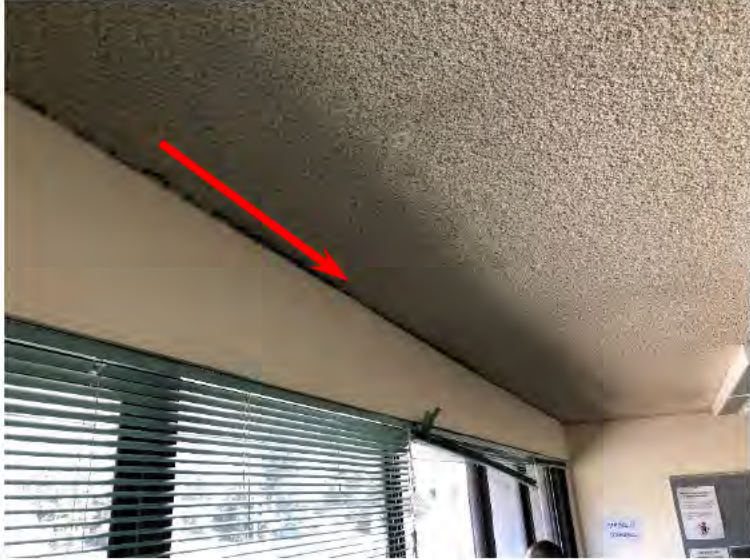
Sample Number	Location Description	Material	Photographs
21	First floor Room 7.2 perimeter wall ceiling gap south central area	Water damaged sprayed coating with perimeter wall gap

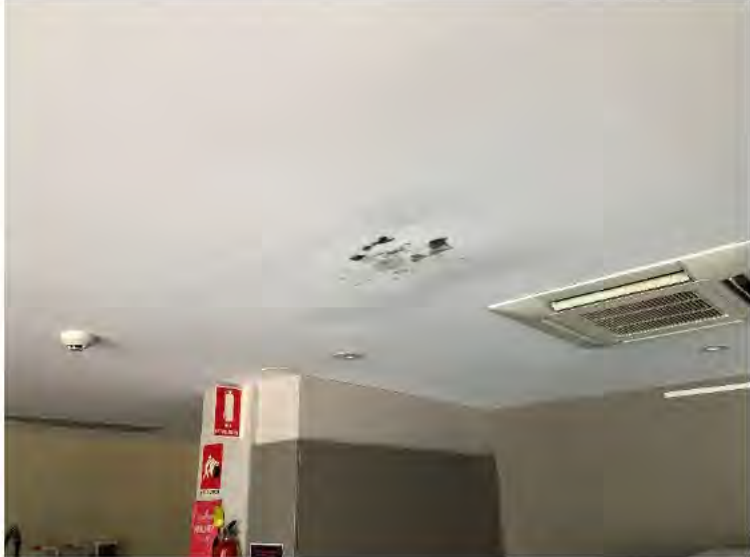
22	Ground floor Kitchen area n/e of Library ceiling stains	Mould to water damaged ceiling underside

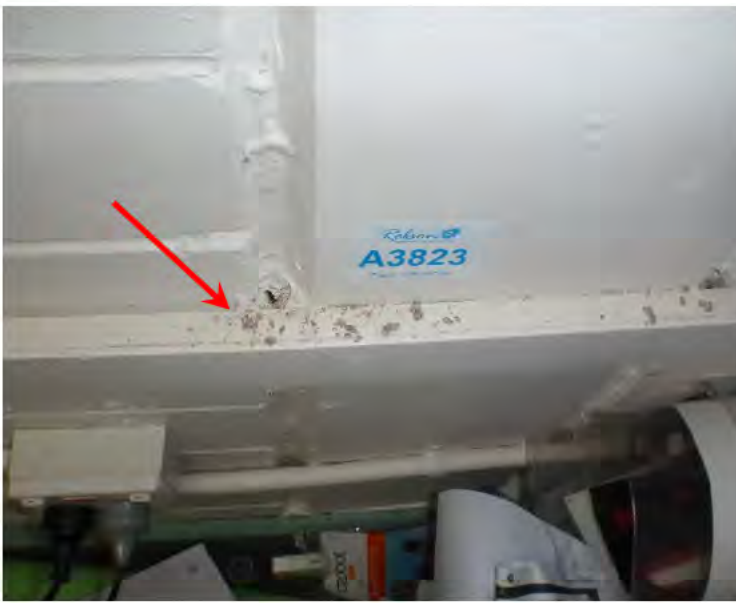
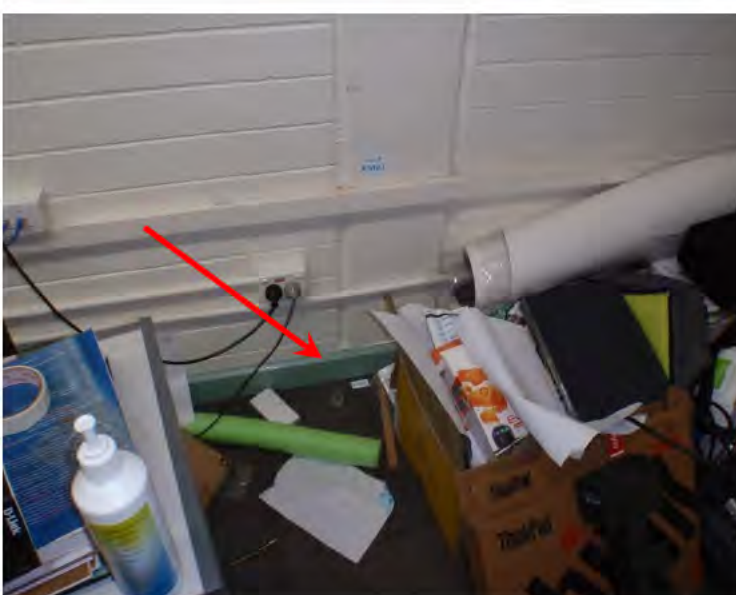
Sample Number	Location Description	Material	Photograph(s)
A3823	B2 F1-18 First Floor Room 7.15 Computer Lab (TL029) - on top cable track attached to wall	Sprayed coating debris

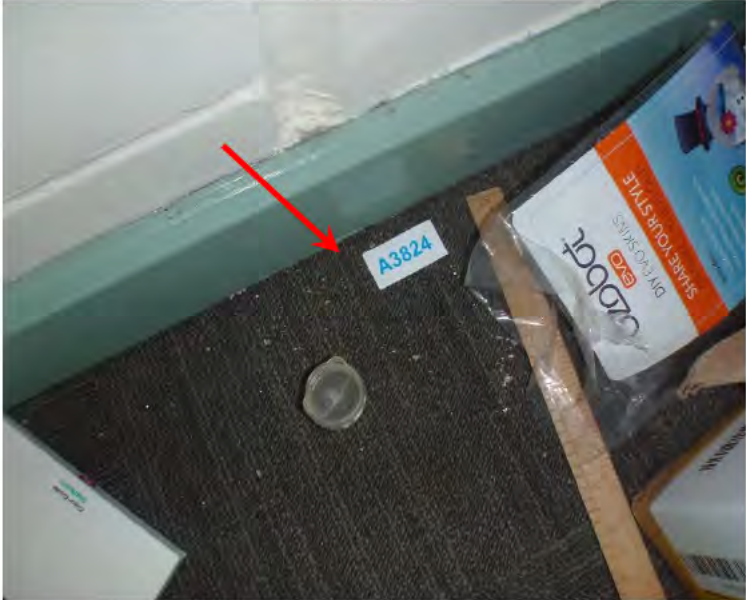
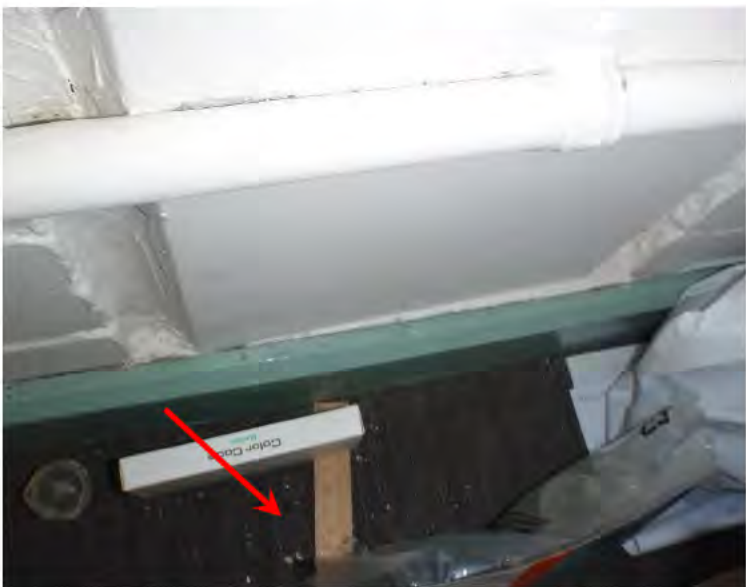
Sample Number	Location Description	Material	Photograph(s)
A3824	B2 F1-18 First Floor Room 7.15 Computer Lab (TL029) – carpet floor	Sprayed coating debris

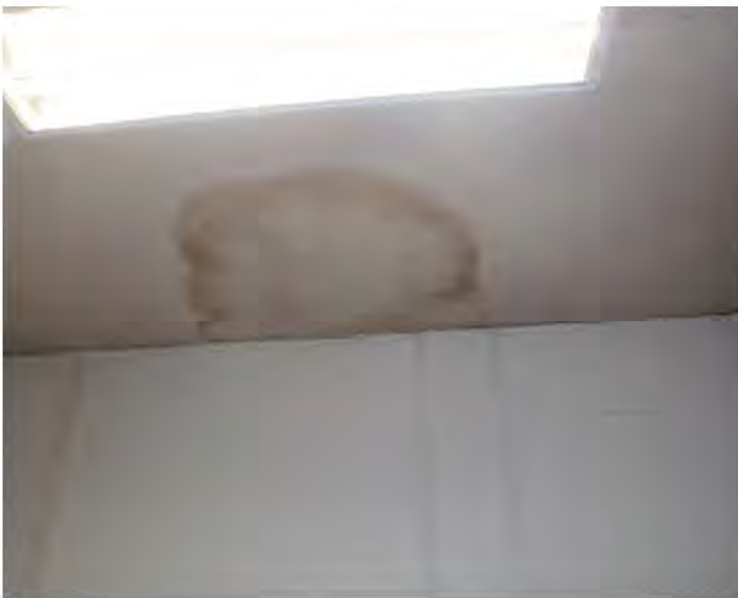
Sample Number	Location Description	Material	Photograph(s)
-	B2 F1-18 First Floor Room 7.15 Computer Lab (TL029) - Ceiling where water leak is located	Sprayed coating
