OPERATIONAL PLAYGROUND INSPECTION CHECKLIST - SCHOOL NAME:

Garran Primary

Garran Primary School Gilmore Crescent Garran ACT Playground Safety Inspection Report

Garran Preschool Robson St Garran ACT

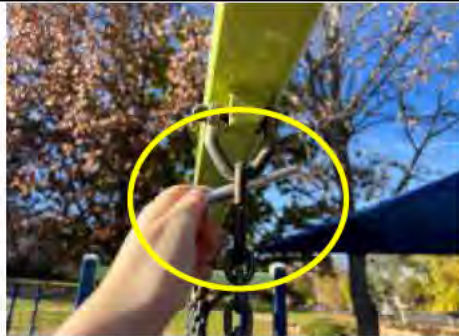
ASSET					HAZARD			RISK				RECTIFICATION		PHOTO	
No	Item/Activity	Qty	Description	Condition	Type	Description	Comment	Probability	Severity	Value	Risk	Action/Comments	Cost \$		
	Surface	1	Edging	2	OK		concrete								
	Bridge	1	Pommel	2	Entrapment	Finger	In S hooks		2	4	8	M	Refer Advisory note 2	300

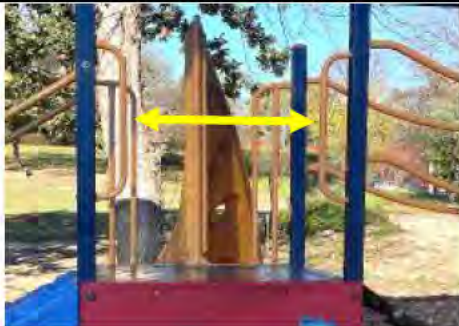
Barrier	1	TubeInfill	2	OK		with wheel					Refer Advisory note 2			
	Barrier	1	Feature	2	OK							Refer Advisory note 2			
	Barrier	4	GripHandle	2	FallProtection	Grasp	The width of the gap between the griphandles is greater than 500mm		2	3	6	L	Replace with AS 4685 2021 compliant griphandles Refer Advisory note 2	3200

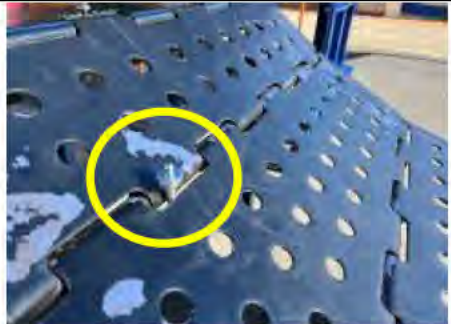
Bridge	1	Suspension	2	Entrapment	Finger	In the gaps over 1m	2	4	8	M	Refer advisory note 2	800

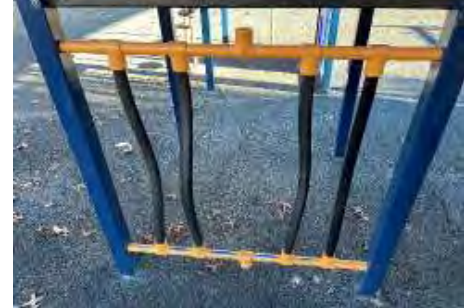
Balancing	2	Beam	2	OK									
	Creative	1	SqueezeBars	2	Structural	Missing	Centre bar missing	1	1	1	VL	Replace centre bar	700

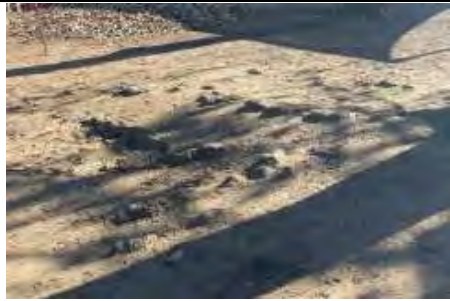
ASSET					HAZARD			RISK				RECTIFICATION		PHOTO
No	Item/Activity	Qty	Description	Condition	Type	Description	Comment	Probability	Severity	Value	Risk	Action/Comments	Cost \$	
	Landscape	1	Shrubs	2	Obstacle	Impale/Cut	Exposed roots could cause a tripping hazard.	2	3	6	L	Top dress and grass over roots	1200

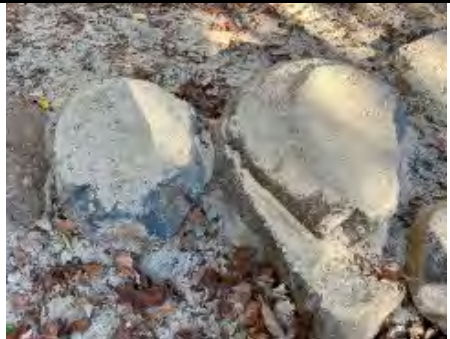
Creative	1	Shopfront	2	OK									
	Landscape	1	Rocks	2	Entrapment	Foot/Leg	Gaps greater than 30mm and less than 100mm	2	4	8	M	Fill gaps	900

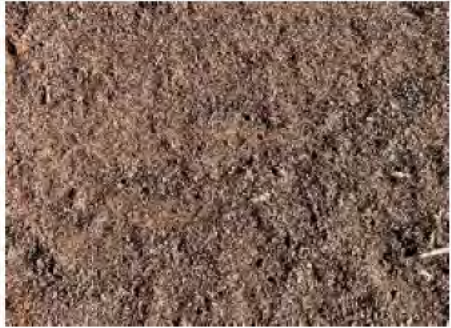
AnimalAccess		Limited				Accessible to small animals							
	CarerAccess		Limited				climbing only access							
	DisabilityAccess		Low				Poor access to cluster							
	Electrical		OK				No major facilities close by							
	Industry		OK				None close by							
	Litter		OK				Clean site							
	MtceAccess		OK				Double gates							
	ShelterShade		Partial				Trees							
	Usage		High				Intensive on weekdays							
	Supervision		Comprehensiv				Supervised							
	Transport		OK fenced				Close but fenced							
	Toilets		<50 metres				In Building							
	Water		OK				Good access to drinking water							
C Activity/Assets														
	Surface	1	PineBark(SF)	2	PGsurface	Impact attenuation	Depth: 150mm. This is too low for these Free Heights of Fall Mulch is heavily pulverised	3	4	12	H	Monitor frequently, especially at key impact areas. Maintain at minimum 300mm consolidated depth Refer Advisory Note 1 below Replace compacted mulch	2000

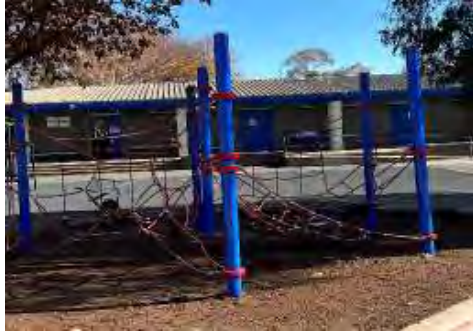
PGstructure	7	Post	2	Structural	Footing	There is a distinct lean on the outer butterfly net post	3	4	12	H	Straighten post with larger footing or brace. Check all posts	1400

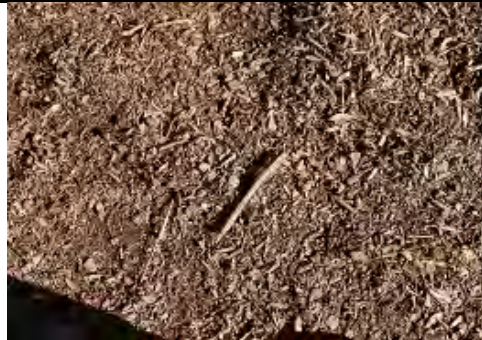
AnimalAccess		Limited				Accessible to small animals							
	CarerAccess		OK				Ladder access to cluster							
	DisabilityAccess		Low				Poor access to cluster							
	Electrical		OK				No major facilities close by							
	Industry		OK				None close by							
	Litter		OK				Clean site							
	MtceAccess		OK				Double gates							
	ShelterShade		Partial				Trees							
	Usage		High				Intensive on weekdays							
	Supervision		Comprehensiv				Supervised							
	Transport		>20 metres											
	Toilets		<50 metres				In Building							
	Water		OK				Good access to drinking water							
C Activity/Assets														
	Surface	1	PineBark(SF)	2	PGsurface	Impact attenuation	Depth: 150-200mm Mulch is significantly pulverised and sticks present	3	4	12	H	Monitor frequently, especially at key impact areas. Maintain at minimum 300mm consolidated depth. Refer Advisory Note 1 below Replace pulverised mulch	4000

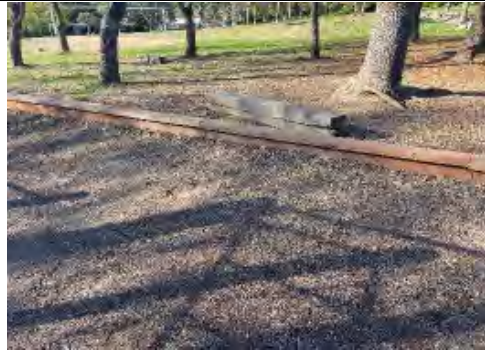
ASSET					HAZARD			RISK				RECTIFICATION		PHOTO
No	Item/Activity	Qty	Description	Condition	Type	Description	Comment	Probability	Severity	Value	Risk	Action/Comments	Cost \$	
	Surface	1	Edging	2	Structural	Inadequate	Timber. Low to contain 300 depth bark but better than before	2	2	4	L	High chance of spillage during use. Monitor

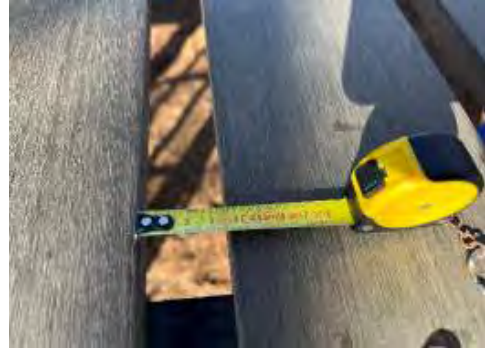
Bridge	1	Suspension	2	Entrapment	Foot/Leg	35mm gaps	1	4	4	L	Reduce gap to <30mm	600

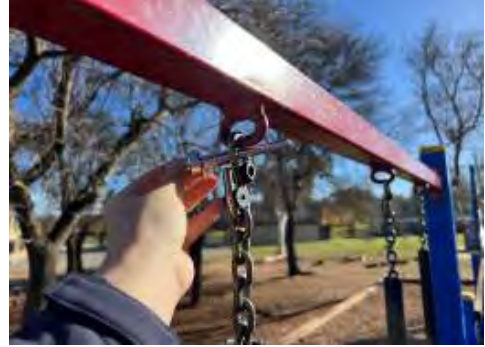
Bridge	1	Pommel	2	Entrapment	Finger	In S hooks	3	4	12	H	Refer Advisory note 2	450

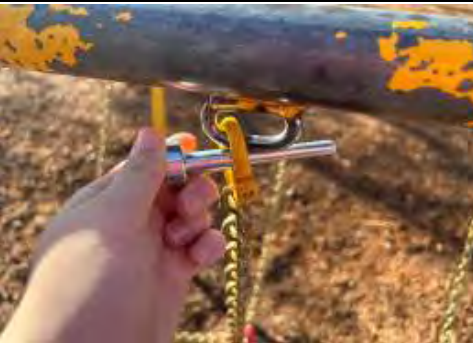
Bridge	1	Burmese	2	Entrapment	Finger	In the hammerlocks	2	3	6	L	Refer Advisory note 2	500

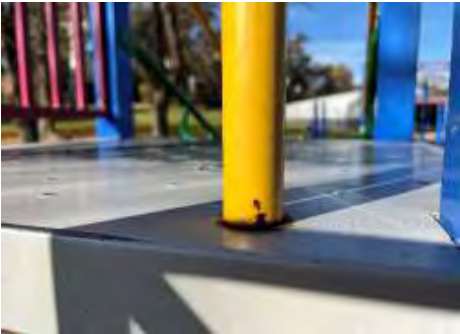
Barrier	2	TubeInfill	2	OK							Refer Advisory note 2		
	Barrier	2	GripHandle	2	Structural	Corrosion	Between handle and platform.	1	2	2	VL	Passivate and paint with corrosion resistant paint. Seal with polyurethane	600

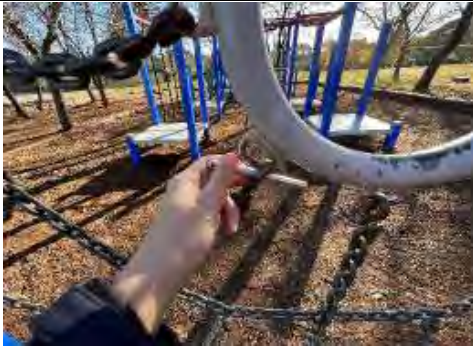
ASSET					HAZARD			RISK				RECTIFICATION		PHOTO
No	Item/Activity	Qty	Description	Condition	Type	Description	Comment	Probability	Severity	Value	Risk	Action/Comments	Cost \$	
	Climbing	1	Net-Medium	2	Entrapment	Finger	Gaps in S-hooks	3	4	12	H	Refer Advisory note 2	800

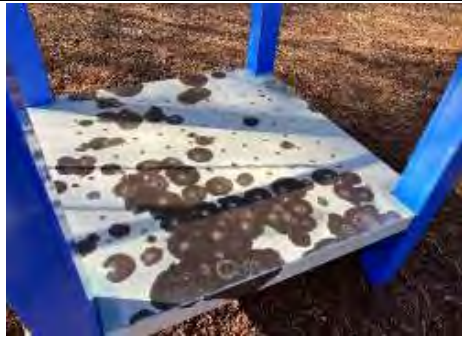
Sliding	1	Firepole	2	OK							Forced movement zone with greater consequence		
	PGstructure	34	Post	2	OK									
	PGstructure	8	Platform	2	Structural	Corrosion	Beginning signs of corrosion where the paint has chipped off	1	2	2	VL	Passivate and paint with corrosion resistant paint. Seal with polyurethane	1500

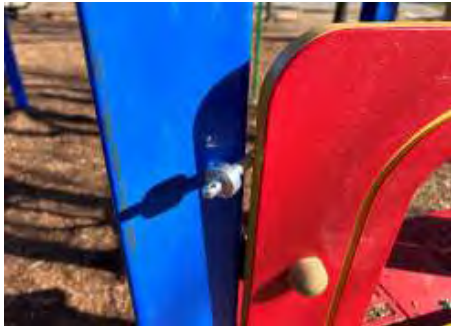
Bridge	1	Beam	2	OK									
	Climbing	1	Loop-half	2	OK		Angled between platforms							
	Hanging	1	Handles	2	OK									
	Balancing	1	Rope	3	OK		Between platforms							
	Creative	1	Shopfront	3	Entrapment	Finger	Panels are becoming flexible due to loose connections	1	1	1	VL	Refer Advisory note 2	300

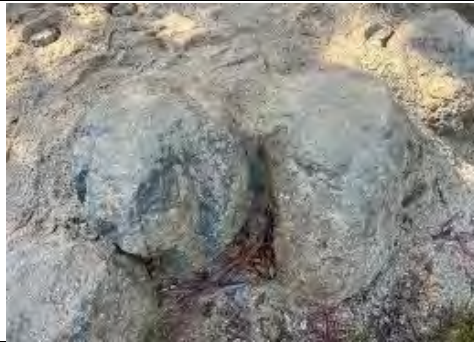
Landscape	1	Rocks	2	Entrapment	Foot/Leg	30mm gaps between rocks	2	2	4	L	Fill gaps	800

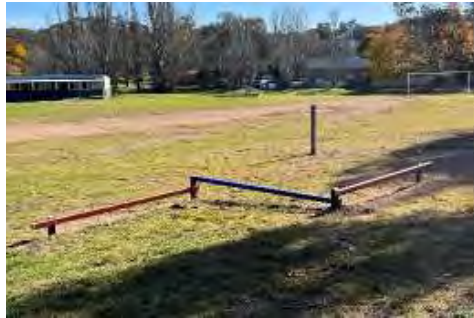
Balancing	3	Beam	2	PGsurface	Impact attenuation	Below 600 height so OK on soil though softfall is preferred in the high use area of a school	2	2	4	L	Refer Advisory Note 1 below

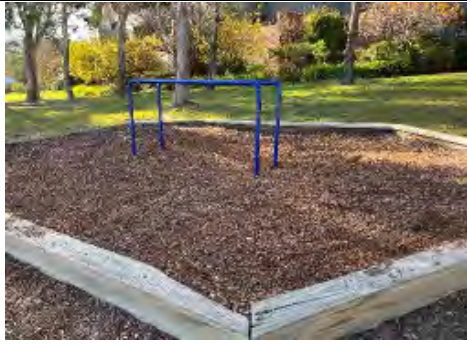
ASSET					HAZARD			RISK				RECTIFICATION		PHOTO
No	Item/Activity	Qty	Description	Condition	Type	Description	Comment	Probability	Severity	Value	Risk	Action/Comments	Cost \$	
	Balancing	1	II Bars	2	PGsurface	Impact attenuation	Depth: 150-180	3	4	12	H	Monitor frequently, especially at impact areas. Maintain at minimum 300mm consolidated depth. Refer Advisory Note 1 below	1000

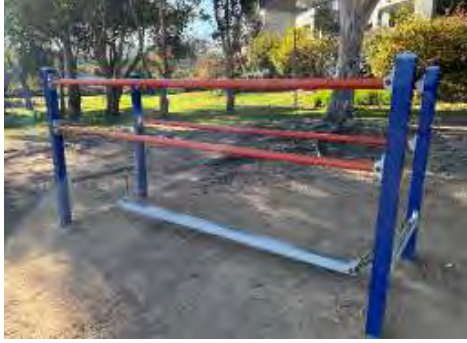
Balancing	1	Beam	2	PGsurface	Impact attenuation	In actual use, children may climb up onto the rails at height 1440mm. Depth 10mm	4	4	16	H	Softfall is required under this item. Refer Advisory note 1	2500

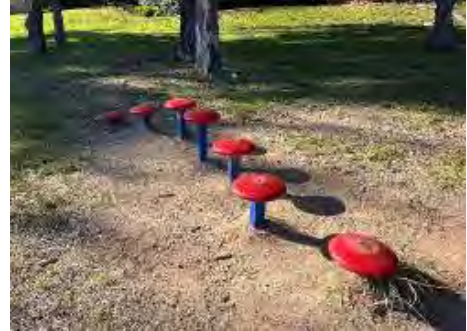
Balancing	3	Steppers	2	OK		Below 600 height so OK on soil though softfall is preferred in the high use of a school	3	3	9	M	Refer Advisory Note 1 below

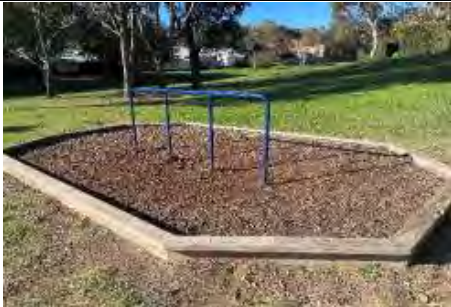
ASSET					HAZARD			RISK				RECTIFICATION		PHOTO
No	Item/Activity	Qty	Description	Condition	Type	Description	Comment	Probability	Severity	Value	Risk	Action/Comments	Cost \$	
	Hanging	3	TurningBar	2	PGsurface	Impact attenuation	Depth: 80mm	3	4	12	H	Monitor frequently, especially at key impact areas. Maintain at minimum 300 consolidated depth Refer Advisory Note 1 below	1000

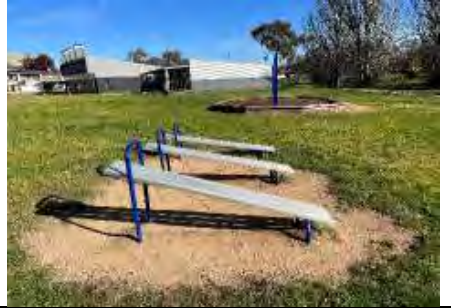
Exercise	3	Situp	2	Obstacle	Impale/Cut	Below 600 height so OK on soil though softfall is preferred in the high use of a school	2	3	6	L	Monitor frequently, especially at key impact areas. Maintain at minimum 300 consolidated depth Refer Advisory Note 1 below	3000

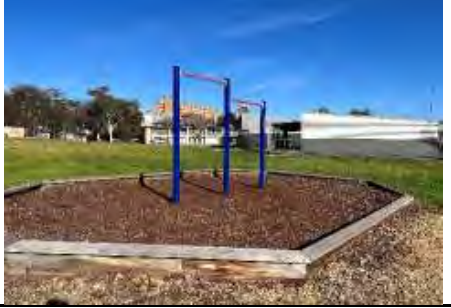
Hanging	1	TurningBar	2	PGsurface	Impact attenuation	Bark depth: 150 Bar maximum height is 2220mm.	3	4	12	H	Remove concrete dags Top-up to minimum 300 consolidated depth Refer Advisory Note 1 below	1500

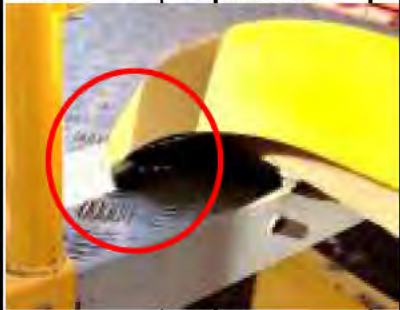
ASSET					HAZARD			RISK				RECTIFICATION		PHOTO
No	Item/Activity	Qty	Description	Condition	Type	Description	Comment	Probability	Severity	Value	Risk	Action/Comments	Cost \$	
	Climbing	4	A Frame	2	OK									
	Barrier	1	Slide Entry	2	Entrapment	Head/Neck	1. between slide & barrier 2. Hair/toggle entrapment in between the platform and slide	3	4	12	H	Install AS 4685 2021 compliant barrier Refer advisory note 2 Forced movement zone with greater consequence	1400

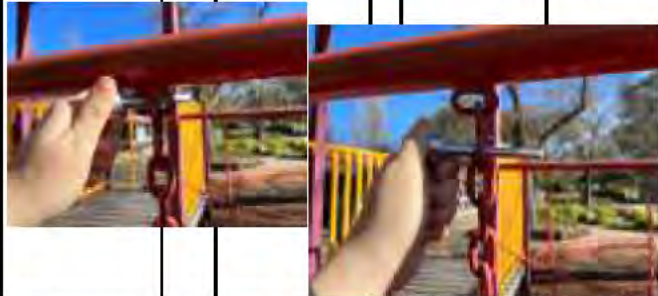
Sliding	1	SingleSlide	2	OK							Forced movement zone with greater consequence		
	Bridge	1	Suspension	2	Entrapment	Finger	In chain and S-hooks Timber gap exceeds 30mm	3	4	12	H	Refer advisory note 2 Reduce gap to <30mm	1200

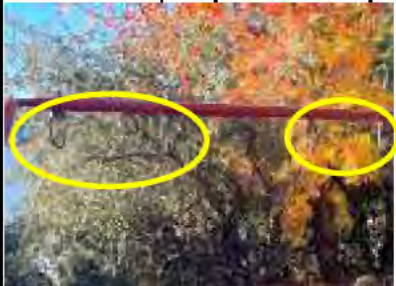
Climbing	1	Net-Small	2	OK									
	Swinging	1	Double	2	Structural	Wear	1. Bearings worn 2. Sensory swings are on a double bay use and ground clearance is 200mm	2	4	8	M	1. Replace bearings 2. Ensure sensory swings are of single bay use only so one swing only at a time Reconfigure to increase clearance to minimum 300mm

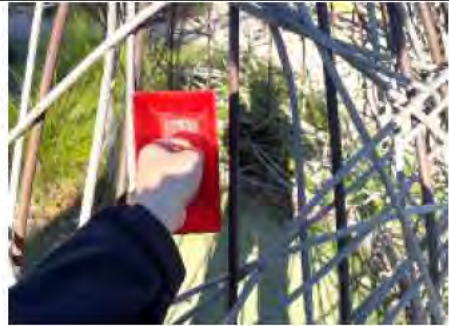
Creative	1	Boat	2	OK									
	Shelter	1	Metal	2	OK		Over sandpit							
	Creative	2	Cubby	2	Entrapment	Head/Neck	1. In gaps over 600mm 2. This structure is climbable and has a concrete footpath in the 1.5m fall zone.	3	4	12	H	1. Repair or remove. 2. Move to a location with a surrounding 1.5m impact attenuating surface free of objects. Refer advisory note 1 & 2

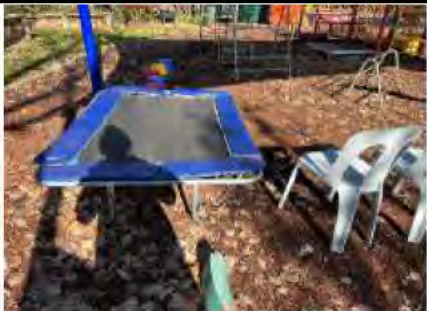
Landscape	1	Creek	2	OK									
	Exercise	1	Trampoline	2	Obstacle	Falling space	Trampolines require a surrounding 1.5m falling space free of objects. There is currently a chair and post in the falling space	3	4	12	H	Move to a location with a surrounding 1.5m falling space free of objects. Ensure single use only.
