Fibre Identification Certificate of Analysis

Laboratory Report Number: T0095614_T-12534

Hawker College 16 May 2022

Re: Visual inspection and Risk Assessment of water damaged sprayed coating areas to prioritise their removal at Hawker College on Friday 12 August 2022

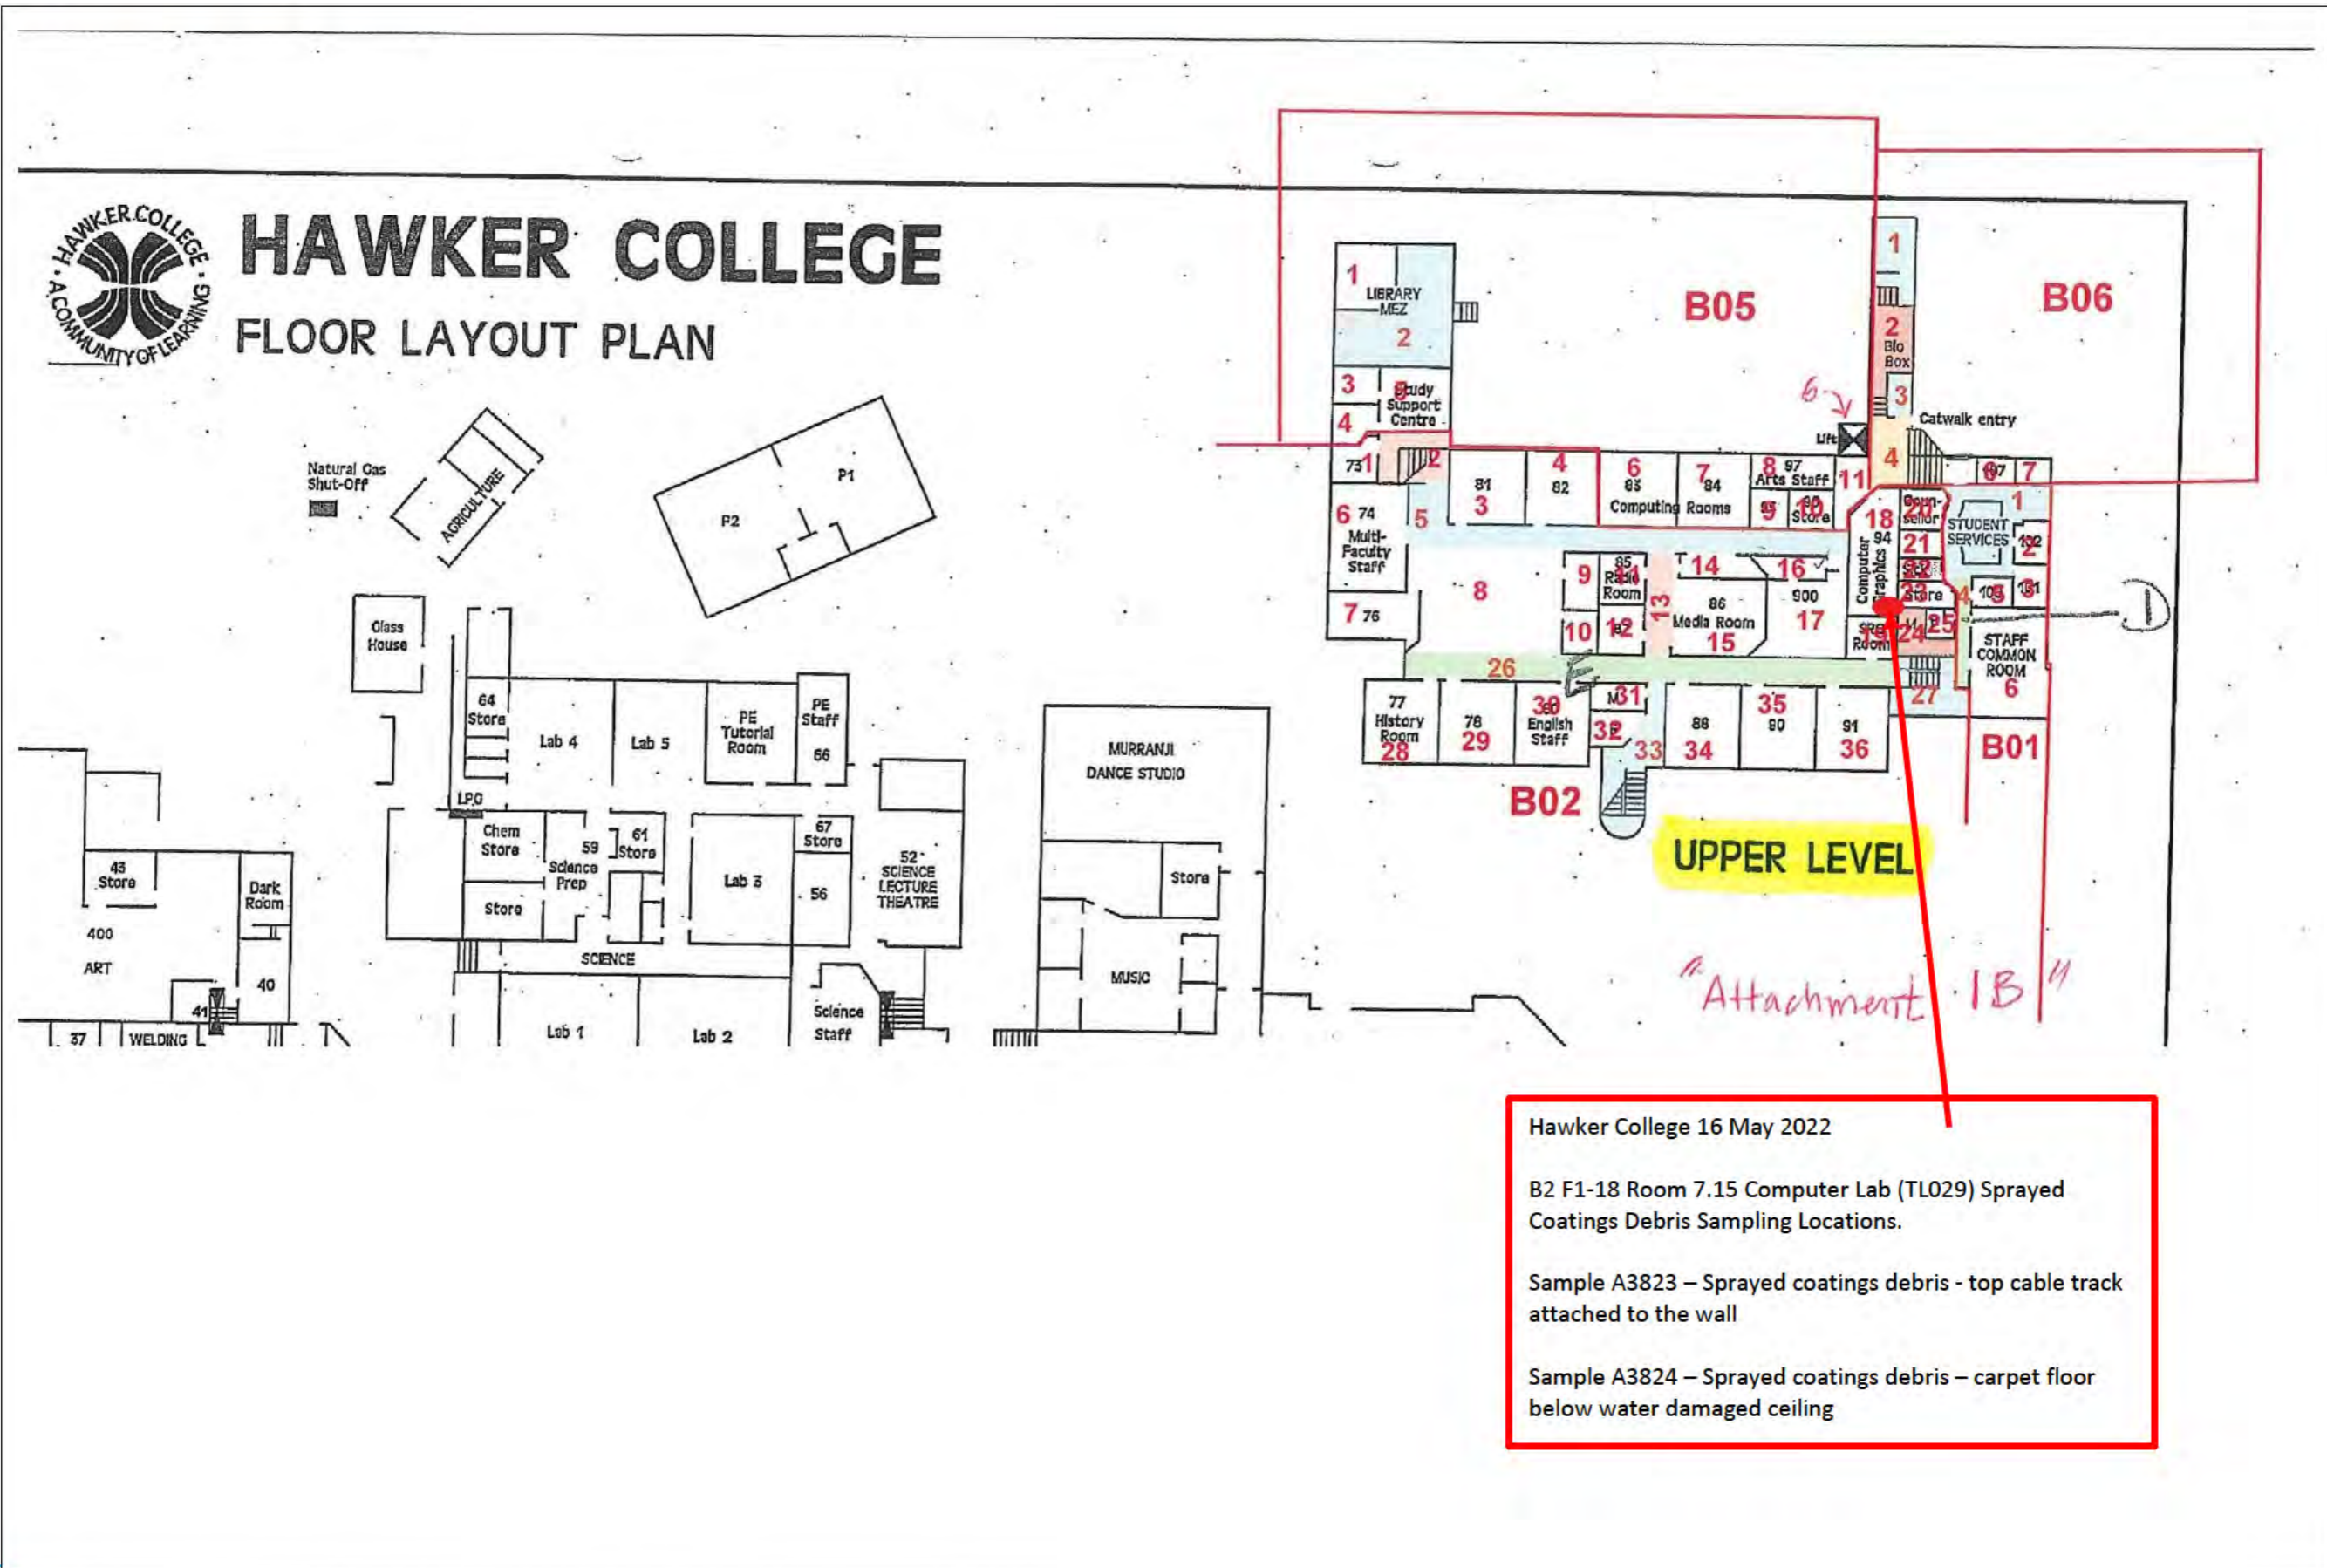
B2 F1-18 Room 7.15 Computer Lab (TL029) Sprayed Coatings Debris Sampling Locations.

Sample A3824 – Sprayed coatings debris – carpet floor below water damaged ceiling

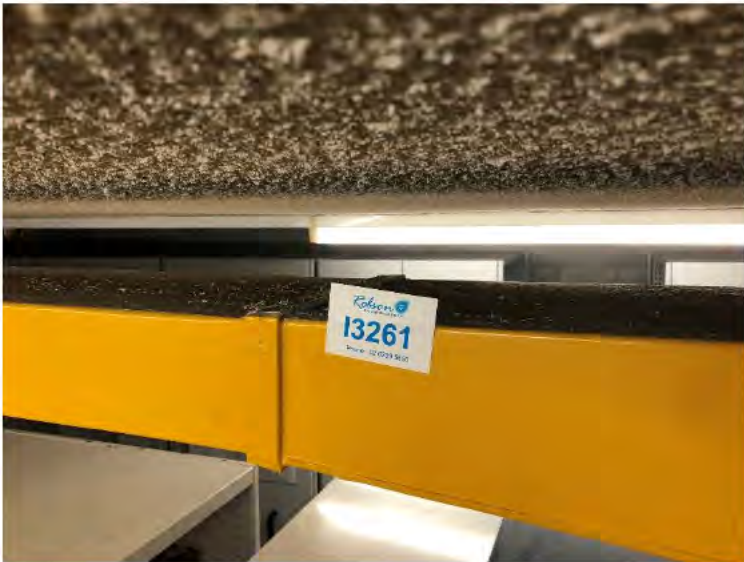
Samples I3261 and I3269 were analysed as positive for containing Unidentified Mineral Fibres (UMF). UMF is the designation given to fibres that cannot be positively identified via polarised light microscopy (PLM) according to the Australian Standard, *AS4964 - 2004: Method for the qualitative identification of asbestos in bulk samples*. It is recommended that all sprayed coating, and spray coating debris be treated as containing asbestos. Based on our experience the application of sprayed coatings has not been homogenous throughout a site. SEM analysis is required for the identification of the lesser utilised forms of asbestos; actinolite, anthophyllite and tremolite. Materials containing UMF must be treated as containing asbestos unless further testing proves otherwise.

Sample Number	Location Description	Material	Photograph(s)
I3261	Library compactus room - On top of compactus and ductwork	Spray coating debris

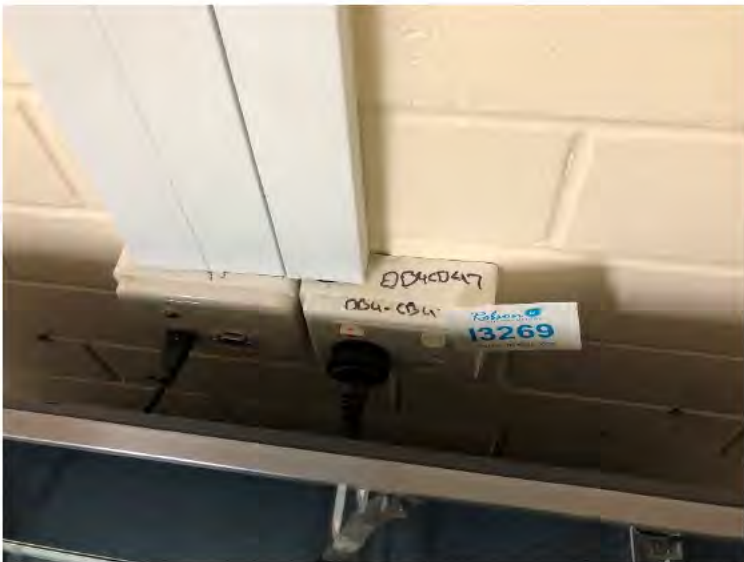
I3269	Meeting room 7.M.1 (030) - On top of power switch behind TV	Debris

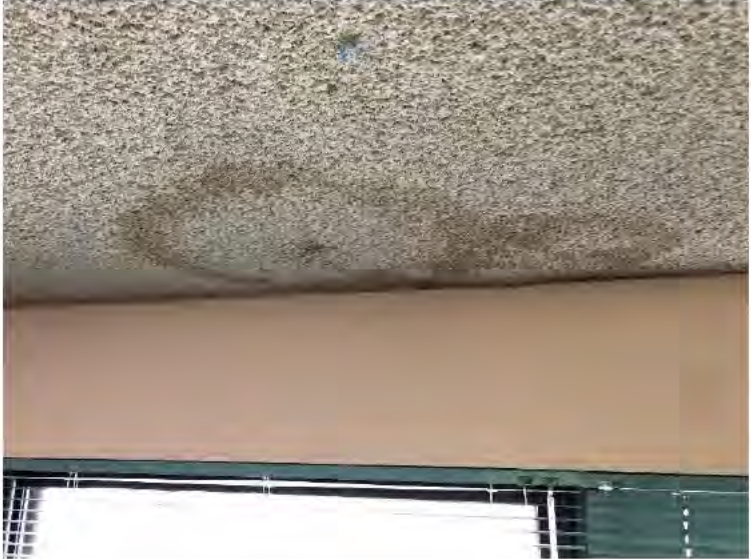
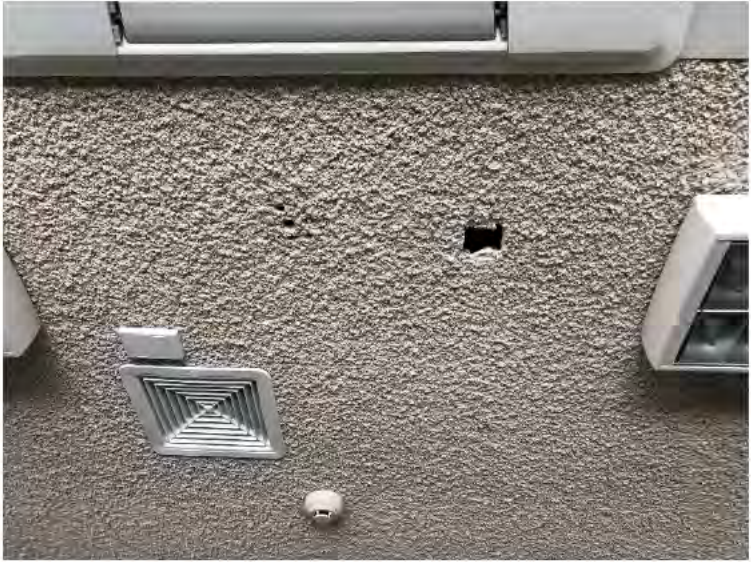
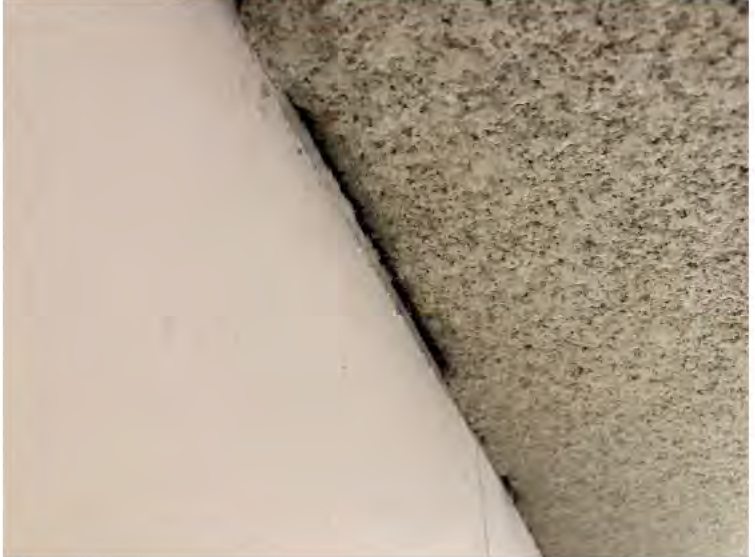
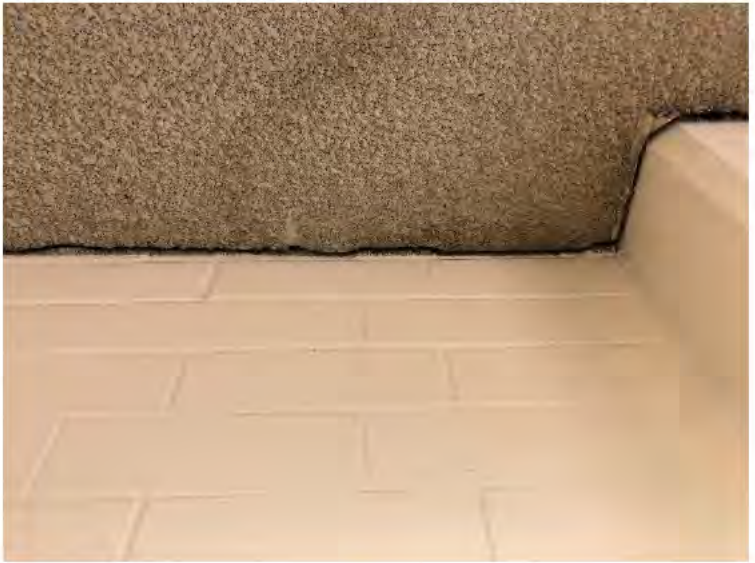
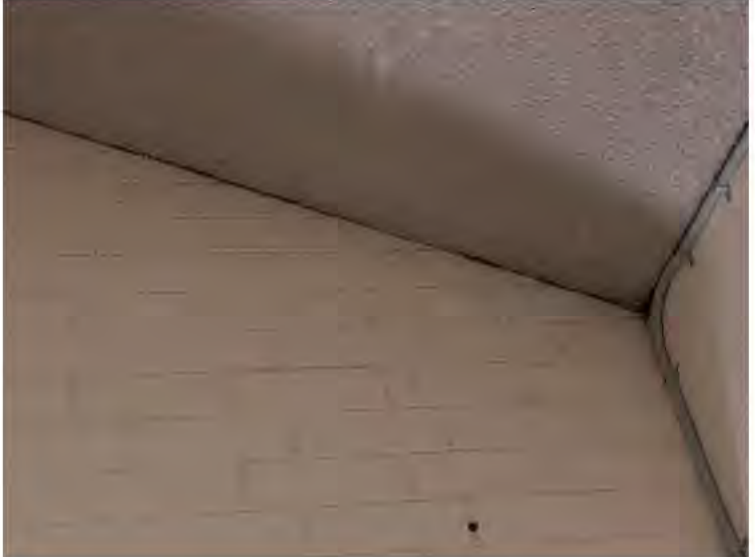
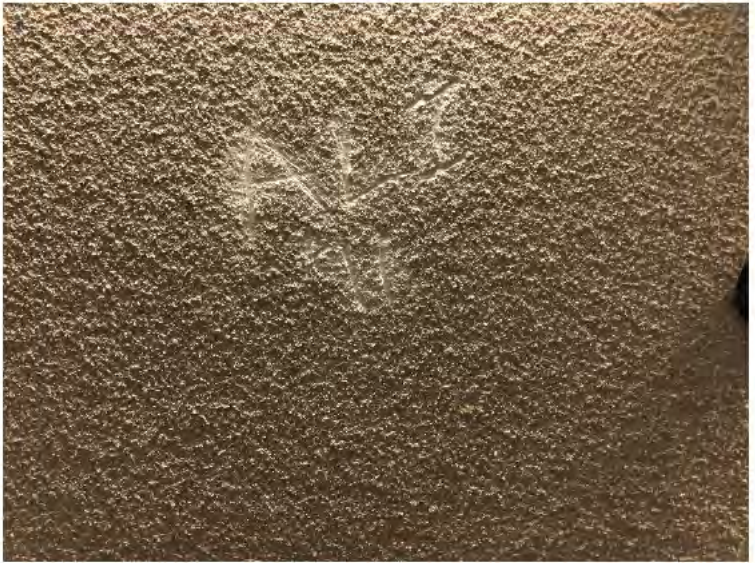
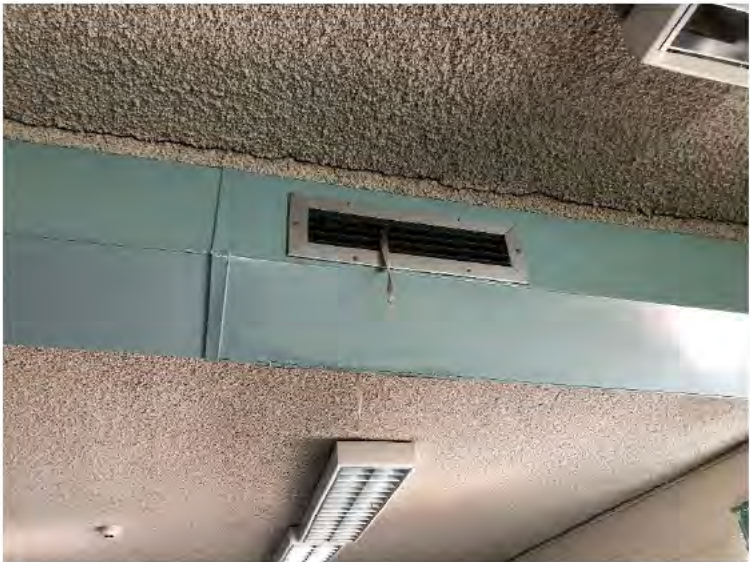
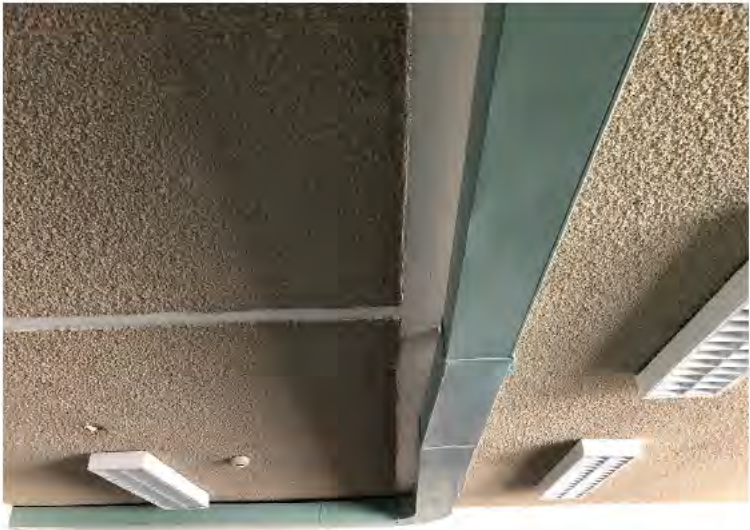
The visual inspection of the sprayed coating in various locations at Hawker College found that many areas within the school showed areas of significant visible water damage and cracking. To prevent the continuing deterioration of the sprayed coating, which can be seen as surface debris on surfaces below the damaged areas throughout the school, it is recommended that these areas be sealed and repaired or a more permanent management approach, removed as soon as practicable.

Location Description	Material	Photograph(s)
<p>Representative photos</p>	<p>Damaged spray coating</p>

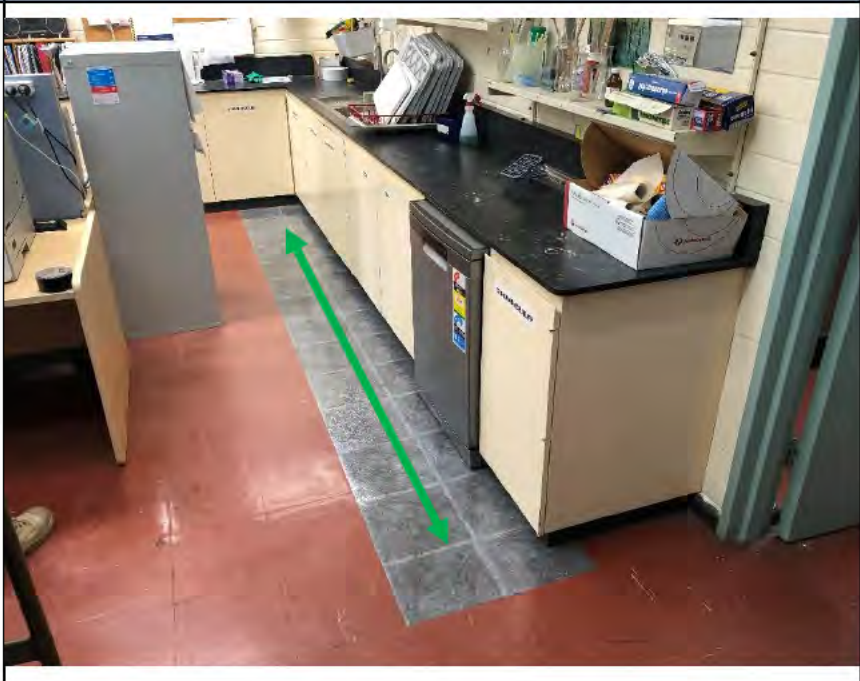
PHOTO NO	LOCATION DESCRIPTION	MATERIAL	PHOTOGRAPH(s)
1	B9-21 Prep Room (188) adjacent to the west wall following removal of ACM VFT and encapsulation of ACM adhesive	VFT

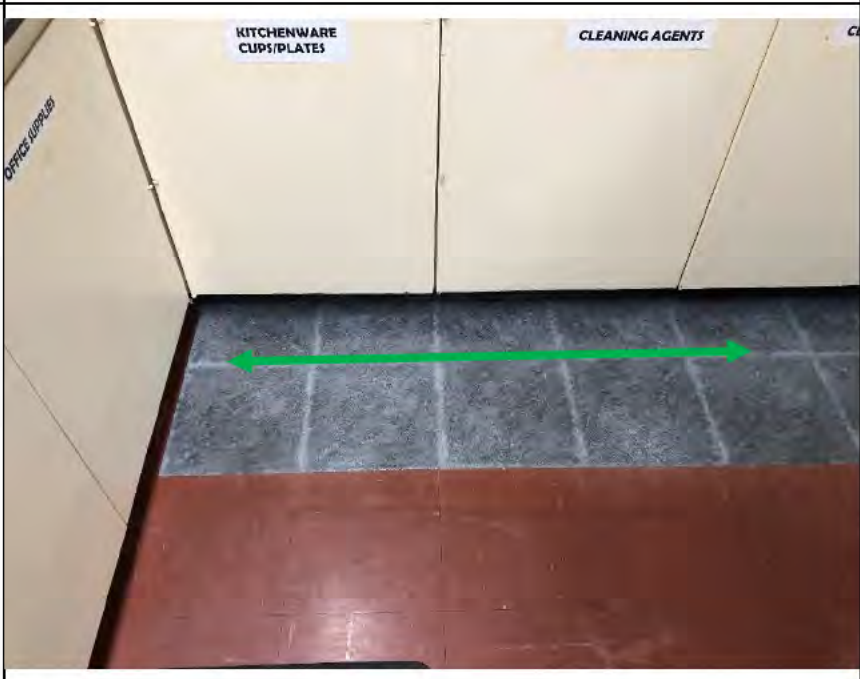
2	B9-21 Prep Room (188) adjacent to the west wall following removal of ACM VFT and encapsulation of ACM adhesive	VFT

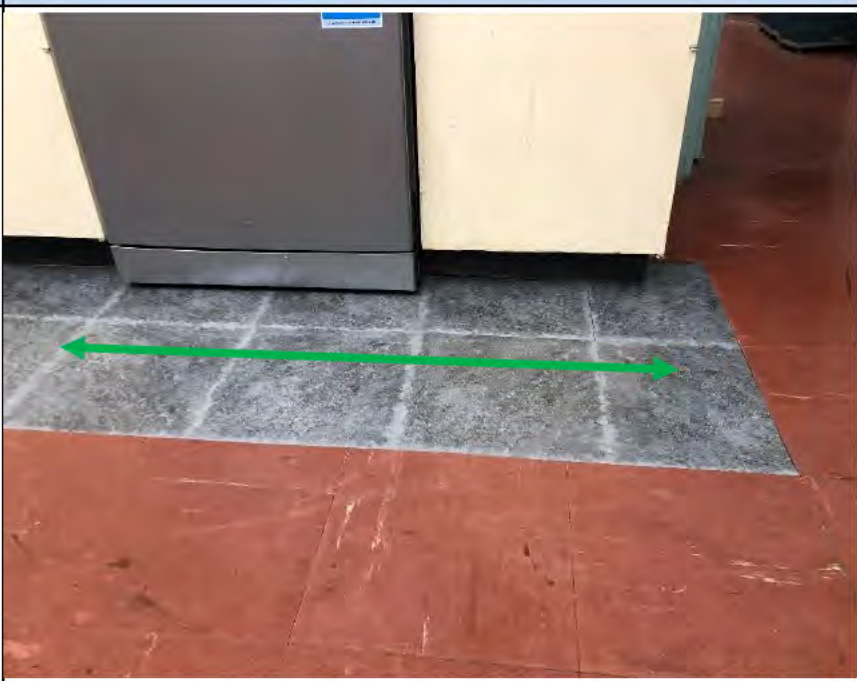
PHOTO NO	LOCATION DESCRIPTION	MATERIAL	PHOTOGRAPH(S)
3	B9-21 Prep Room (188) adjacent to the west wall following removal of ACM VFT and encapsulation of ACM adhesive	VFT

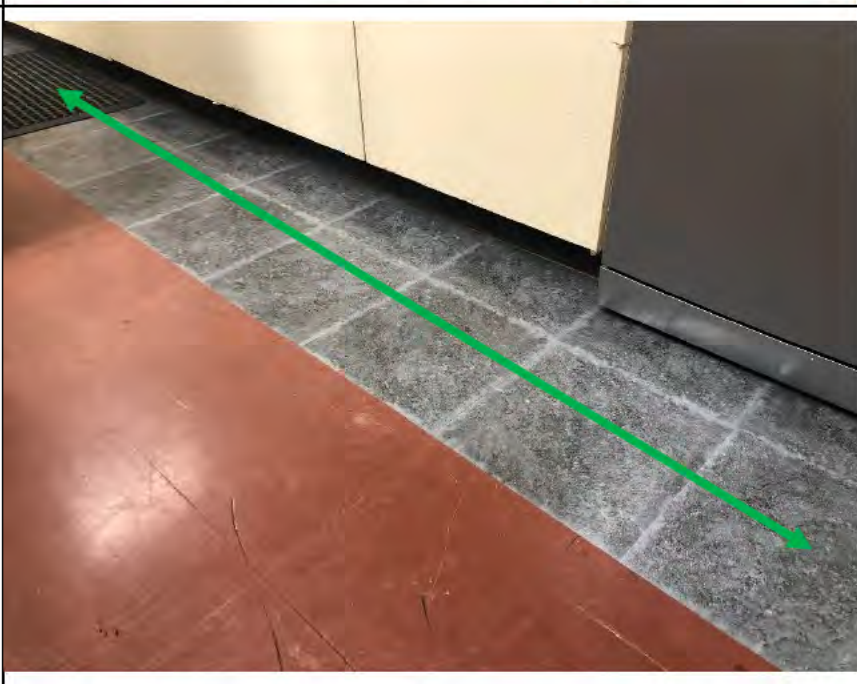
4	B9-21 Prep Room (188) adjacent to the west wall following removal of ACM VFT and encapsulation of ACM adhesive	VFT

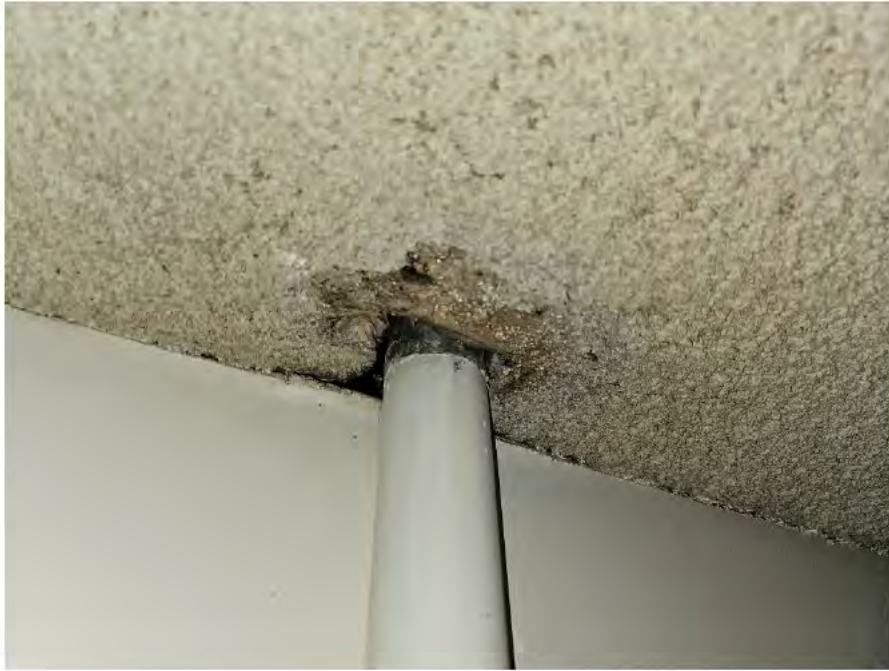
Photograph 1
Damage to exposed spray coating in the staff room

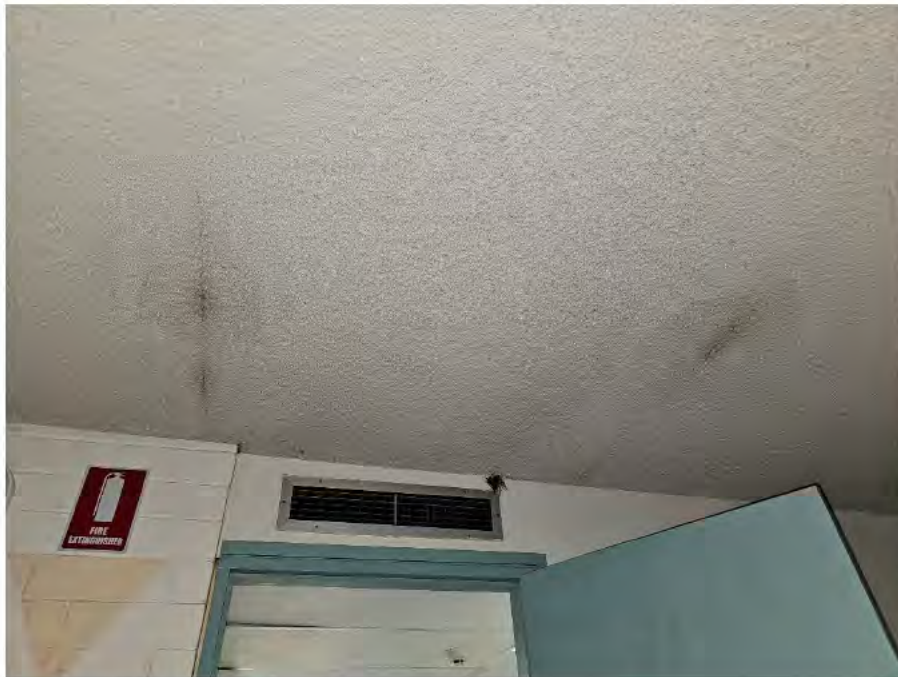
Photograph 2
Water damage to exposed spray coating in the staff room

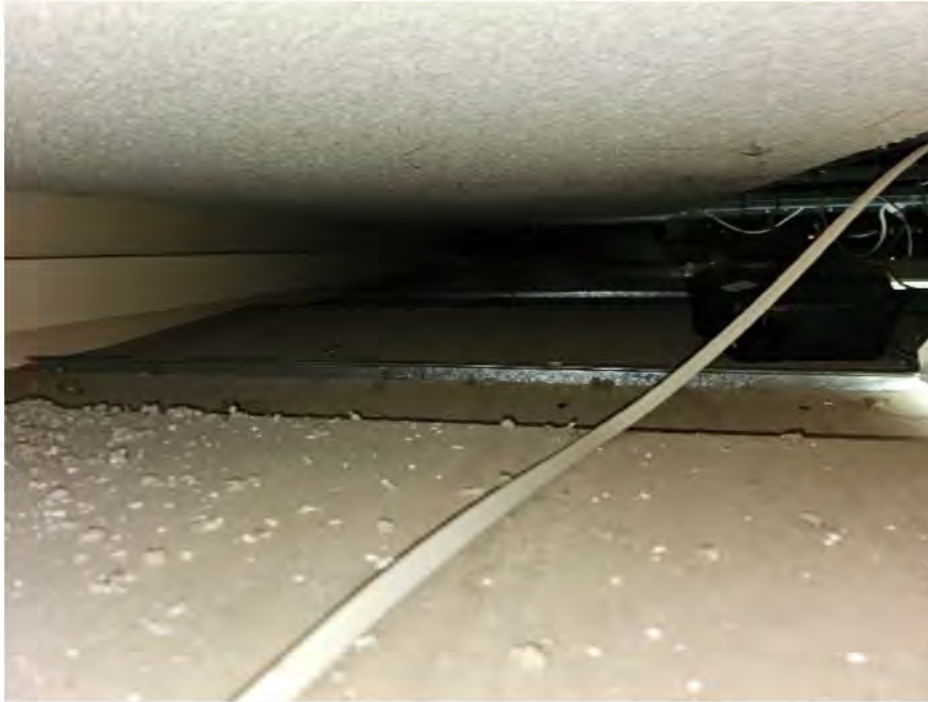
Photograph 3

Photograph of loose spray coating debris on suspended ceiling tiles

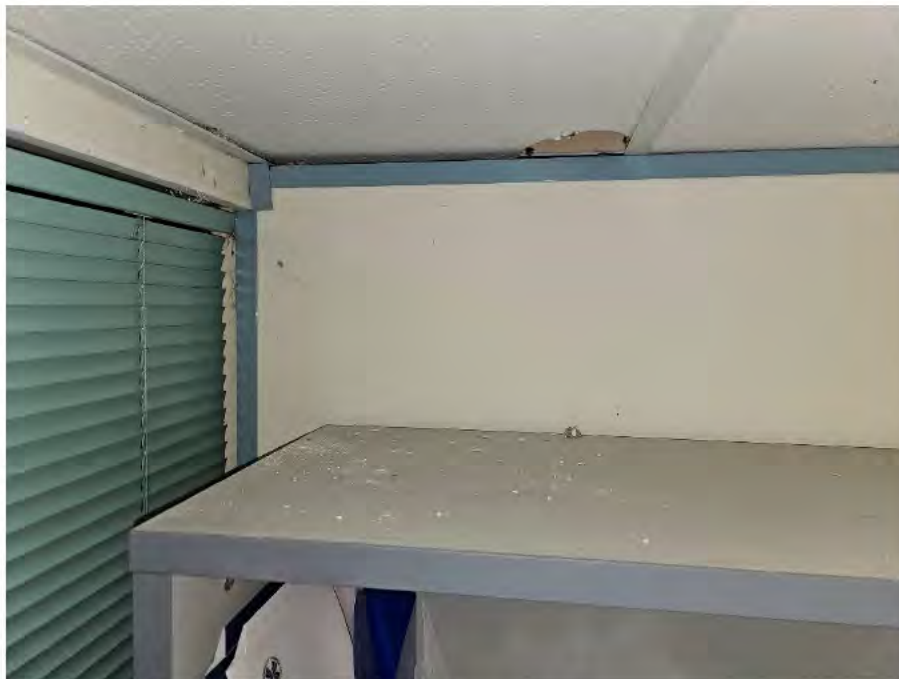
Photograph 4

Suspect spray coating material debris was identified next to and on top of shelving in the work experience office beneath a section of missing ceiling tile and was sampled.

Photograph of loose spray coating debris on shelves in Work Experience office

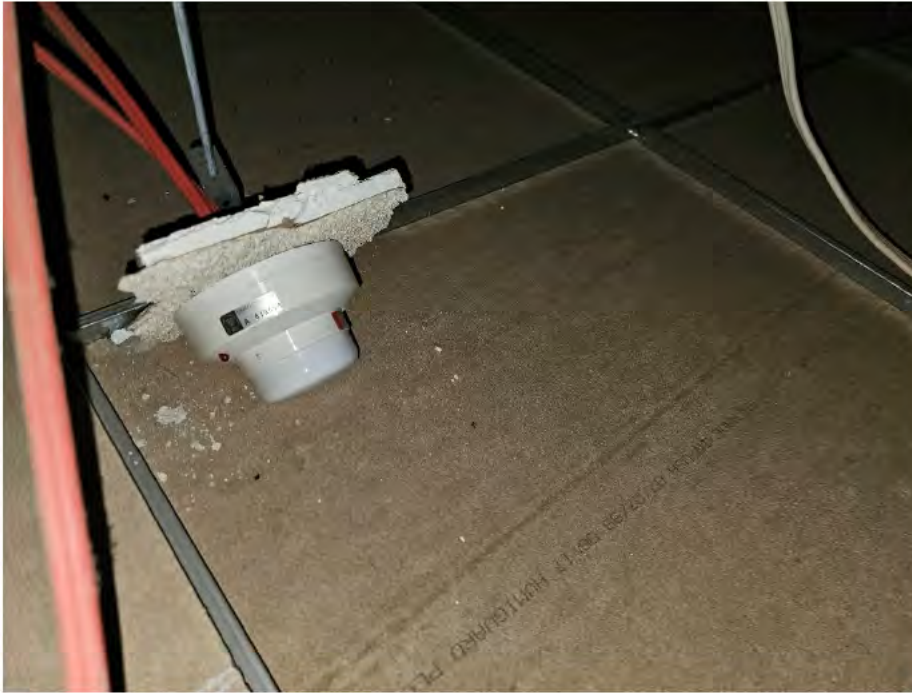
Photograph 5

Photograph of piece of spray coated plasterboard in ceiling void

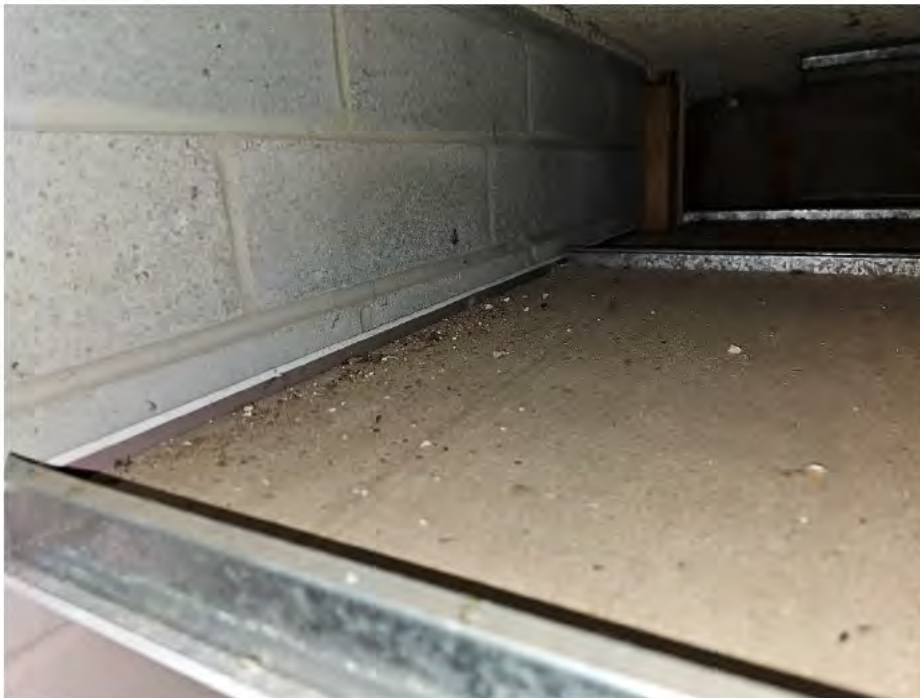
Photograph 6

Photograph of loose spray coating debris on suspended ceiling tiles

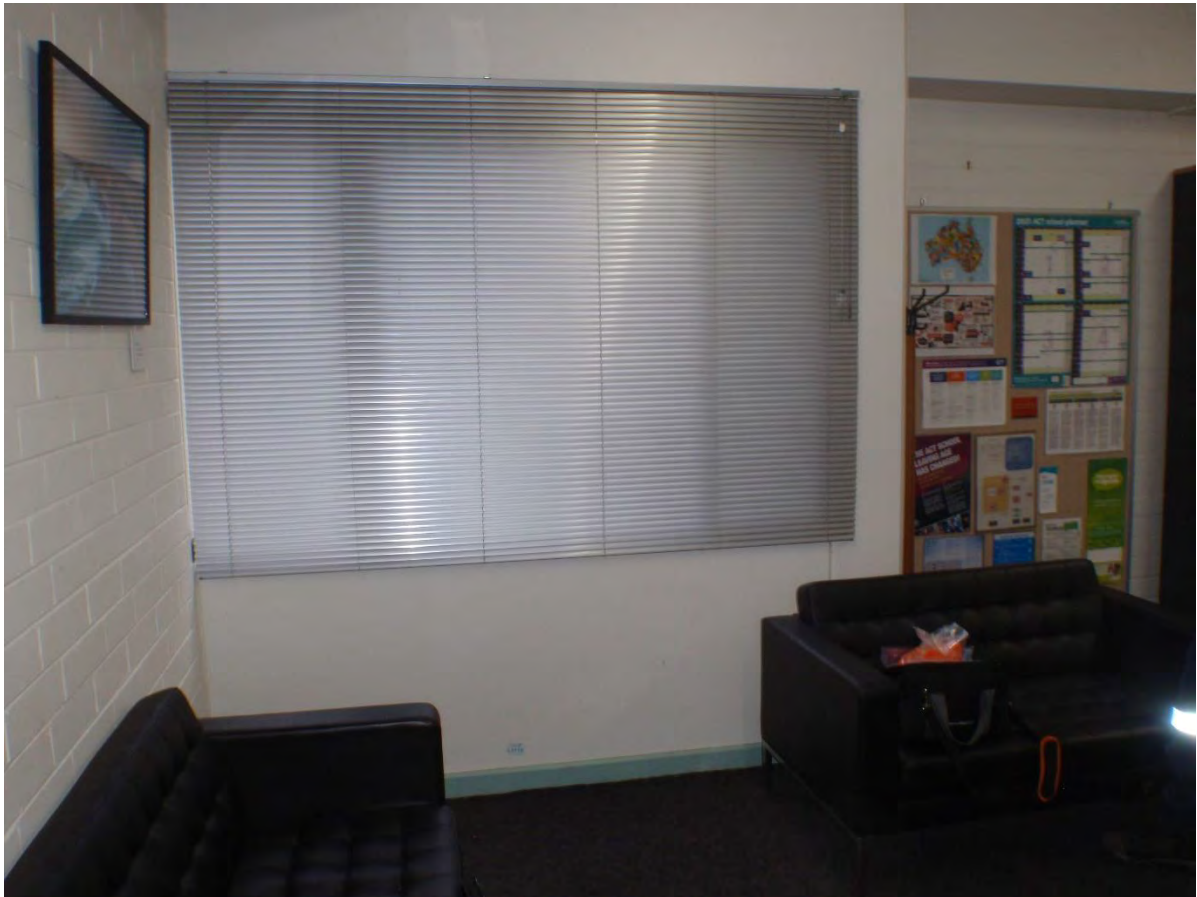
Figure 1 - L3119 - Masonry wall
