**ASBESTOS CLEARANCE CERTIFICATE
INSPECTION PASS**

Project/Location: Yarralumla Primary School

Lead Paint Clearance

Yarralumla Primary School 13 July, 2019

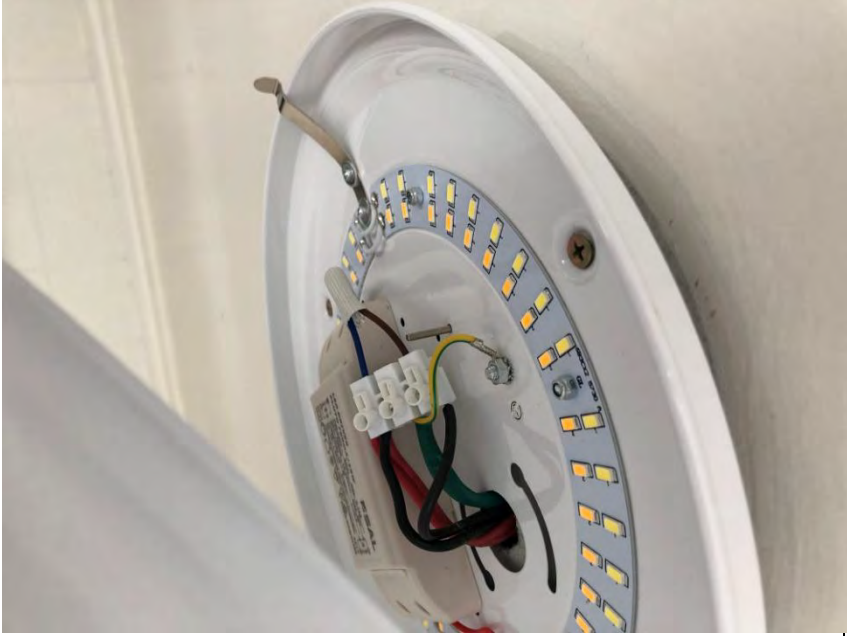
PHOTO NO	LOCATION DESCRIPTION	MATERIAL	PHOTOGRAPH
1	After removal of non-friable asbestos oyster lights from the Gambarri Centre staff toilet (Location 024)	Cable wrap

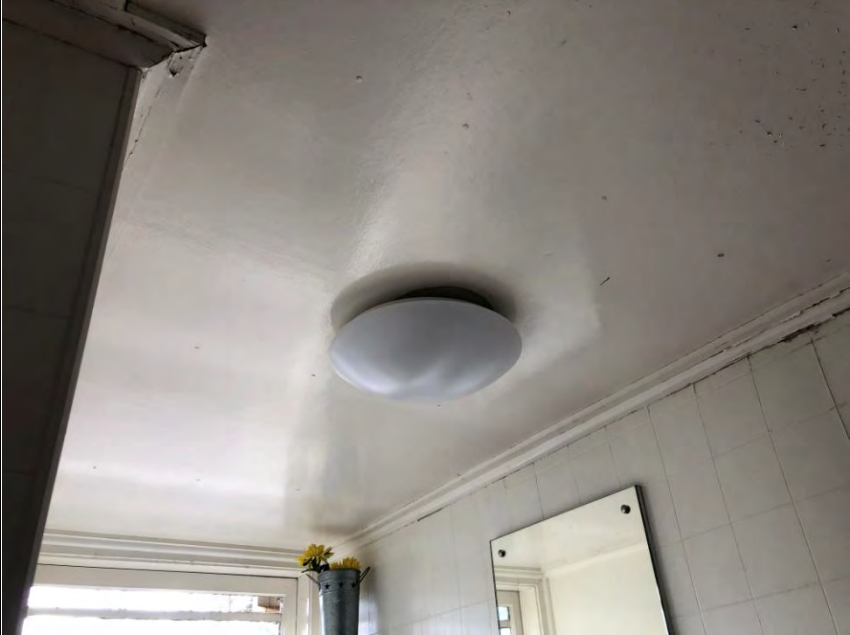
2	After removal of non-friable asbestos oyster lights from the Gambarri Centre staff toilet (Location 024)	Cable wrap

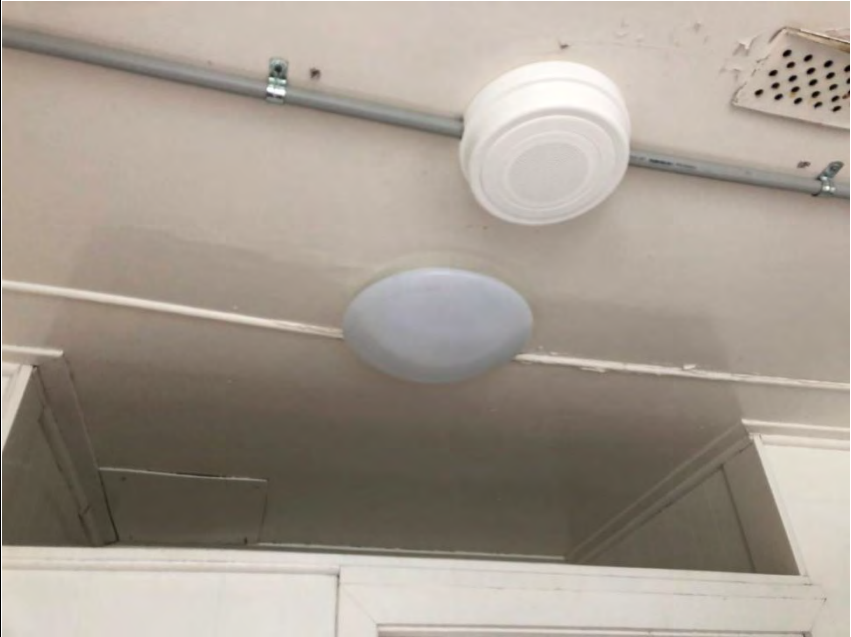
PHOTO NO	LOCATION DESCRIPTION	MATERIAL	PHOTOGRAPH
3	After removal of non-friable asbestos oyster lights from the Gambarri Centre staff toilet (Location 024)	Cable wrap

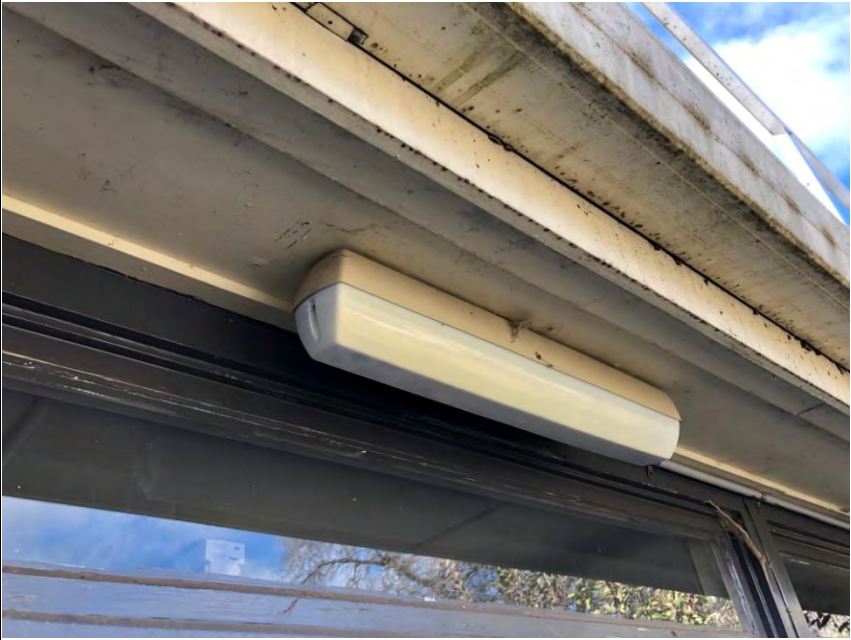
4	After refitting of loose light fixtures to perimeter non-friable asbestos eave soffits from the Gambarri Centre	Sheet

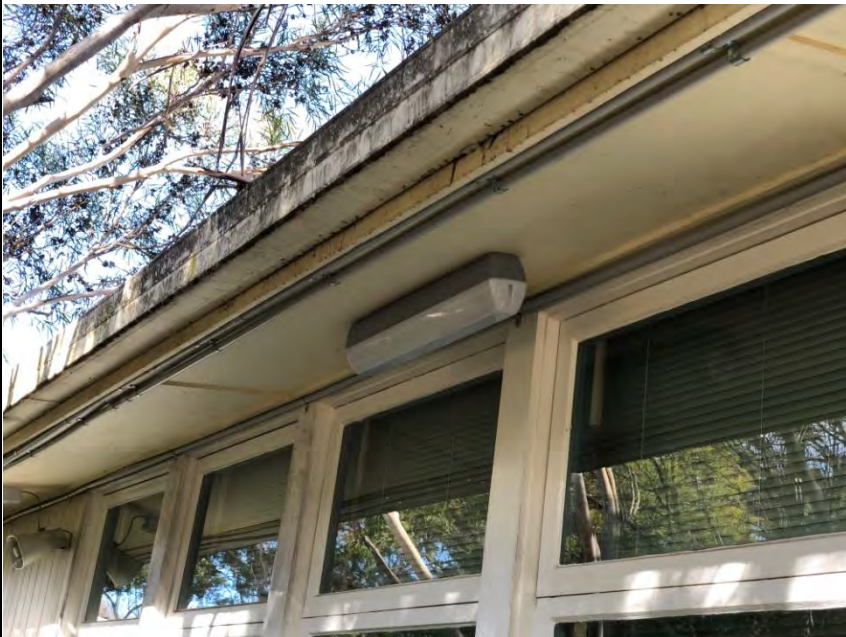
PHOTO NO	LOCATION DESCRIPTION	MATERIAL	PHOTOGRAPH
5	After refitting of loose light fixtures to perimeter non-friable asbestos eave soffits from the Gambarri Centre	Sheet
