Lead Dust Investigation

Yarralumla Primary School and Montessori Preschool

24 July 2020

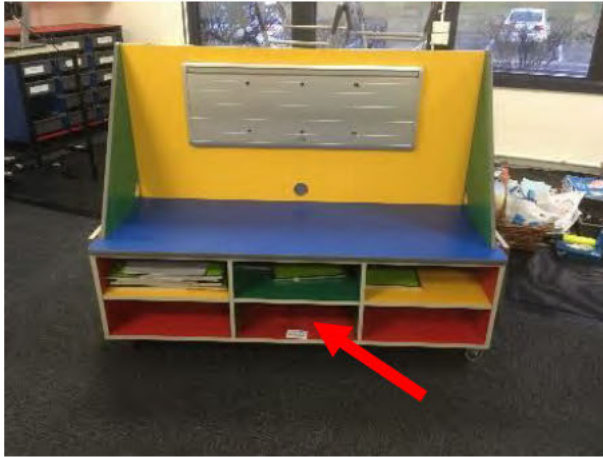
Figure 8: Sample H2032 inside storage unit shelf

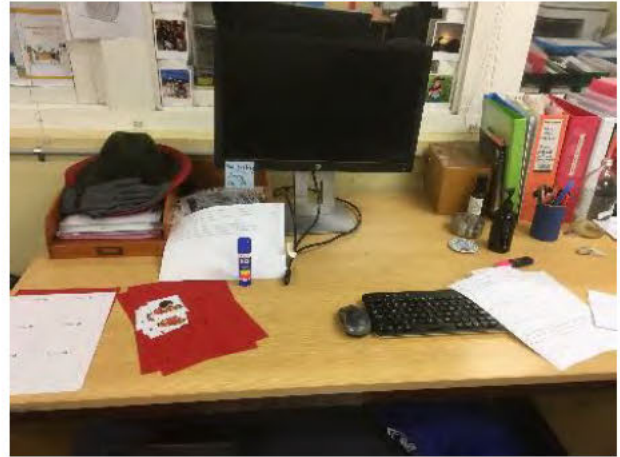
Figure 9: Sample H2037 behind monitor

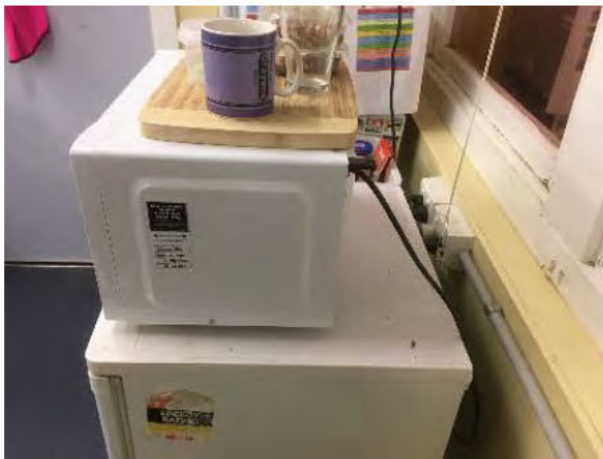
Sample Number		Location	Concentration (mg/m ²)
H2038	Gambarri Centre – 002 – Staff Office	Photocopier	0.025
H2039	Gambarri Centre – 002 – Staff Office	Behind microwave (Figure 10)	0.356
H2040	Gambarri Centre – 002 – Staff Office	Arms of chair (Figure 11)	0.211
H2041	After School Care – 002	Top of cupboard (Figure 12)	0.178
H2043	After School Care – 002	Piano cover	0.088
H2045	After School Care – 009	Side of bookcase (Figure 13)	0.578
H2047	After School Care – 005 – Store	Tennis racket shelf	0.089
H2048	After School Care – 005 – Store	Shelf behind bikes, parachute	0.044
H2049	Primary School – 054 – Canteen	Shelf above sink	0.089
H2055	Primary School – 052 – Hall side store (left of stage)	Top of piano (Figure 14)	0.489
H2057	Primary School – 049 – Corridor	Floor	0.089
H2059	Primary School – 056 – Art Room	Top of cupboard	1.422
H2061	Primary School – 058 – Studio	Bench top (Figure 15)	0.489
H2063	Primary School – 057 – Store	Top of shelves (Figure 16)	0.444

Figure 10: Sample H2039 behind microwave

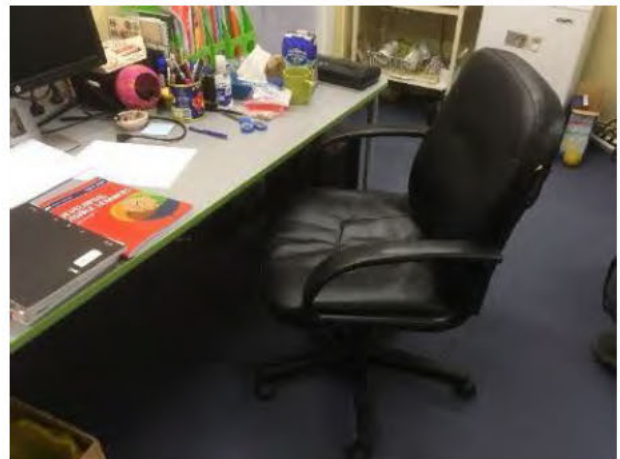
Figure 11: Sample H2040 arms of chair

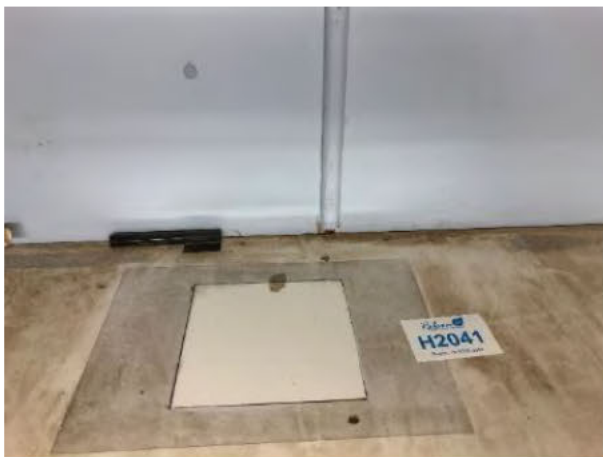
Figure 12: Sample H2041 top of cupboard

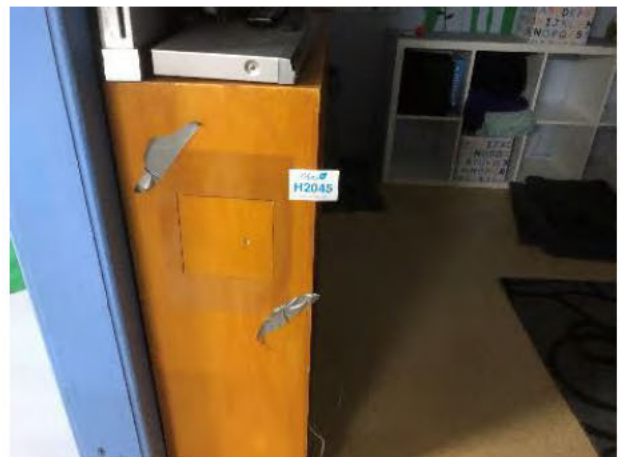
Figure 13: Sample H2045 side of bookcase

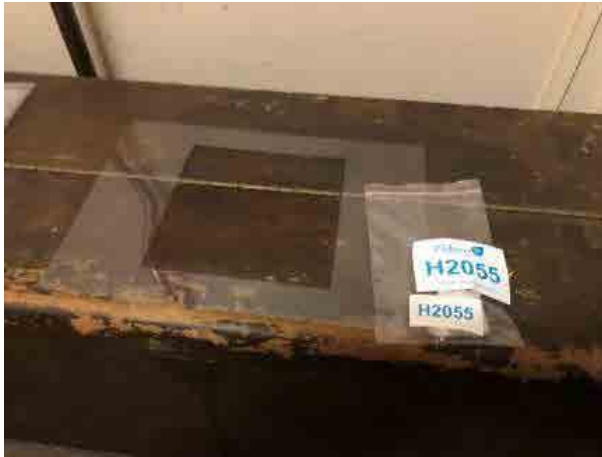
Figure 14: Sample H2055 top of piano

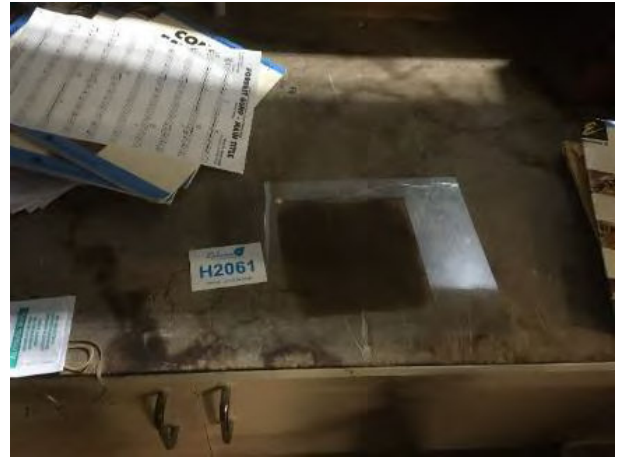
Figure 15: Sample H2061 benchtop

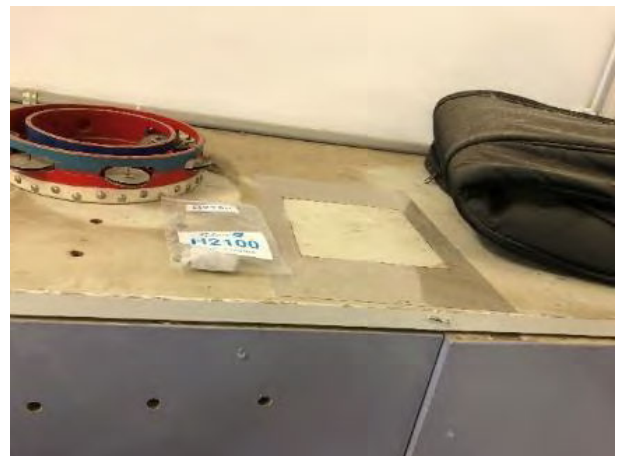
H2097	Primary School – 012	Soft chair under window	0.044
H2100	Primary School – 011	Top of corner cupboard (Figure 17)	0.667
H2105	Primary School – 006 – Cleaner’s Room	Floor near mops	0.089
W2265	Montessori Preschool – Central Bathroom	Top of cupboard adjacent first aid	0.089
W2266	Montessori Preschool – Central Bathroom	Top of partition wall (Figure 18)	0.489
W2269	Montessori Preschool – 012 – Office	Bookshelf (animals/family/friends shelf) (Figure 19)	0.178

Figure 17: Sample H2100 top of corner cupboard

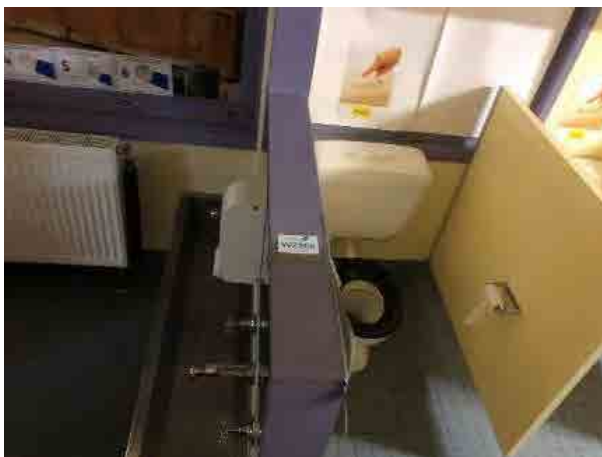
Figure 18: Sample W2266 top of partition

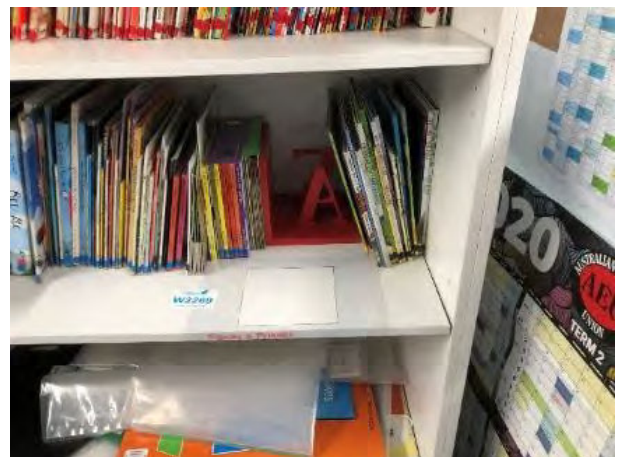
Figure 19: Sample W2269 bookshelf

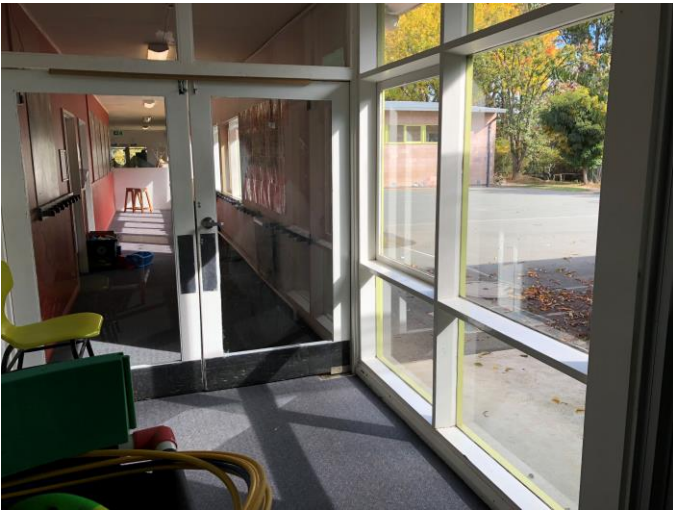
Figure 1: Pb01 23/04/2019

Sample ID	Sample Location	Photo Reference	Paint Colour	Paint Condition	Lead Conc. (%w/w)	Lead Paint?	Exposure Likelihood	Risk Rating as at 16/09/19	Known Management History
Pb01	Yarralumla Primary School Main Building – Internal window frames, door frames and skirting boards throughout	Appendix 1 Figure 1	White	Poor Non-stabilised	0.29	Yes	Very Likely	High	
Pb02	Yarralumla Primary School Main Building – Internal radiator heating pipes throughout	Appendix 1 Figure 2	White	Sound	0.090	No	N/A		
Pb03	Yarralumla Primary School Main Building – Internal Cleaners’/Bathroom masonry walls	Appendix 1 Figure 3 Figure 4	Grey	Sound Stabilised	0.19	Yes	Possible	Medium	Lead paint has been stabilised via over painting 11/08/19.
Pb04	Yarralumla Primary School Main Building – Internal Cleaners’/Bathroom doors	Appendix 1 Figure 5	Dark Blue	Sound Non-stabilised	0.82	Yes	Likely	High	
Pb05	Yarralumla Primary School Main Building – Internal Cleaners’/Bathroom riser walls and pipes	Appendix 1 Figure 6	Green	Poor Non-Stabilised	0.26	Yes	Unlikely	Low

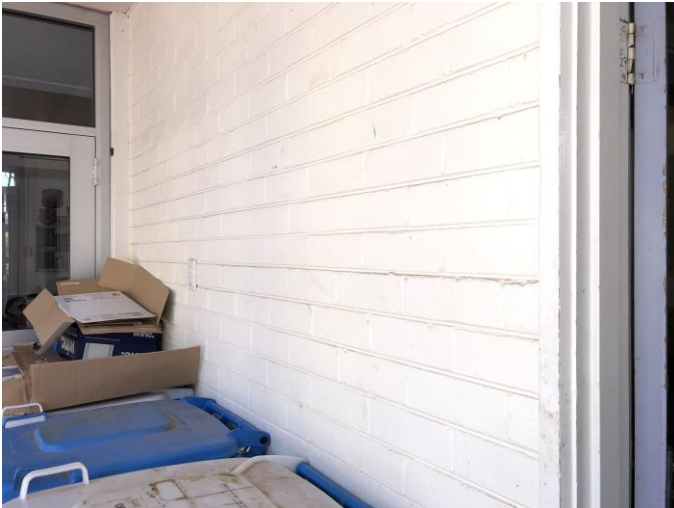
Figure 7: Pb06 23/04/2019

Pb06	Yarralumla Primary School Main Building – Internal brick walls throughout	Appendix 1 Figure 7	White	Sound	<0.005	No	N/A		
Pb07	Yarralumla Primary School Main Building – Internal masonry walls throughout	Appendix 1 Figure 8	Yellow	Sound	<0.005	No	N/A		
Pb08	Yarralumla Primary School Main Building – Exterior windows and infill panels	Appendix 1 Figure 9	Green	Poor Non-stabilised	0.32	Yes	Very Likely	High	Some areas have been stabilised by over-painting on 18/07/19. Over-painted surfaces have deteriorated as of 16/09/2019.

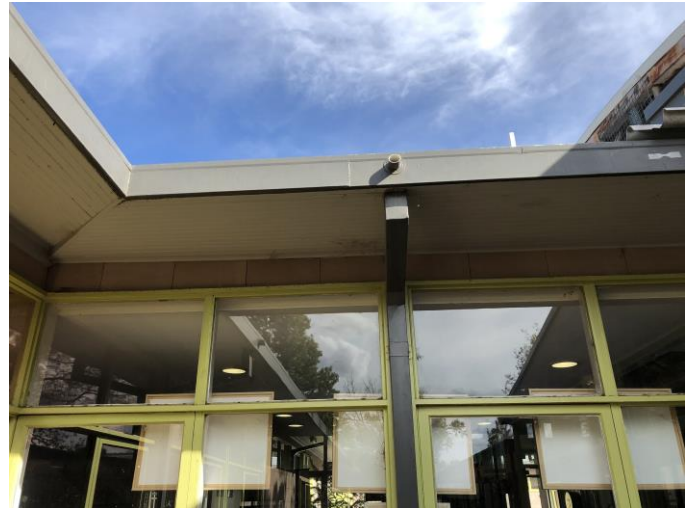
Figure 10: Pb09 23/04/2019

Sample ID	Sample Location	Photo Reference	Paint Colour	Paint Condition	Lead Conc. (%w/w)	Lead Paint?	Exposure Likelihood	Risk Rating as at 16/09/19	Known Management History
Pb09	Yarralumla Primary School Main Building – Exterior down pipes and fascias	Appendix 1 Figure 10	Grey	Sound	0.1	No		N/A	
Pb10	Yarralumla Primary School Main Building – Exterior timber eave soffits	Appendix 1 Figure 11	Grey	Sound	<0.005	No		N/A	
Pb11	Yarralumla Primary School Main Building – External window frames and doors	Appendix 1 Figure 12	Grey	Sound	0.05	No		N/A	
Pb12	Yarralumla Gambarri and Preschool – Exterior window frames, doors, masonry walls and eave soffits	Appendix 1 Figure 13 Appendix 1 Figure 14	White	Poor Non-stabilised	0.13	Yes	Very Likely	High	Stabilisation by over-painting on 13/07/19. Over-painted surfaces have deteriorated as of 16/09/2019.
Pb13	Yarralumla Primary School After School Care – Exterior window frames and eave soffits	Appendix 1 Figure 15 Appendix 1 Figure 16	White	Poor Non-stabilised	0.28	Yes	Possible	High	Stabilisation by over-painting on 17/07/19. Over-painted surfaces have deteriorated as of 16/09/2019.

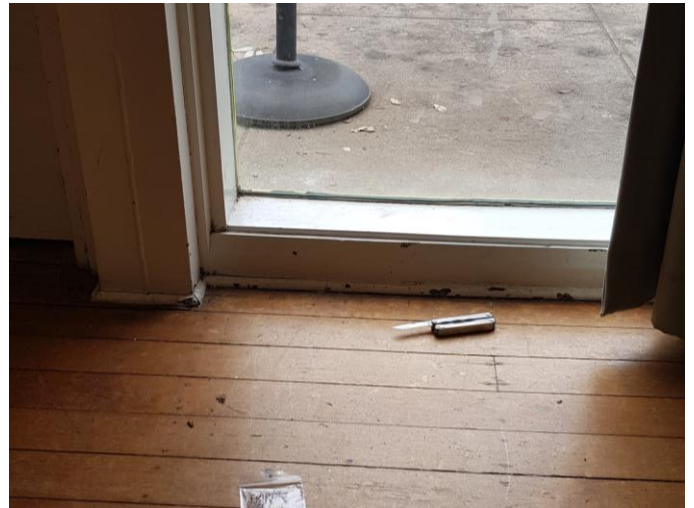
Figure 22: T010352 27/08/2019

*This paint is probably the same as the paint in sample T010352, given its location and similarity to the paint on the opposite side of the Hall. The variation in lead concentration could be due to different thickness of paint application or from overpainting in some areas, and it is likely that there is variation in concentration of lead in the paint on skirting boards throughout the Hall. It is recommended that all paint on skirting board in the Hall be managed as lead paint.

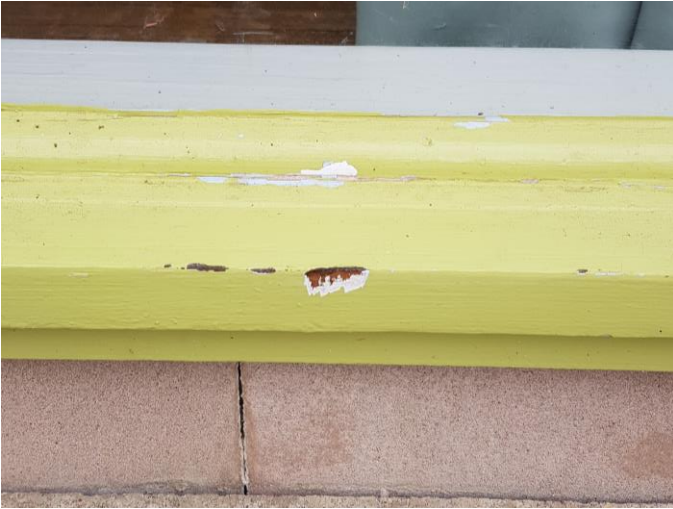
Figure 25: T010355 27/08/2019

Sample ID	Sample Location	Photo Reference	Paint Colour	Paint Condition	Lead Conc. (%w/w)	Lead Paint?	Exposure Likelihood	Risk Rating as at 16/09/19	Known Management History
T010352	Yarralumla Canteen and Hall – Skirting board south (window side) Hall	Appendix 1 Figure 22	White	Poor Non-stabilised	0.15	Yes	Very Likely	High	
T010353	Yarralumla Canteen and Hall – Skirting board North (internal side) Hall	Appendix 1 Figure 23	White	Poor Non-stabilised	0.092*	Probable	See note below. This paint should be managed the same as the paint from sample T010352 as it likely to contain a similar amount of lead, on average.		
T010354	Yarralumla Canteen and Hall – Between windows in Quad outside Hall	Appendix 1 Figure 24	Green	Poor Non-stabilised	0.15	Yes	Very Likely	High	
T010355	Yarralumla Canteen and Hall – Skirting under windows in Quad outside Hall	Appendix 1 Figure 25	Green	Poor Non-stabilised	0.44	Yes	Very Likely	High
