# Visual Lead Paint Clearance

## Yarralumla Primary School

Document Name	Lead Paint Clearance – Yarralumla Primary Gambarri Centre		
Date of Issue	11 September 2019	Job Number	T-01035
Client	ACT Property Group		
Sampling and Report Preparation	Reviewed	Approved	
Robson Environmental Pty. Ltd.	Robson Environmental Pty. Ltd.	Robson Environmental Pty. Ltd.

# Airborne Lead Monitoring During Lead Paint Remediation

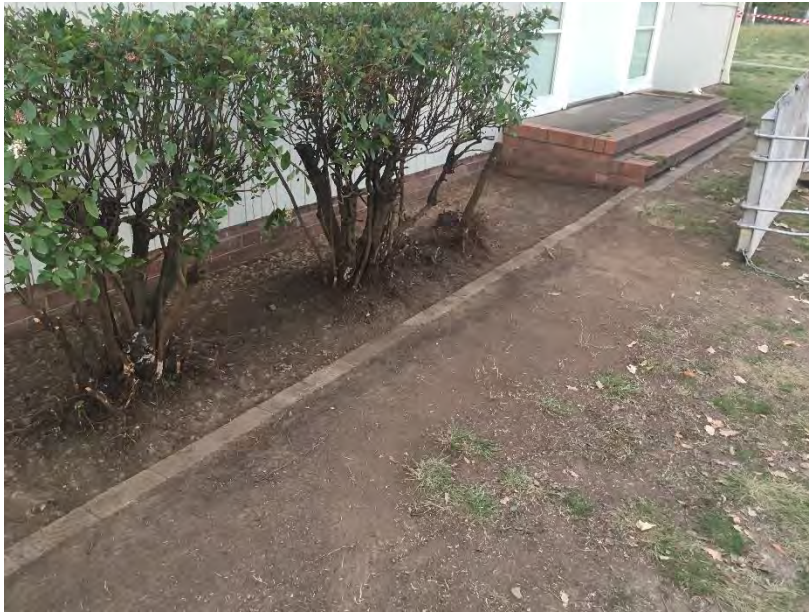
**Figure 1: Ground surface after the remediation works in the garden bed at the south end of the Gambarri Centre entrance**

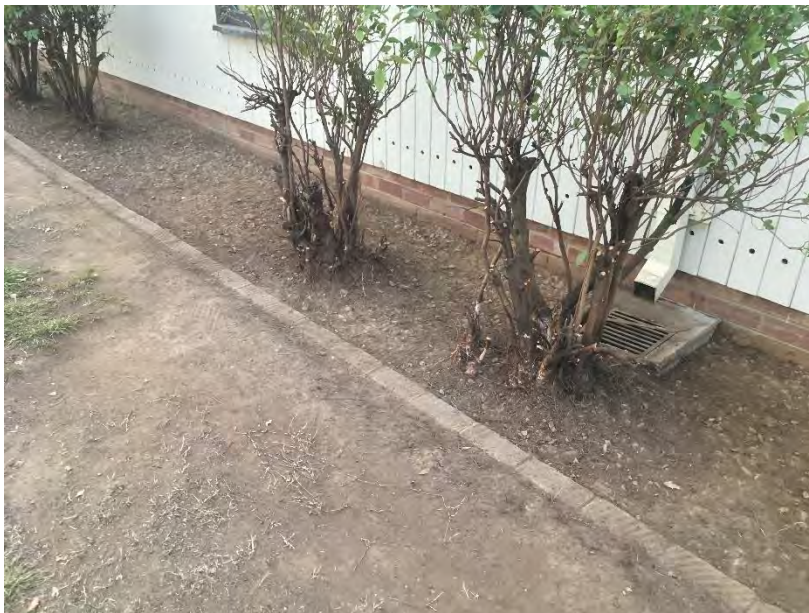
**Figure 2: Ground surface after the remediation works in the garden bed at the south end of the Gambarri Centre entrance**

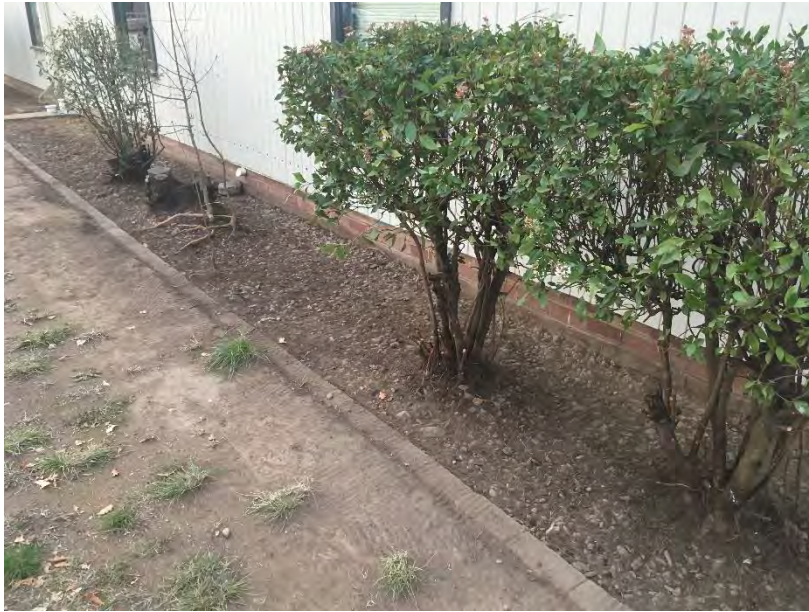
**Figure 3: Ground surface after the remediation works in the garden bed at the south end of the Gambarri Centre entrance**

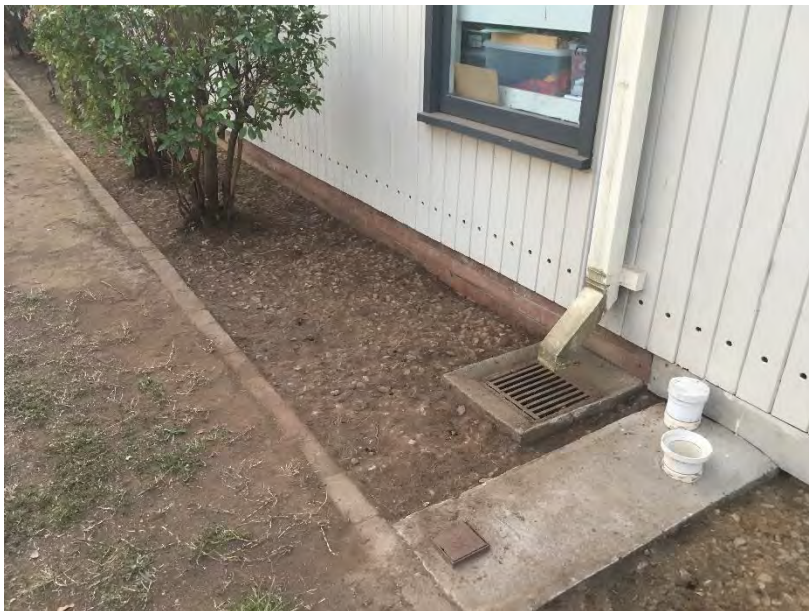
**Figure 4: Ground surface after the remediation works in the garden bed at the south end of the Gambarri Centre entrance**

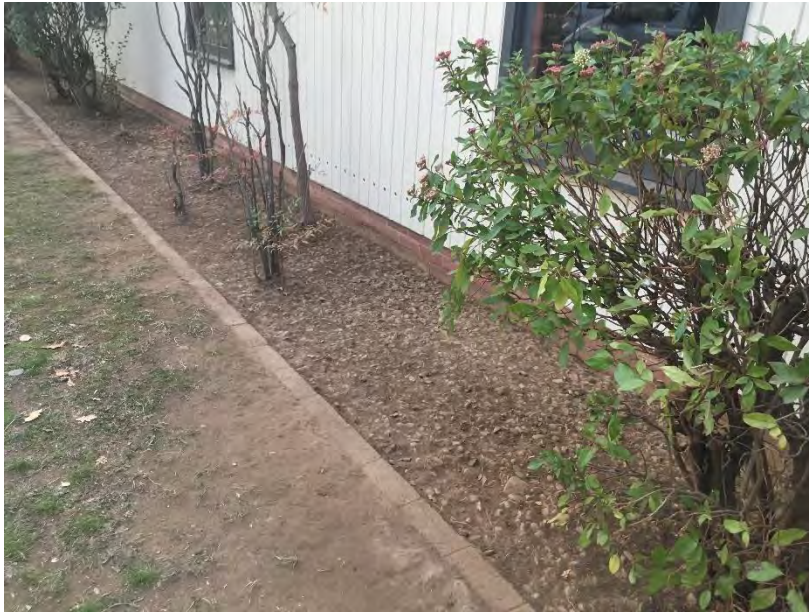
**Figure 5: Ground surface after the remediation works in the garden bed at the south end of the Gambarri Centre entrance**

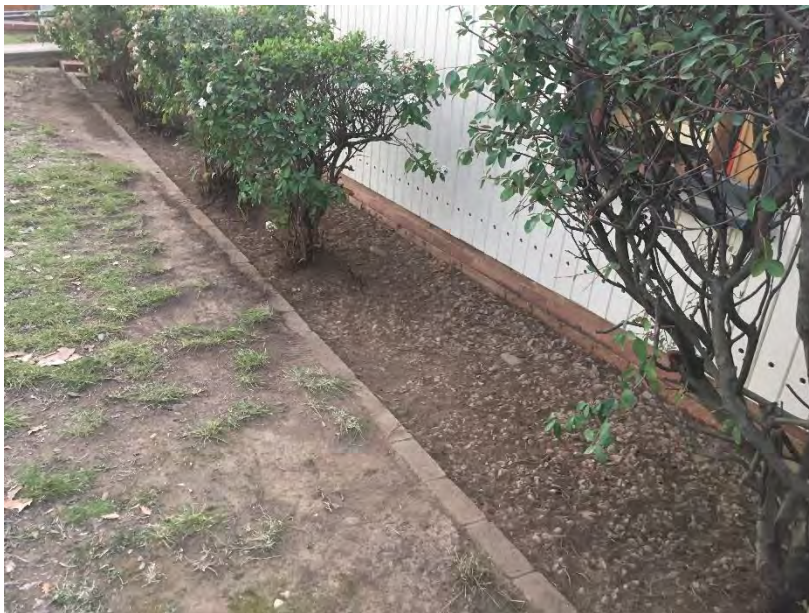
**Figure 6: Ground surface after the remediation works in the garden bed at the south end of the Gambarri Centre entrance**

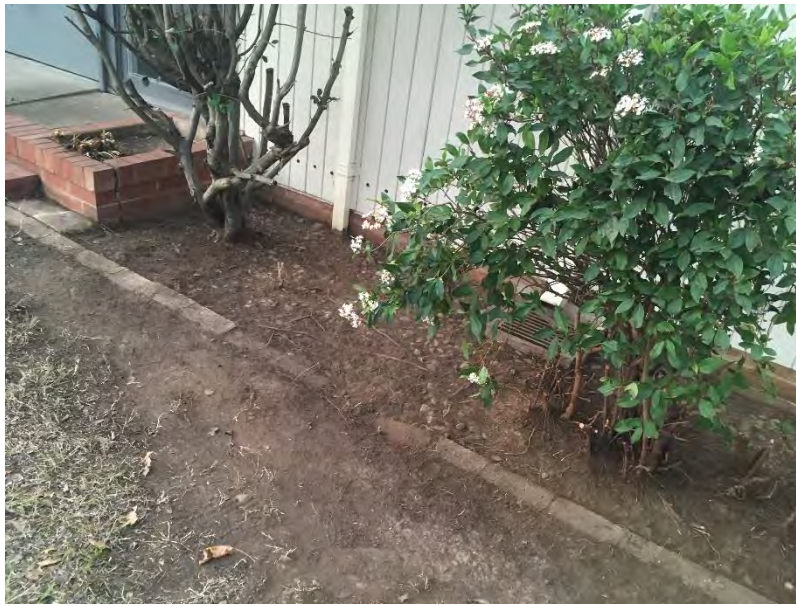
**Figure 7: Ground surface after the remediation works in the garden bed at the south end of the Gambarri Centre entrance**

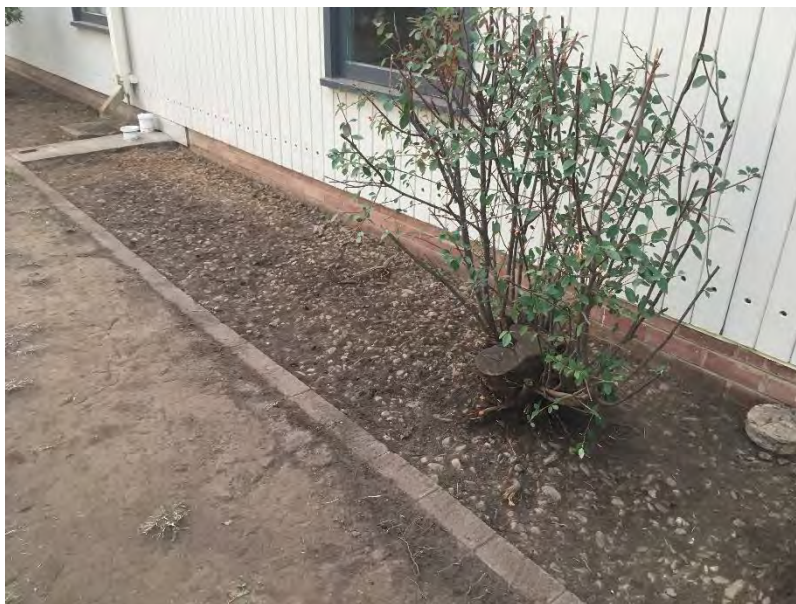
**Figure 8: Ground surface after the remediation works in the garden bed at the south end of the Gambarri Centre entrance**

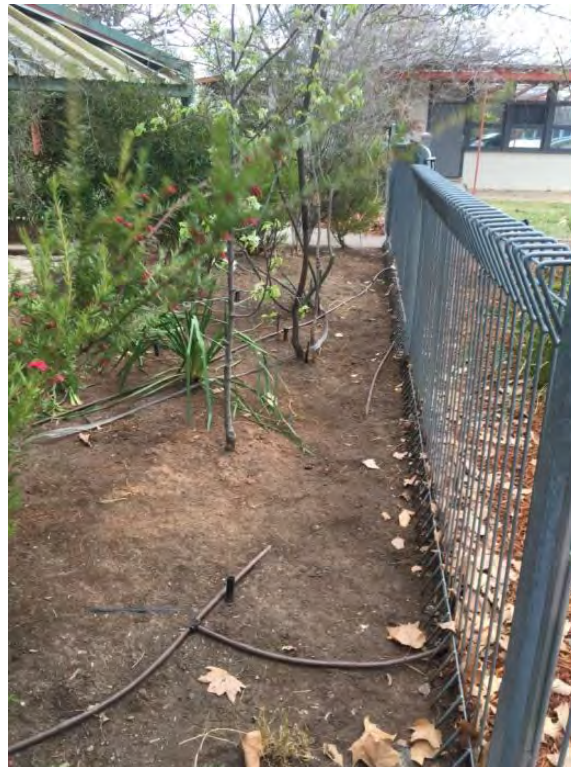
**Figure 1: Ground surface after the remediation works in the garden bed between sandpit and fence line at the outdoor play area of the Gambarri Centre**

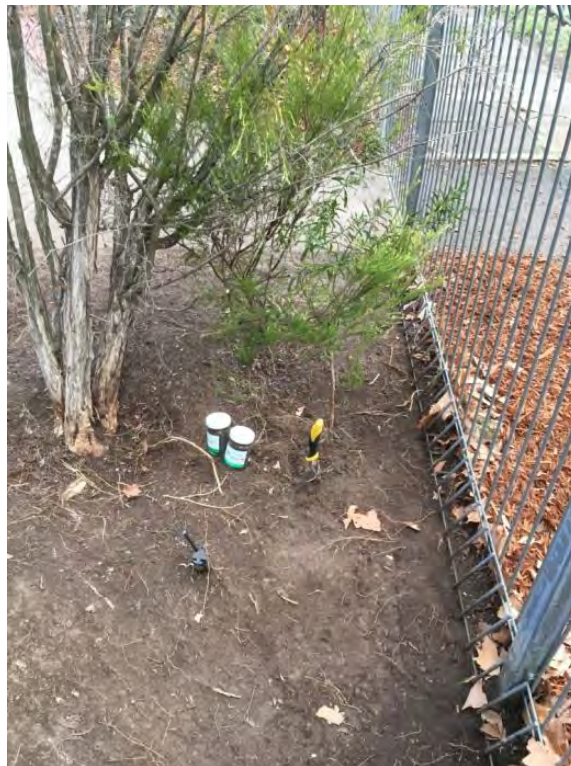
**Figure 2 Ground surface after the remediation works in the garden bed between sandpit and fence line at the outdoor play area of the Gambarri Centre**

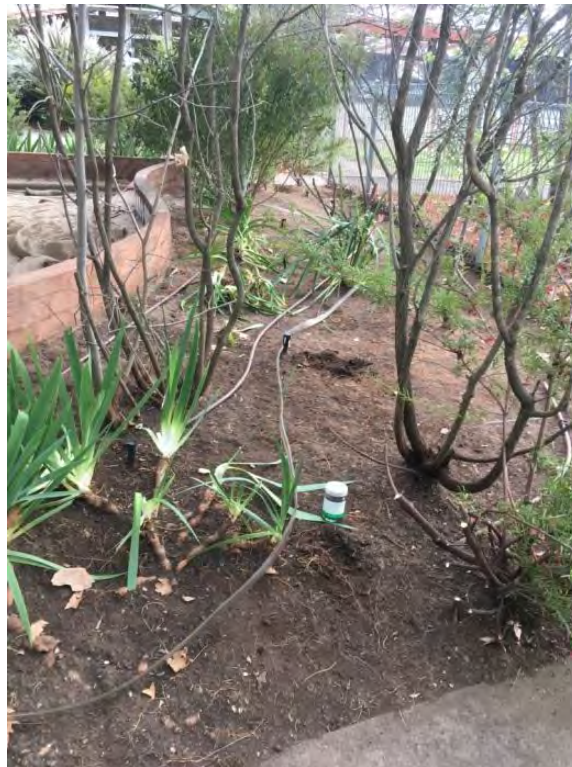
**Figure 3 Ground surface after the remediation works in the garden bed at the between sandpit and fence line at the outdoor play area of the Gambarri Centre**

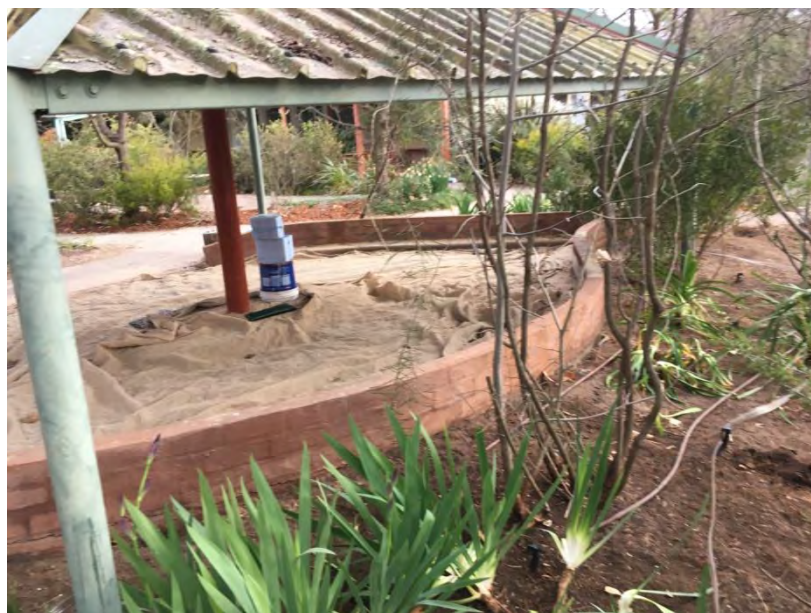
**Figure 4 Ground surface after the remediation works in the garden bed at the between sandpit and fence line at the outdoor play area of the Gambarri Centre**

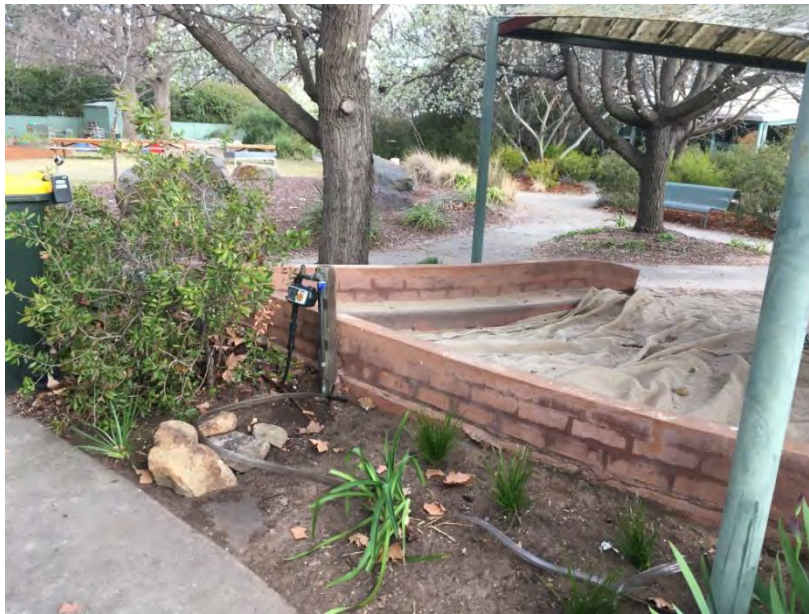
**Figure 5 Ground surface after the remediation works in the garden bed at the between sandpit and fence line at the outdoor play area of the Gambarri Centre**
