# Lead Paint Assessment

**T-01035 Yarralumla Primary & Preschool**

**Client: ACT Property Group**

**Survey Date: 23/04/2019**

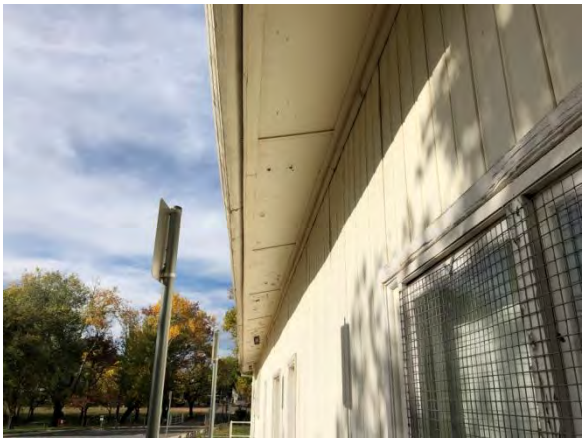
After School Care				
SAMPLE NO	TRACKER LOCATION NO	LOCATIONS	ACM TYPE	PHOTOGRAPH
RA 2123-28-8	001	Exterior - high level eave soffits	Sheet (Non-Friable)

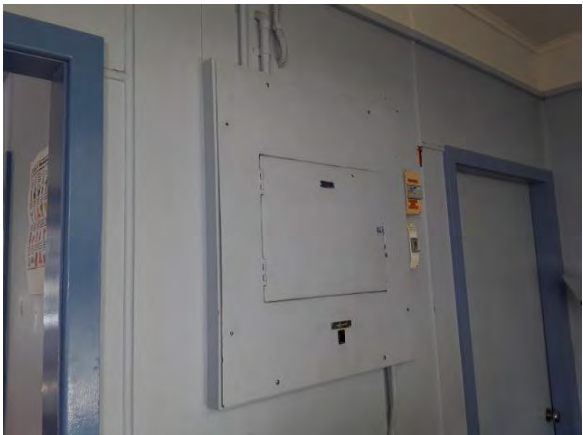
VA04	N/A	Electrical switchboards - backing boards (throughout building)	Sheet (Presumed Non-Friable)

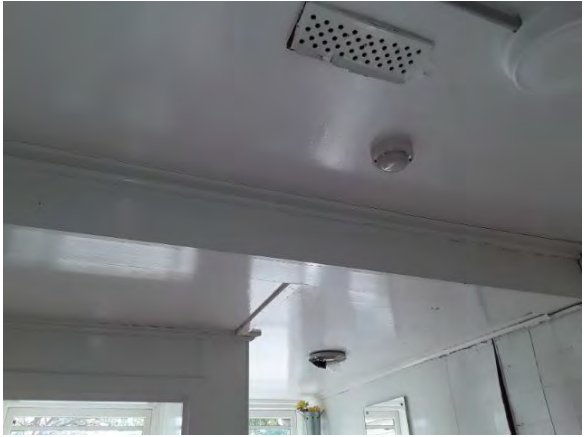
Gambarri Centre				
SAMPLE NO	TRACKER LOCATION NO	LOCATIONS	ACM TYPE	PHOTOGRAPH
RA 3741-47-A4	024	Ground floor staff toilet - ceiling	Sheet (Non-Friable)

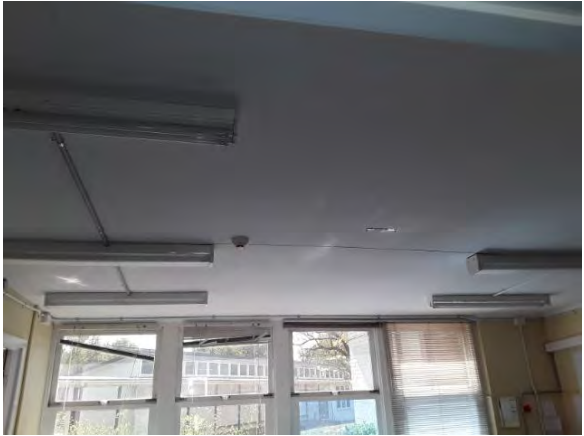
3741-47-A4	002	Ground floor Staff Office - ceiling	Sheet (Non-Friable)

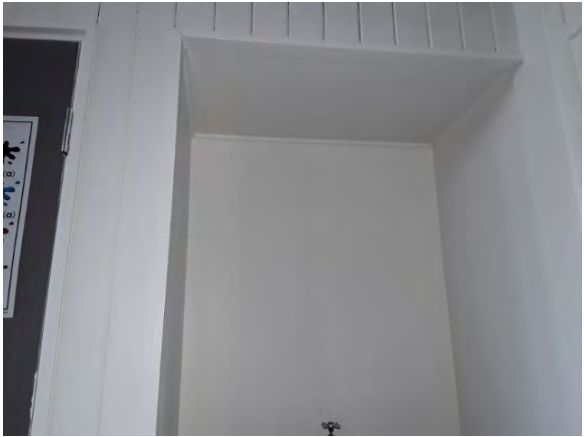
3741-47-A8	017	Ground floor Music Room - ceiling to sink alcove	Sheet (Non-Friable)

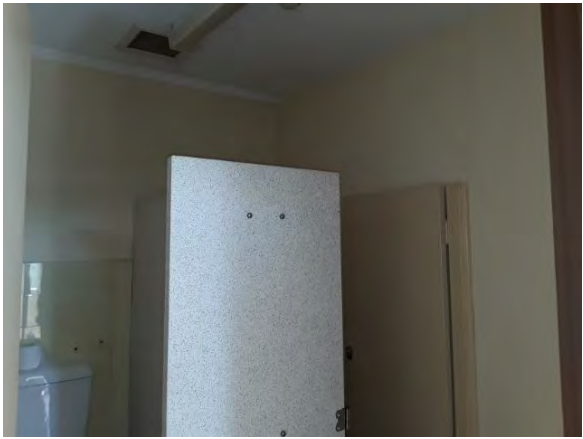
Gambarri Centre				
SAMPLE NO	TRACKER LOCATION NO	LOCATIONS	ACM TYPE	PHOTOGRAPH
D2148	003	Ground floor toilets adjacent Staff Office - walls	Sheet (Non-Friable)

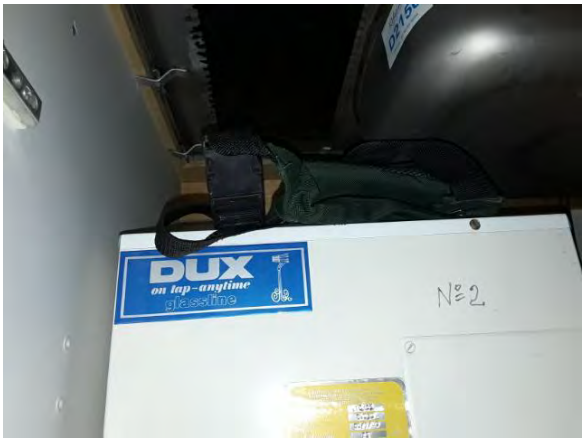
D2150	006	Ground floor store room - to underside of sink	Bituminous pad to underside of sink (Non-Friable)

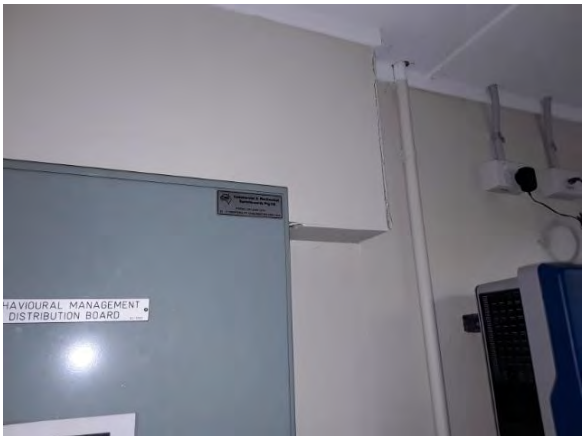
F1058	015	Ground floor Electrical Switchboard Room - walls	Sheet (Non-Friable)

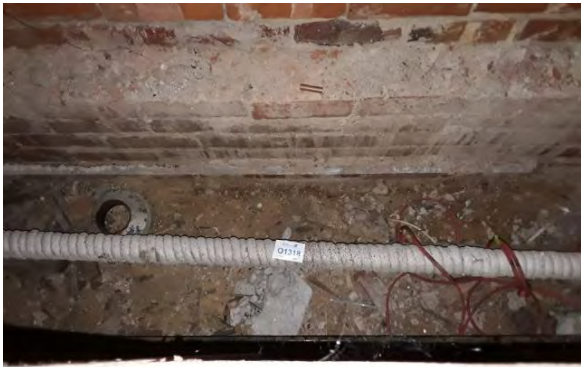
Gambarri Centre				
SAMPLE NO	TRACKER LOCATION NO	LOCATIONS	ACM TYPE	PHOTOGRAPH
O1318	004	Corridor wall cavity to main entrance - to hot water pipes in wall cavity and subfloor (throughout building)	Pipe lagging (fibrous) (Friable)

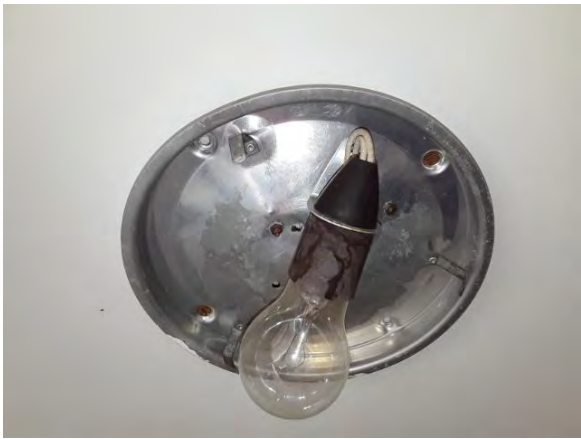
VA02	024	Staff toilet - oyster light fittings (throughout building)	Cable wrap (Presumed Non-Friable)

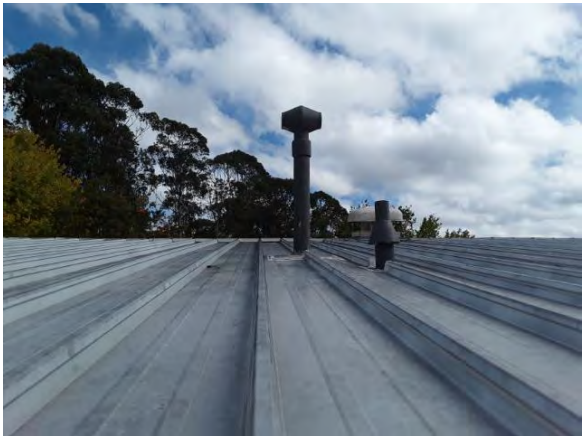
Primary				
SAMPLE NO	TRACKER LOCATION NO	LOCATIONS	ACM TYPE	PHOTOGRAPH
3741-47-A3	001	Exterior - to roof	Cement flue pipe (Non-Friable)

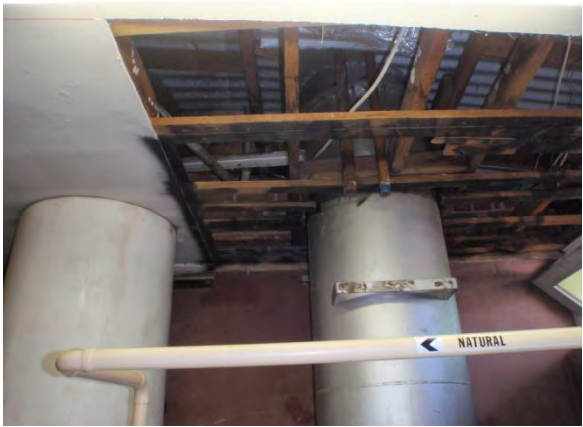
P0322	043	Ground floor Boiler Room - ceiling around flue	Sheet (Non-Friable)

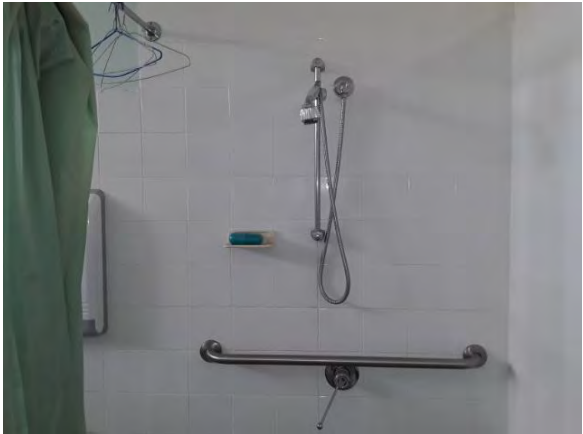
VA01	N/A	Wet areas - to hot water pipes embedded in masonry walls (throughout building)	Pipe lagging (fibrous) (Presumed Friable)

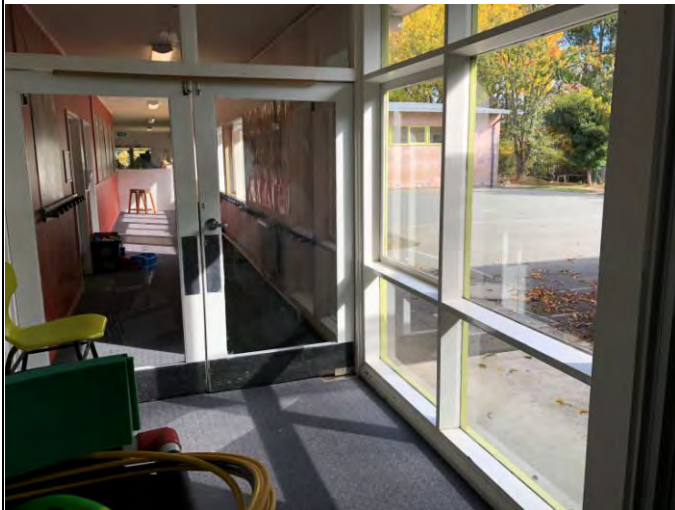
Sample ID	Sample Location	Paint Colour	Classified as Lead Paint?	Photograph(s)
Pb01	Yarralumla Primary School Main Building – Internal window frames, door frames and skirting boards throughout	White	Yes

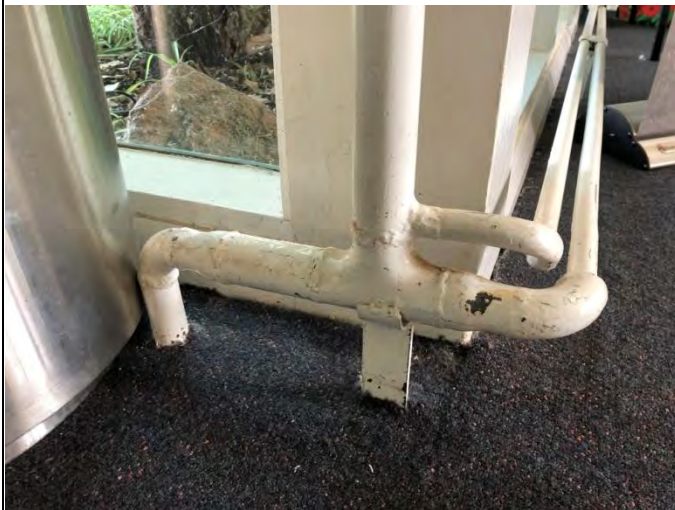
Pb02	Yarralumla Primary School Main Building – Internal radiator heating pipes throughout	White	No

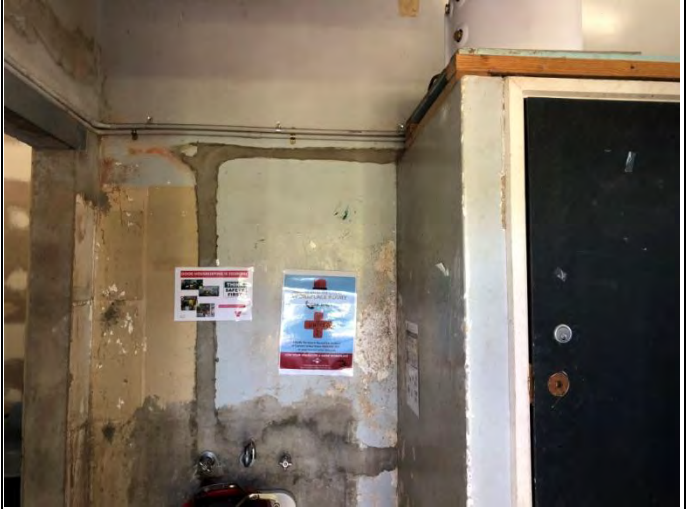
- Sample ID – Pb03 – Grey Paint
  - Internal Cleaners’/Bathroom masonry walls
- Sample ID – Pb08 – Green Paint
  - Exterior windows and infill panels

Sample ID	Sample Location	Paint Colour	Classified as Lead Paint?	Photograph(s)
Pb03	Yarralumla Primary School Main Building – Internal Cleaners’/Bathroom masonry walls	Grey	Yes

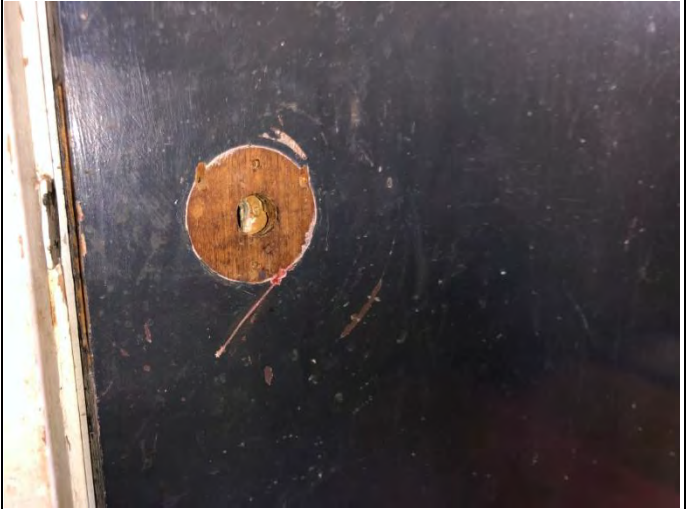
Pb04	Yarralumla Primary School Main Building – Internal Cleaners'/Bathroom walls	Dark Blue	Yes	0.82	L	<p>Ongoing preventative action should be planned. This includes:</p> <ul style="list-style-type: none"> <li>• Maintain the lead paint system in good condition.</li> <li>• Check it periodically to ensure a low exposure risk (i.e. no cracking, flaking, chalking or peeling observed and that it is not a friction or impact surface).</li> <li>• Review and update the risk rating appropriately.</li> </ul>
Pb05	Yarralumla Primary School Main Building – Internal Cleaners'/Bathroom riser walls and pipes	Spearmint/Green	Yes	0.26	L	<p>Ongoing preventative action should be planned. This includes:</p> <ul style="list-style-type: none"> <li>• Maintain the lead paint system in good condition.</li> <li>• Check it periodically to ensure a low exposure risk (i.e. no cracking, flaking, chalking or peeling observed and that it is not a friction or impact surface).</li> <li>• Review and update the risk rating appropriately.</li> </ul>

Pb04	Yarralumla Primary School Main Building –Internal Cleaners’/Bathroom walls	Dark Blue	Yes

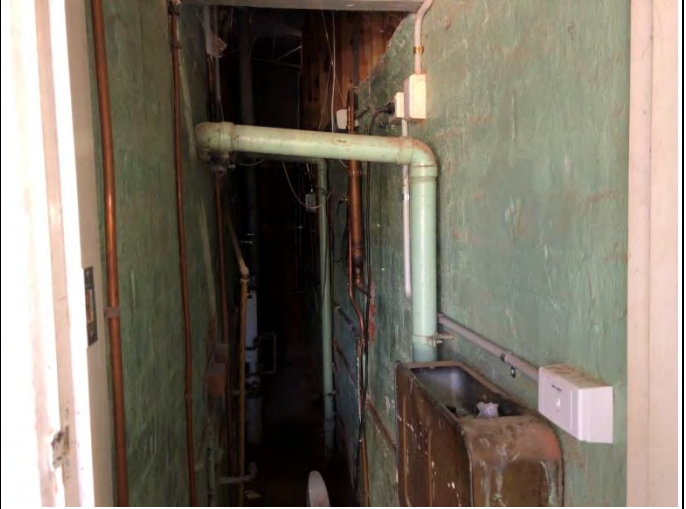
Sample ID	Sample Location	Paint Colour	Classified as Lead Paint?	Photograph(s)
Pb05	Yarralumla Primary School Main Building – Internal Cleaners’/Bathroom riser walls and pipes	Spearmint/Green	Yes

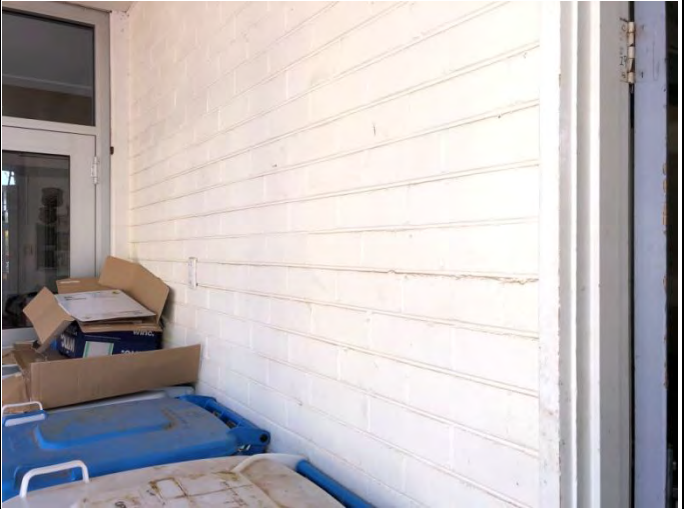
Pb06	Yarralumla Primary School Main Building – Internal brick walls throughout	White	No

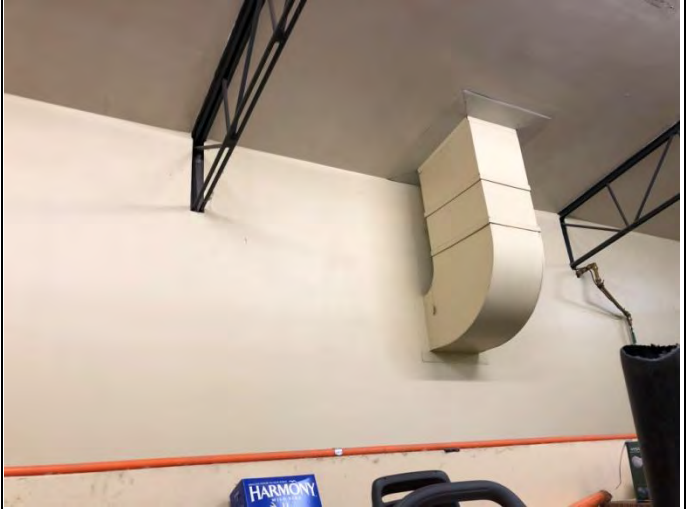
Sample ID	Sample Location	Paint Colour	Classified as Lead Paint?	Photograph(s)
Pb07	Yarralumla Primary School Main Building –Internal masonry walls throughout	Yellow	No

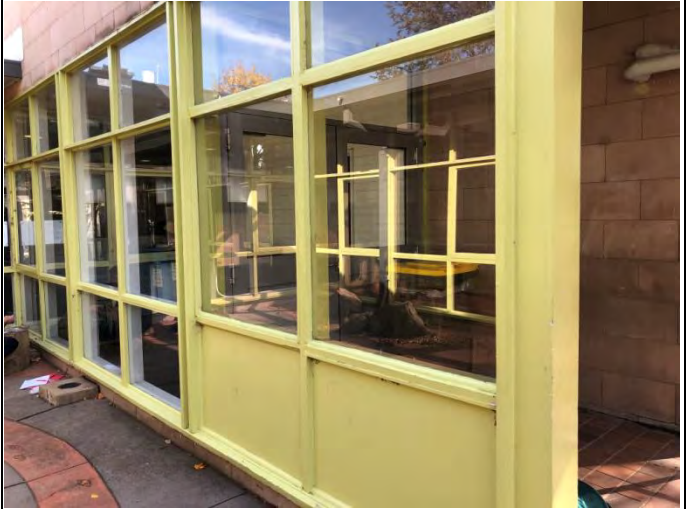
Pb08	Yarralumla Primary School Main Building – Exterior windows and infill panels	Green	Yes

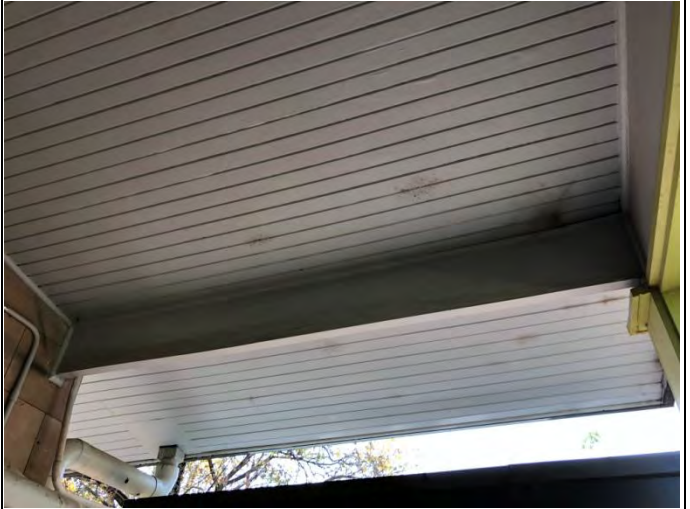
Sample ID	Sample Location	Paint Colour	Classified as Lead Paint?	Photograph(s)
Pb09	Yarralumla Primary School Main Building – Exterior down pipes and fascias	Grey	No	 
Pb10	Yarralumla Primary School Main Building – Exterior timber eaves	Grey	No

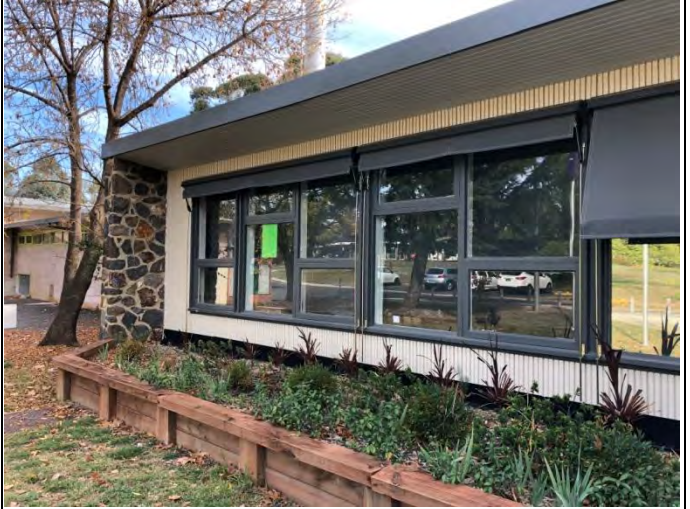
Sample ID	Sample Location	Paint Colour	Classified as Lead Paint?	Photograph(s)
Pb11	Yarralumla Primary School Main Building – External window frames and doors	Grey	No

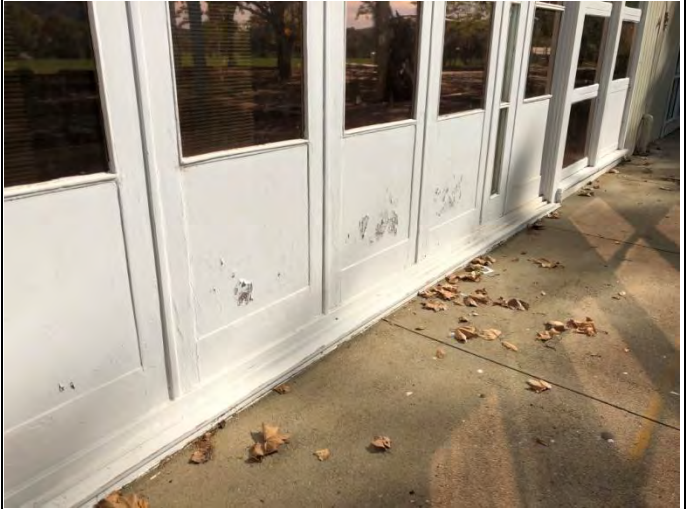
- Sample ID – Pb12 – White Paint
  - Exterior window frames and doors

Pb12	Yarralumla Gambarri and Preschool – Exterior window frames and doors	White	Yes

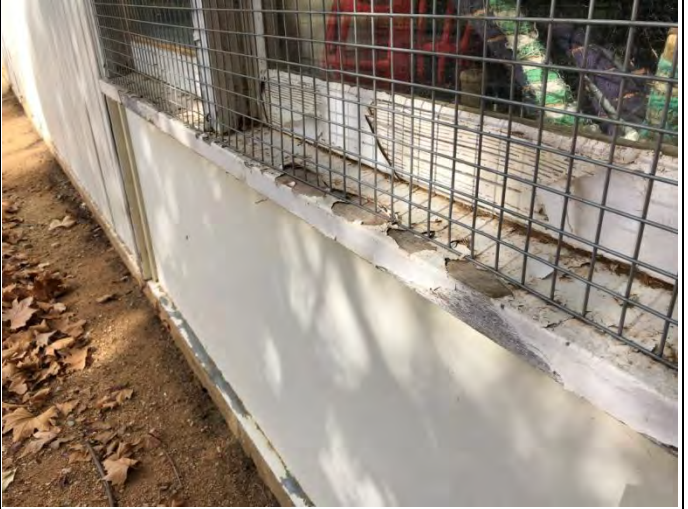
- Sample ID- Pb13 – White Paint
  - Exterior window frames and doors

Sample ID	Sample Location	Paint Colour	Classified as Lead Paint?	Photograph(s)
Pb13	Yarralumla Primary School After School Care – Exterior window frames and eaves	White	Yes

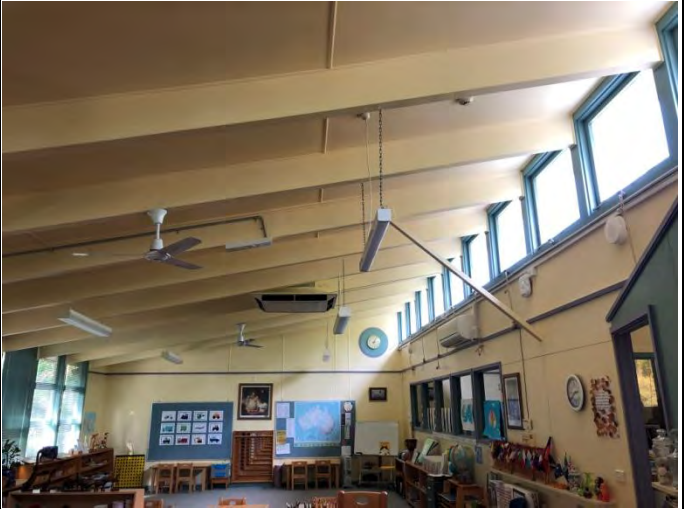
Pb14	Yarralumla Preschool – Internal roof support beam	Yellow	No

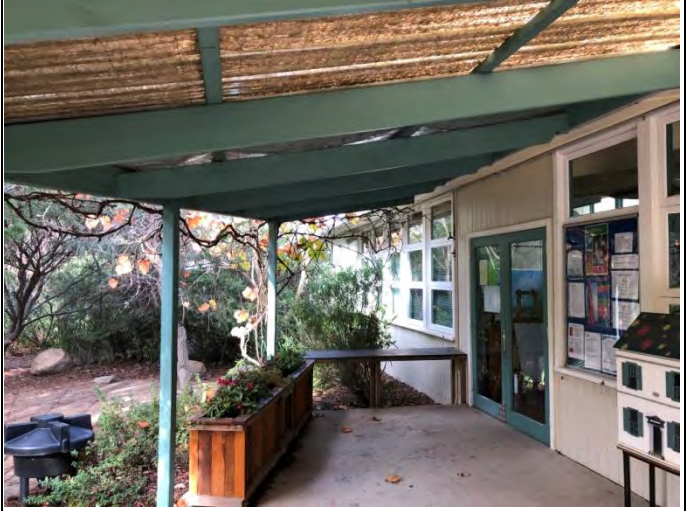
Sample ID	Sample Location	Paint Colour	Classified as Lead Paint?	Photograph(s)
Pb15	Yarralumla Preschool – Internal and external window frames, pergola frame and doors	Grey	No

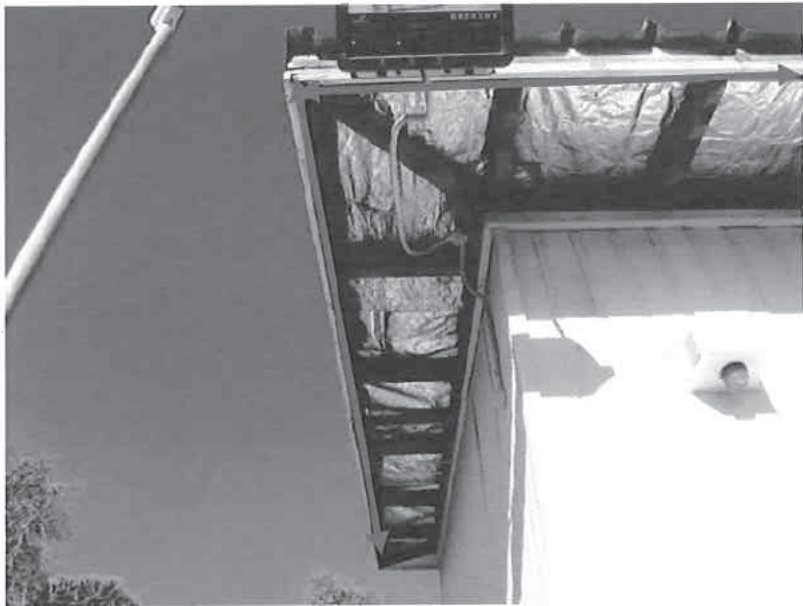
PHOTO NO	LOCATION DESCRIPTION	MATERIAL	PHOTOGRAPH
1	Removal of non-friable asbestos eave sheets from the After School Care Building.	sheet

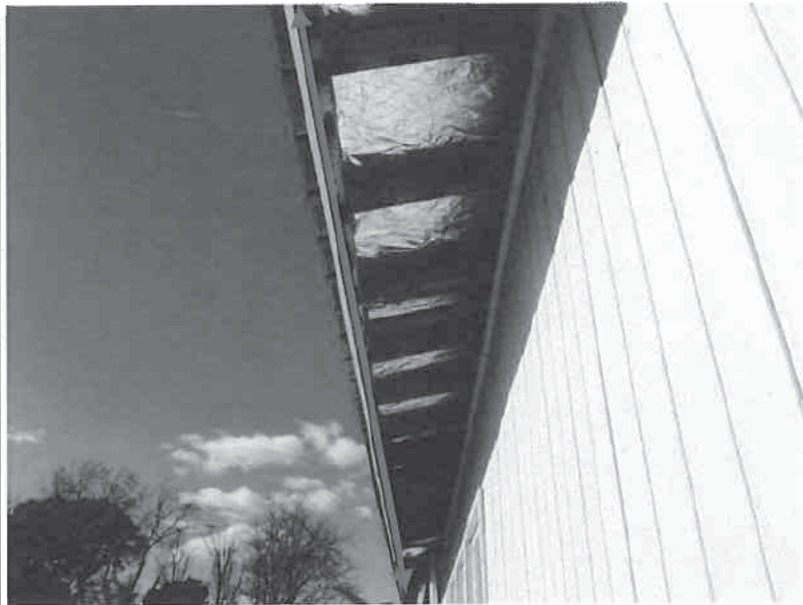
2	Removal of non-friable asbestos eave sheets from the After School Care Building.	sheet

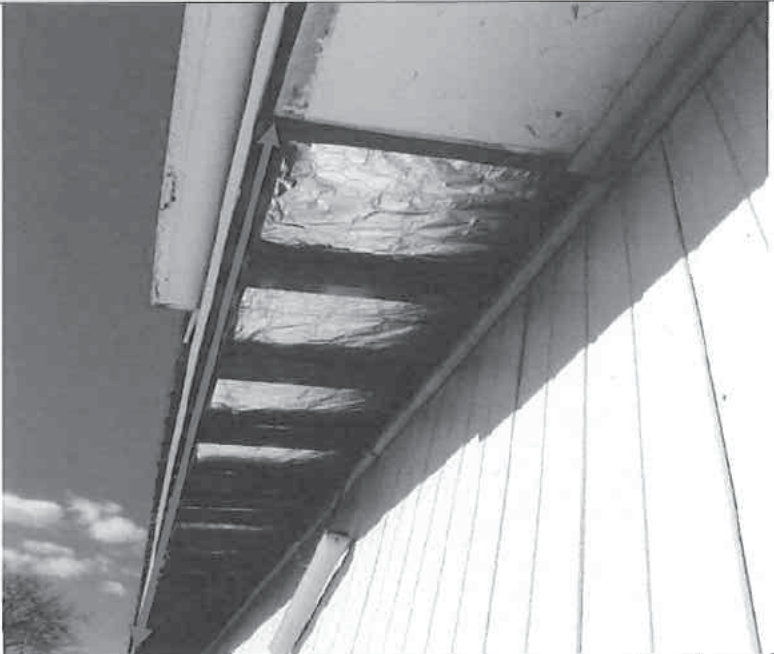
PHOTO NO	LOCATION DESCRIPTION	MATERIAL	PHOTOGRAPH
3	Removal of non-friable asbestos eave sheets from the After School Care Building.	sheet

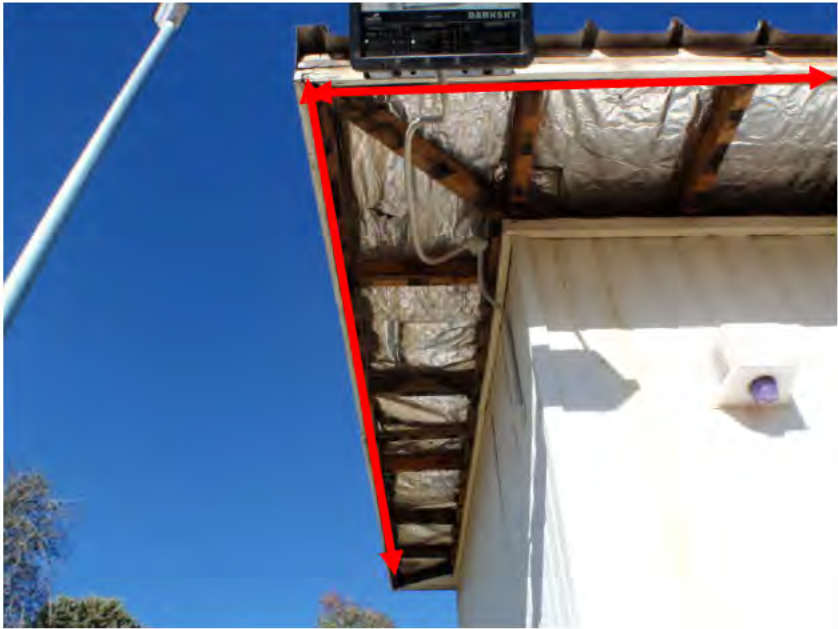
PHOTO NO	LOCATION DESCRIPTION	MATERIAL	PHOTOGRAPH
1	Removal of non-friable asbestos eave sheets from the After School Care Building.	sheet

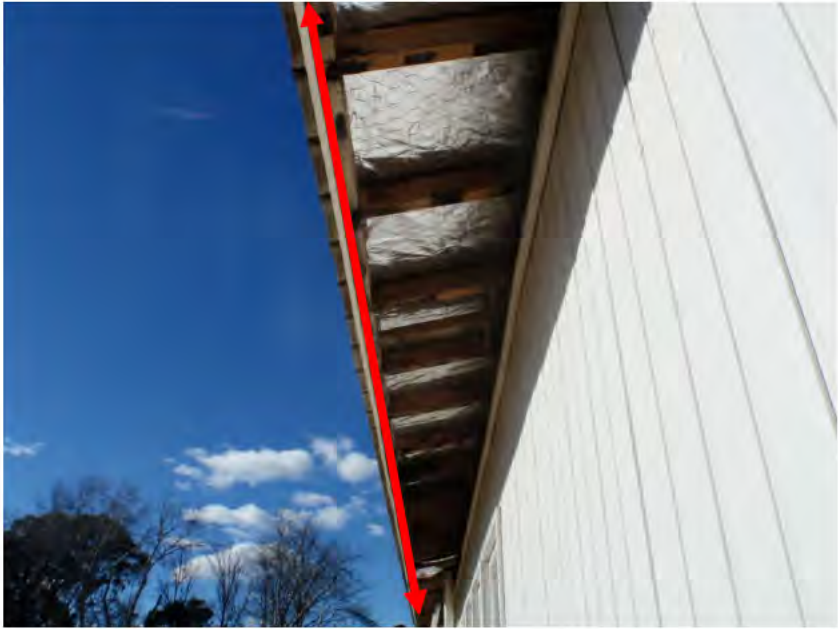
2	Removal of non-friable asbestos eave sheets from the After School Care Building.	sheet
