Re: Cleaning Procedures for Window Glass with Asbestos Containing Putty

Re: Asbestos analysis and risk assessment of 2 samples collected from the Yarralumla Primary School – 14 January 2015

Re: Site assessment of previously identified asbestos containing materials located in the toilet at Yarralumla Preschool, Yarralumla ACT 2600 – 03 February 2015

Project/Location:	Yarralumla Primary School, Yarralumla ACT
Job Number:	7335471
Date of Inspection:	Wednesday, 25 March 2015
Description of Work:	Environmental clean and seal holes in asbestos eave sheet where a wire cover to light fitting had been damaged. See attached photograph.
Aspesius Nemuvalisi.

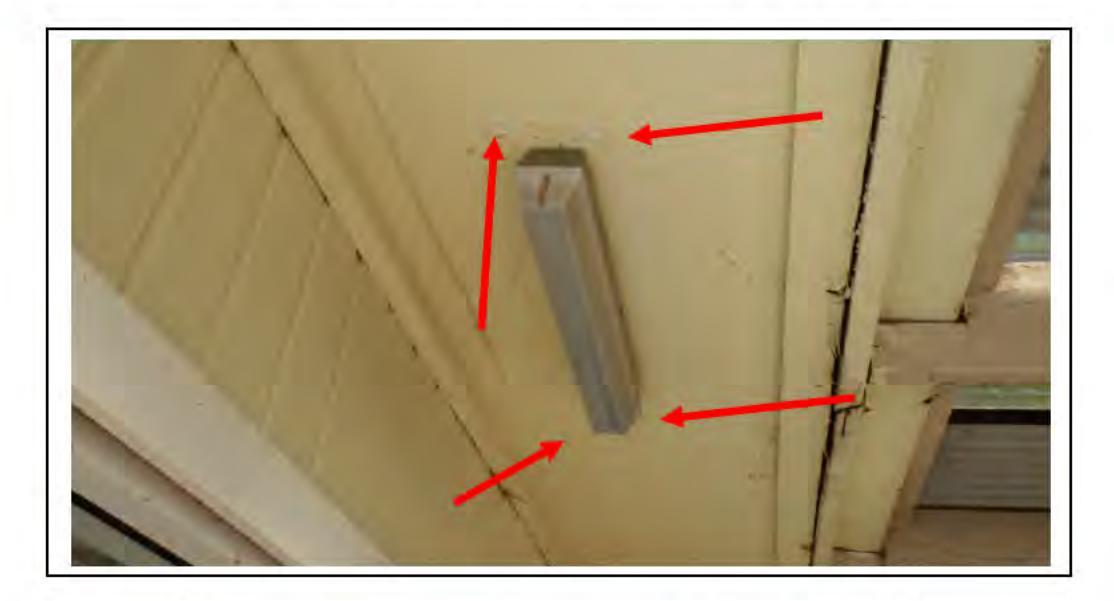
Photograph 1: Environmental clean and seal holes in asbestos eave sheet where a wire cover to light fitting had been damaged.

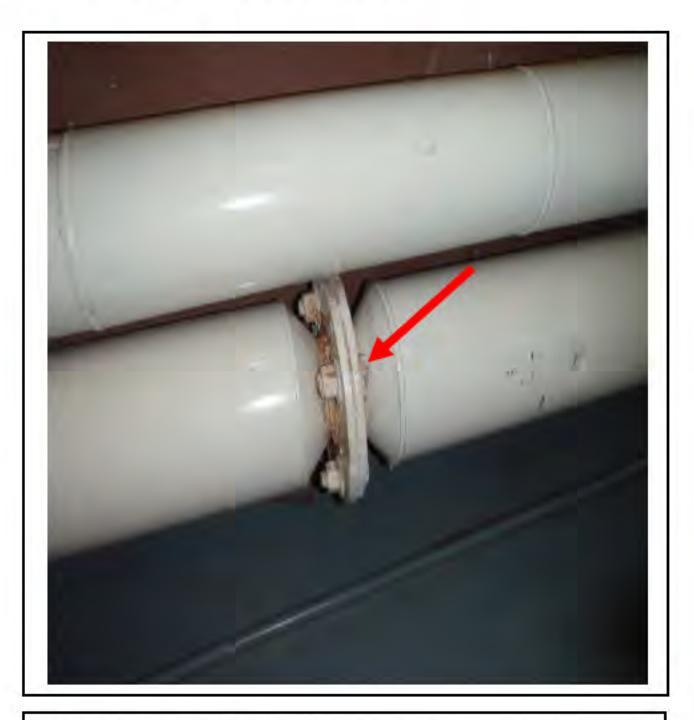
Photograph 1: Environmental clean and removal of friable asbestos pipe lagging residue to pipe flanges, pipe brackets and walls in the boiler room.

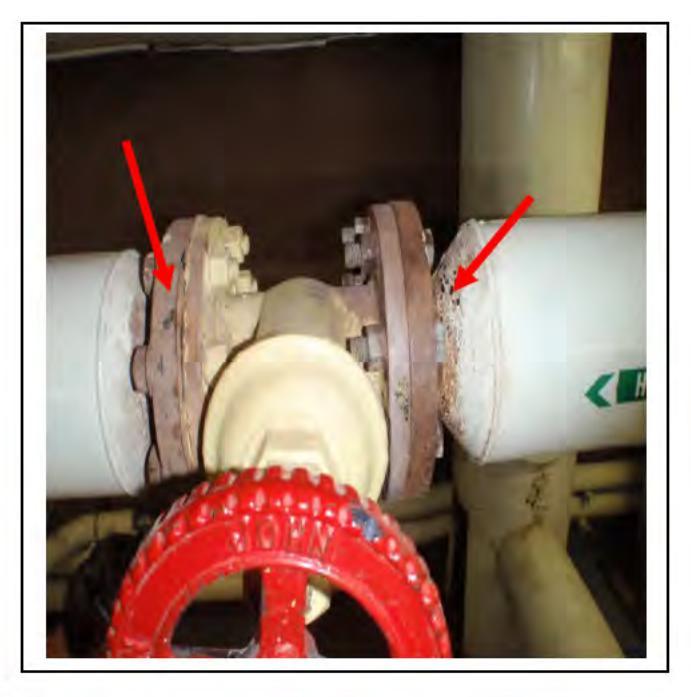
Photograph 2: Environmental clean and removal of friable asbestos pipe lagging residue to pipe flanges, pipe brackets and walls in the boiler room.

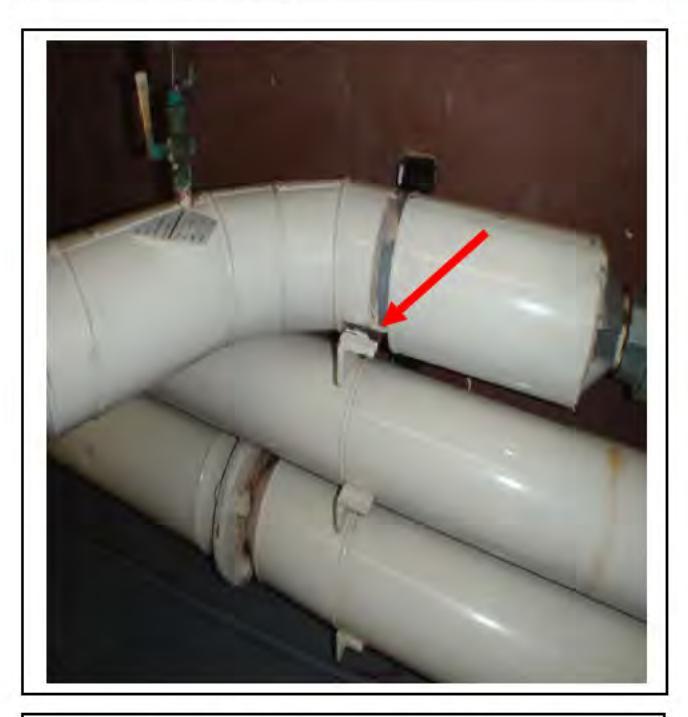
Photograph 3: Environmental clean and removal of friable asbestos pipe lagging residue to pipe flanges, pipe brackets and walls in the boiler room.

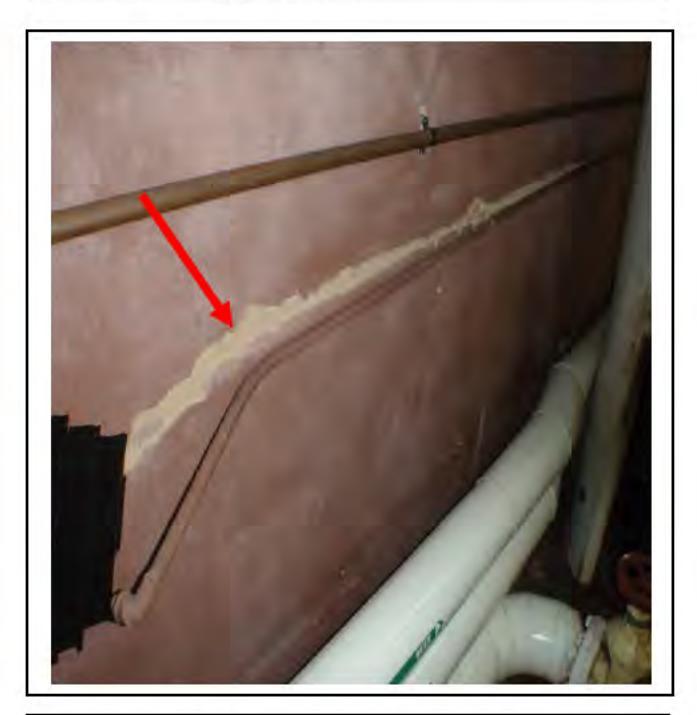
Photograph 4: Environmental clean and removal of friable asbestos pipe lagging residue to pipe flanges, pipe brackets and walls in the boiler room.

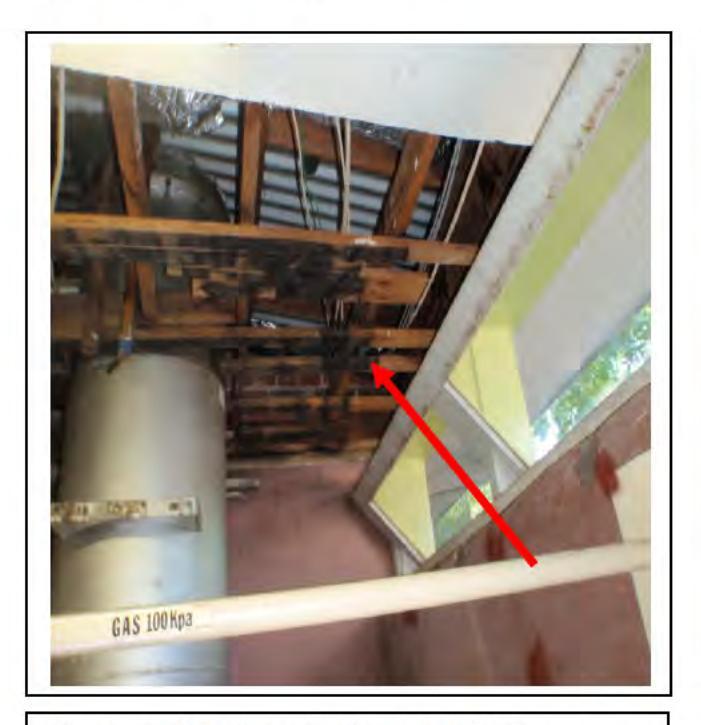
Photograph 1: Removal of non friable asbestos ceiling sheets to flue in the boiler room.

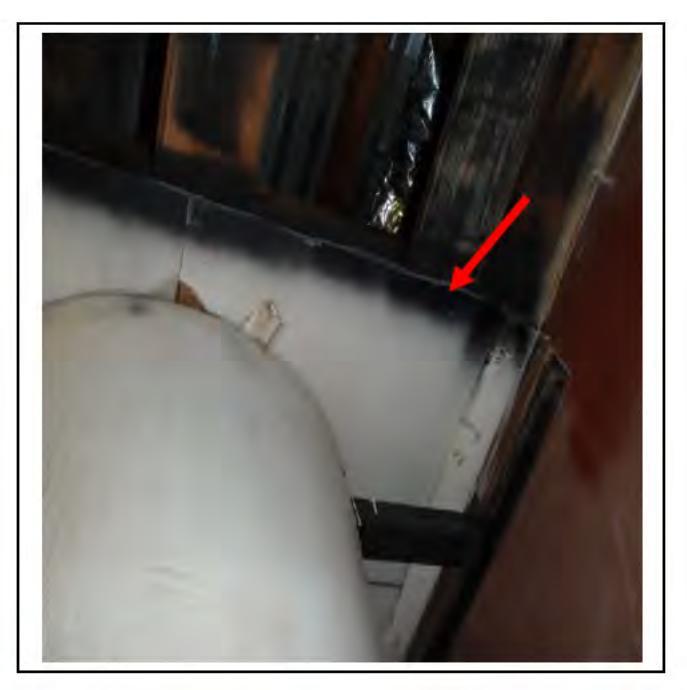
Note: this was a partial removal of damaged ceiling sheets around the flue on the right hand side. Asbestos ceiling sheets still remain around the flue on the left hand side. The edges to the remaining ceiling sheets have been sprayed with paint to prevent any fibre release. Care should be taken when working around the asbestos ceiling sheets.

Photograph 2: Remaining of non friable asbestos ceiling sheets to flue on the left hand side.

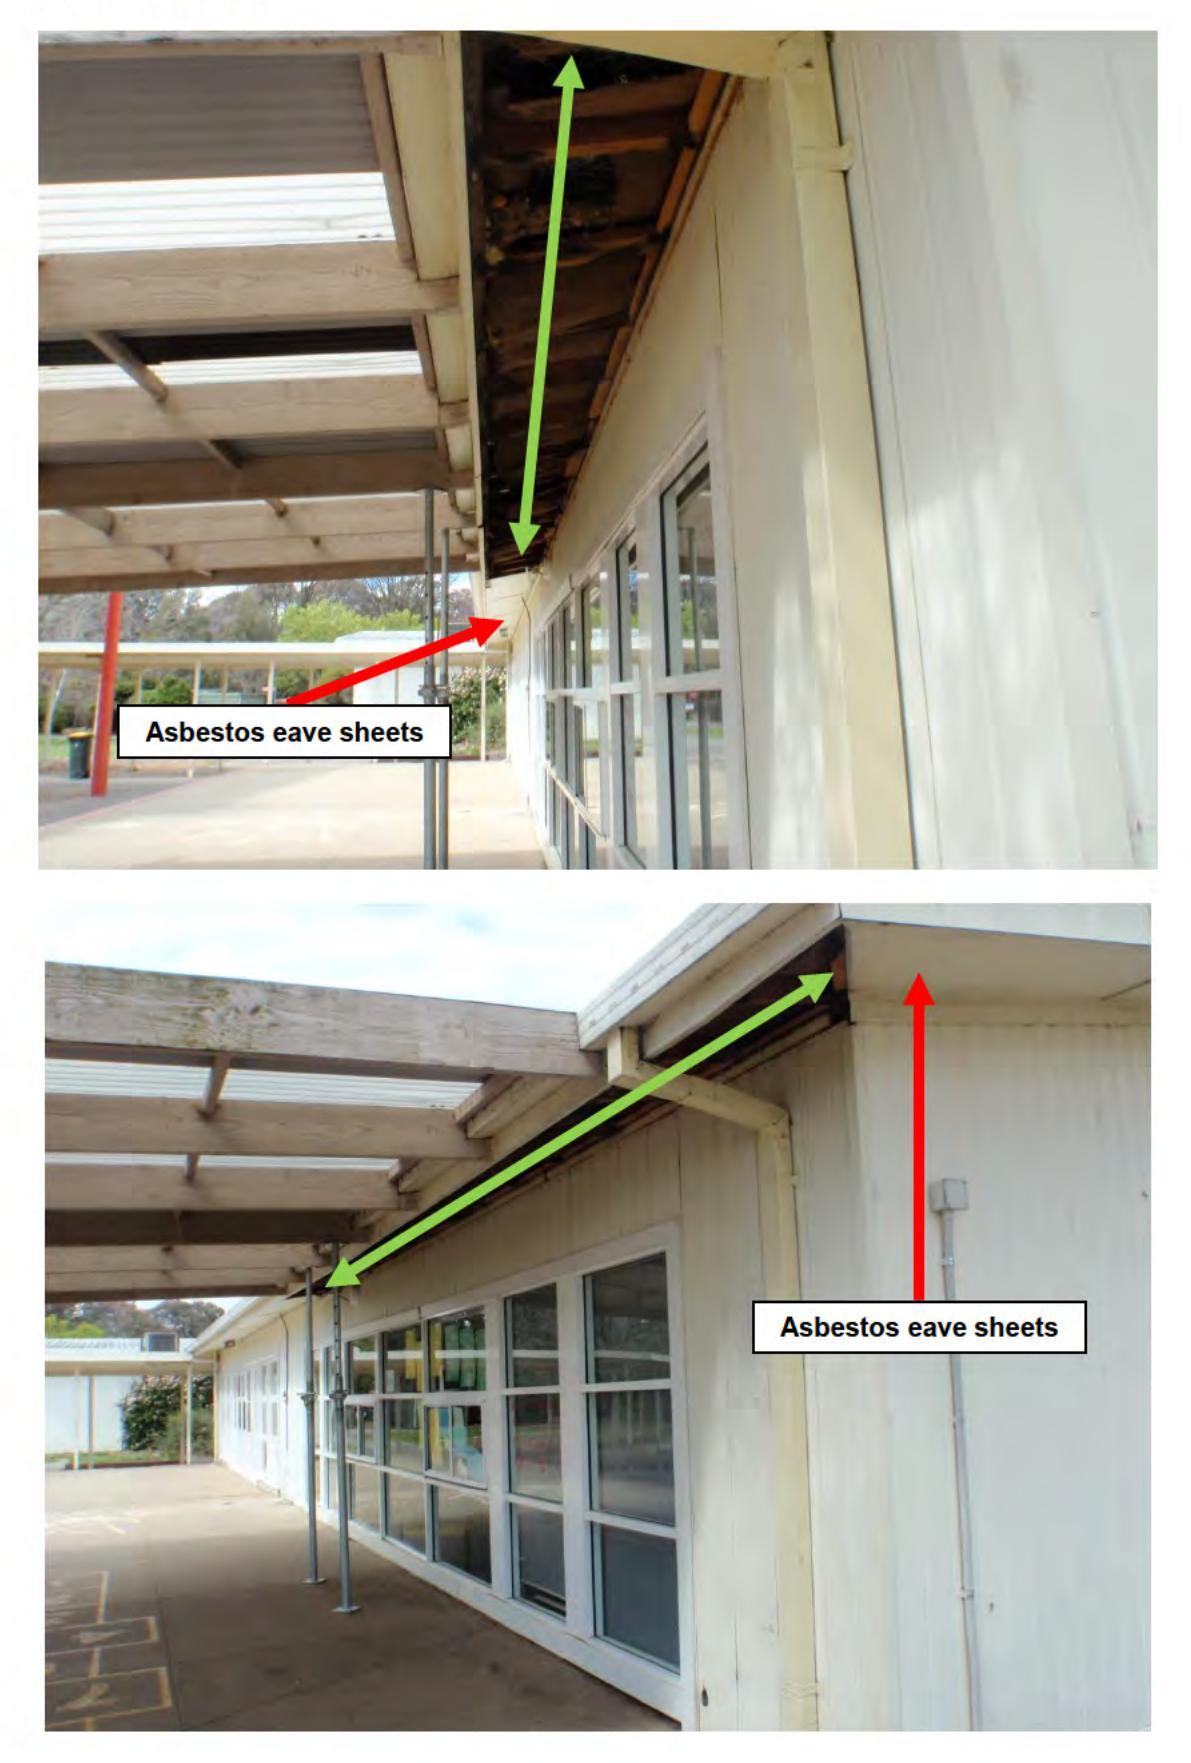
Appendix B – Photo(s)

Note: This was only a partial removal to allow works to proceed. Asbestos containing eaves still remain in situ and must not be disturbed.
