Re: Asbestos analysis and Risk Assessment of pipe lagging insulation to hot water pipes in the sub floor of the Gambarri Centre and Montessori Building during [REDACTED] between the staff room and classroom 16 at Yarralumla Primary School on the 8th of May 2018.

ASBESTOS CLEARANCE CERTIFICATE INSPECTION PASS

Project/Location: Yarralumla Primary School, Loftus Street, Yarralumla, ACT, 2600

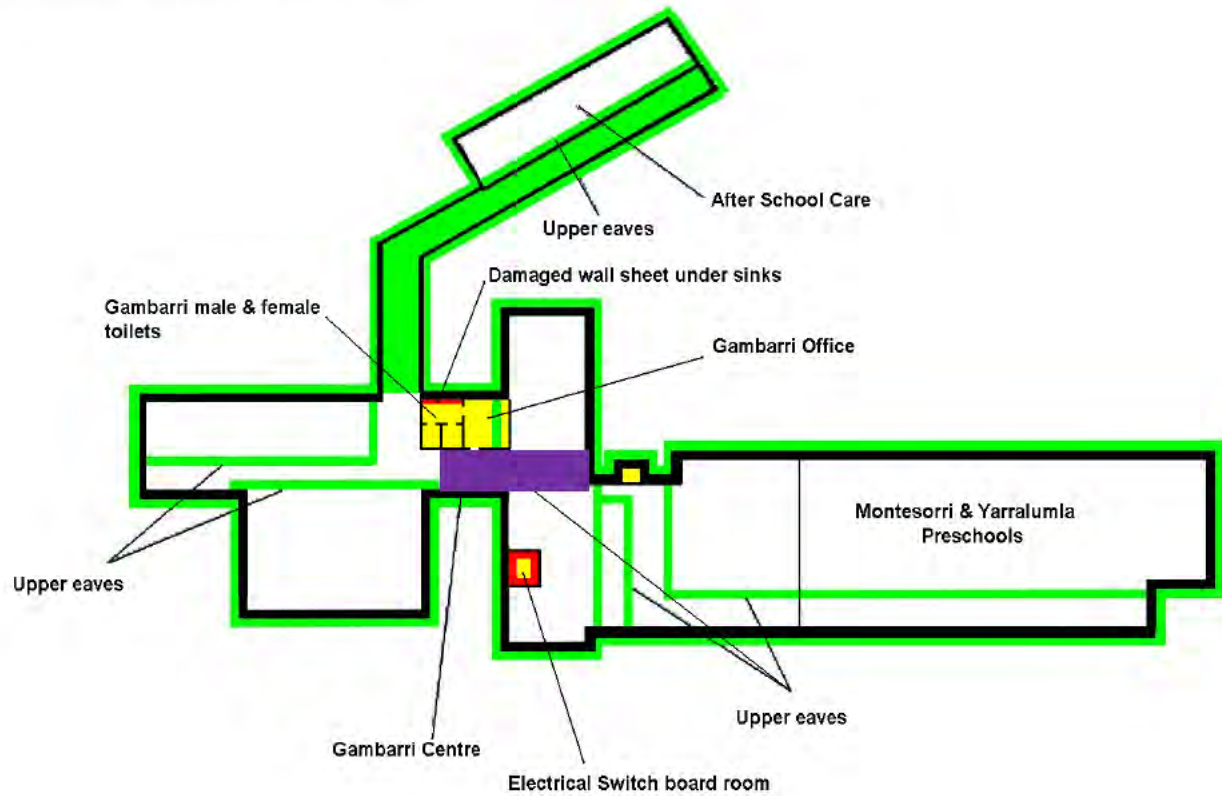
Appendix C – Site Plan(s)

Approximate area of works shown by purple rectangle

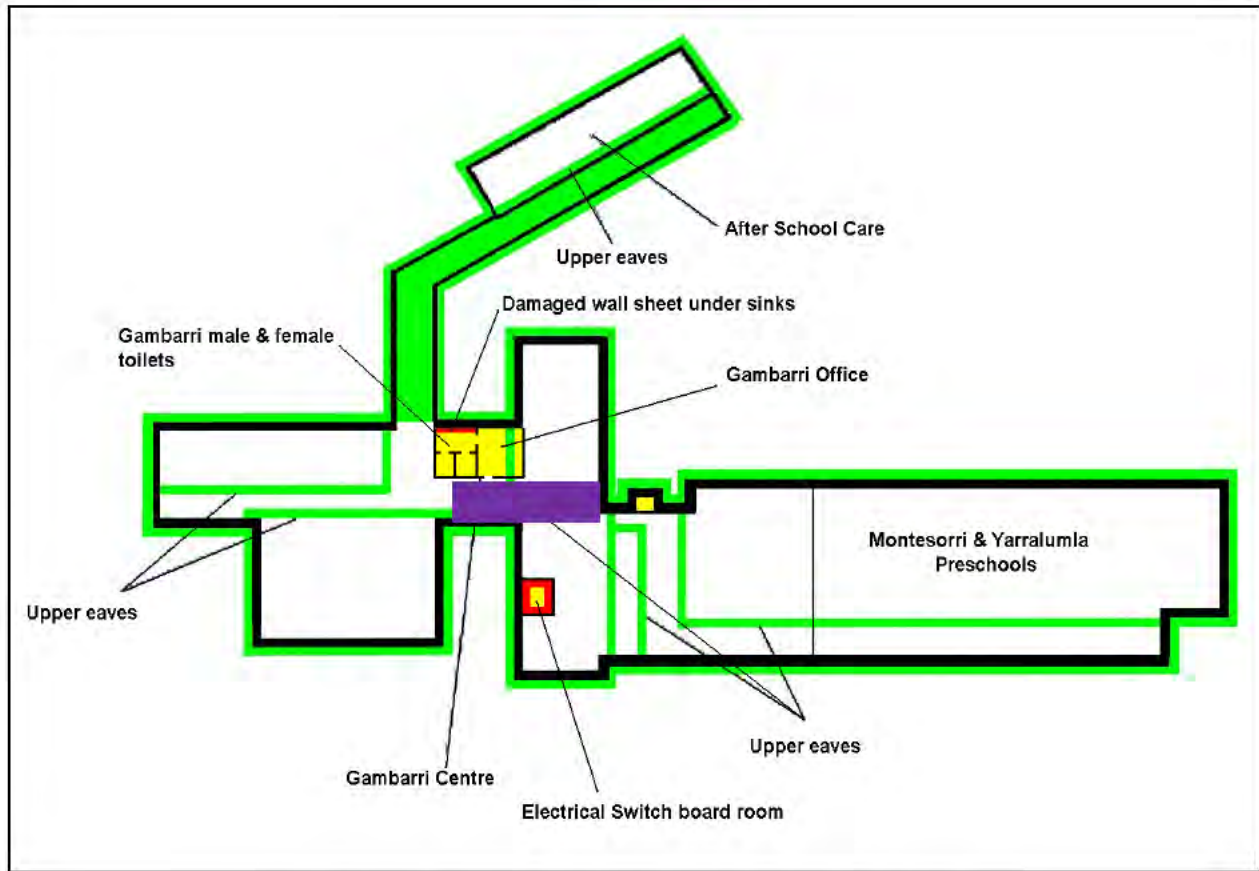
Appendix C – Site Plan(s)

Visible lagging after black painting and after pink PVA glue spraying

Approximate area of works shown by purple rectangle

Note: Lagging is still present where the pipes leave the removal area. These have been sealed with black paint and pink PVA glue. Care must be taken not to disturb remaining lagging. If works are to be conducted in this area (such as termite inspections or re-flooring) by persons other than licensed Asbestos Removalists, it is recommended that they be briefed by a licensed Asbestos Assessor.
