ASBESTOS CLEARANCE CERTIFICATE INSPECTION PASS

Project/Location: Yarralumla Primary School

Job Number: 7335471

Lead Paint analysis of samples collected from proposed work areas in the Gambarri Wing at Yarralumla Primary School, Loftus Street, Yarralumla, ACT 2600 – 20 July 2017

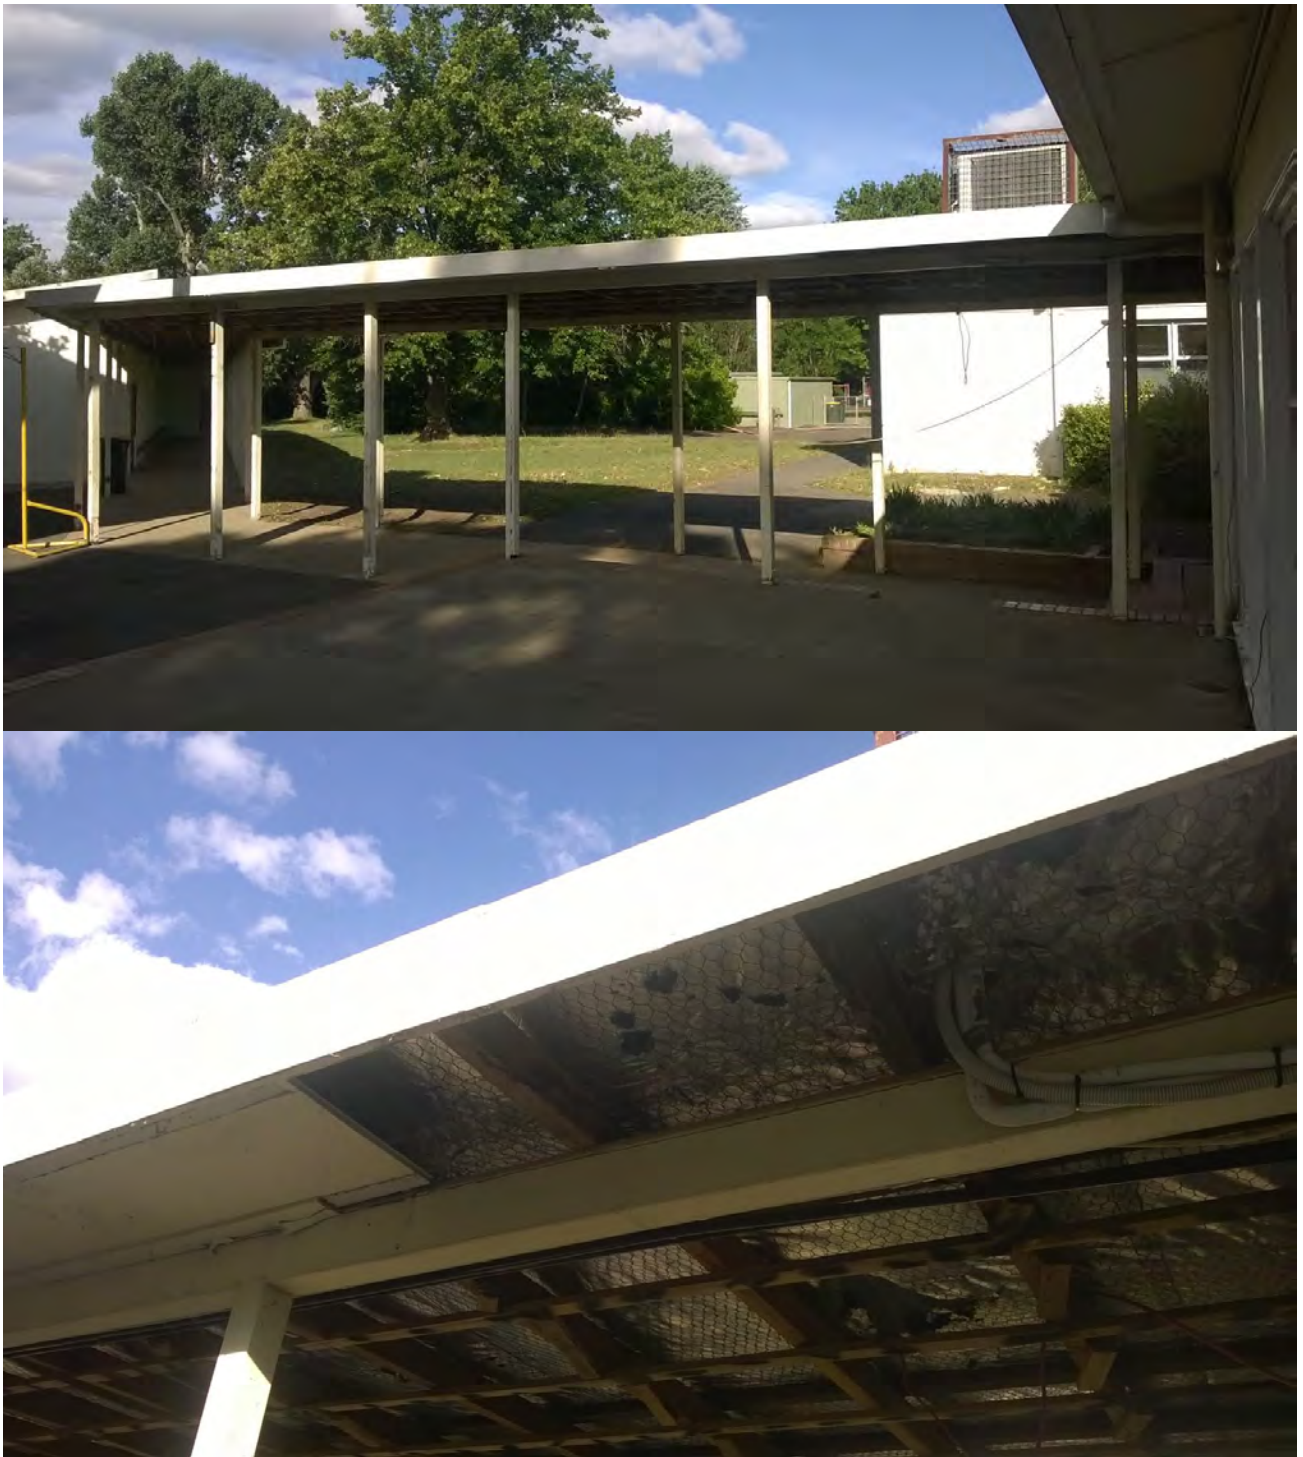
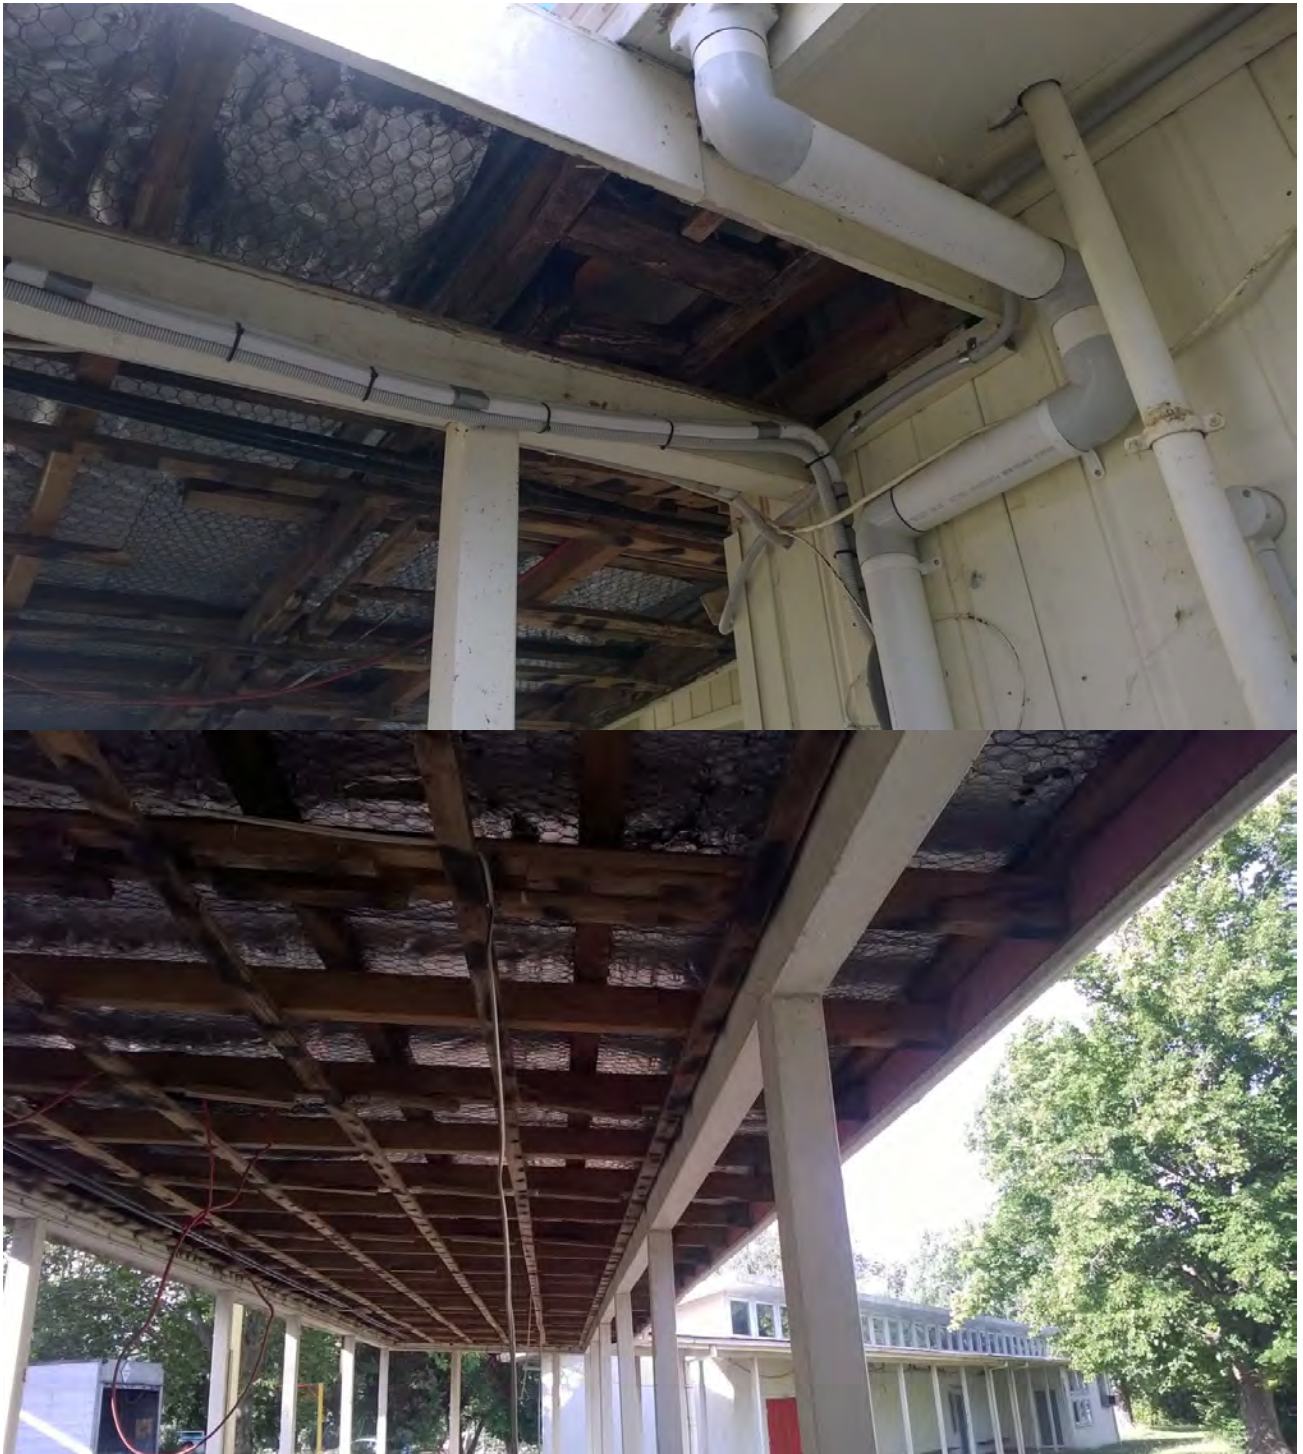
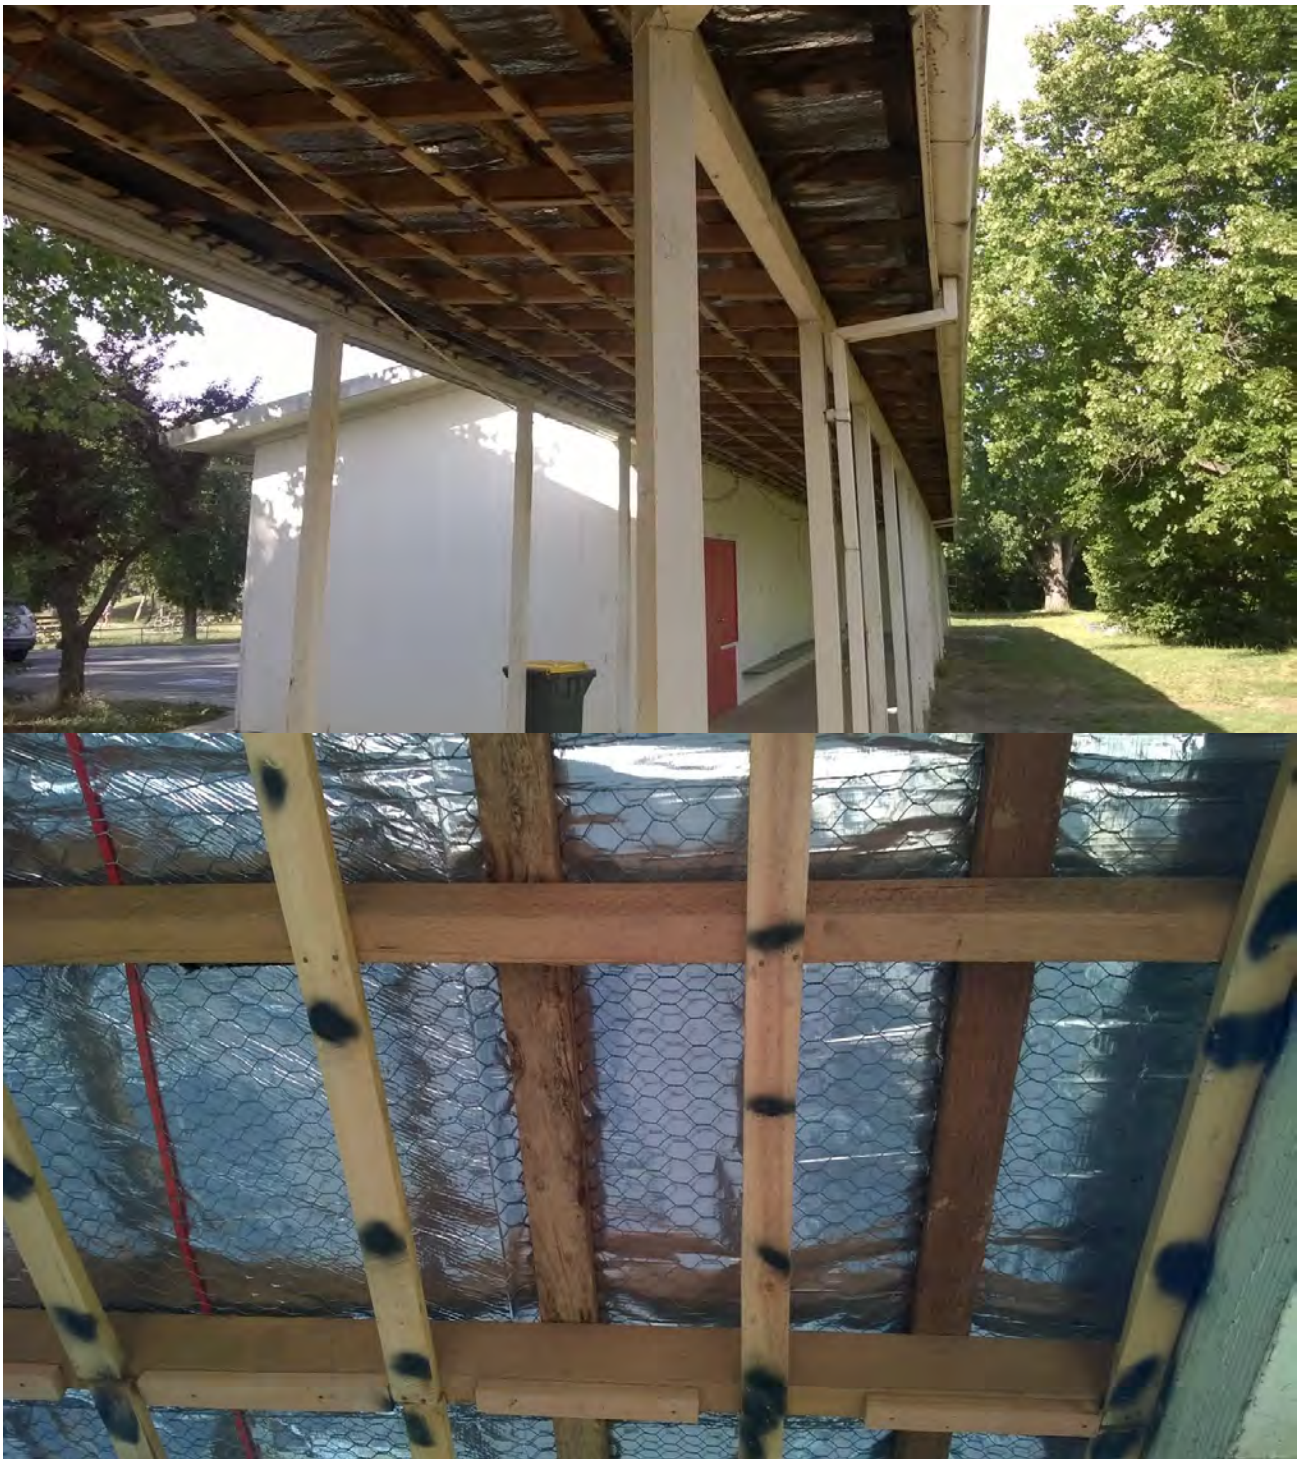
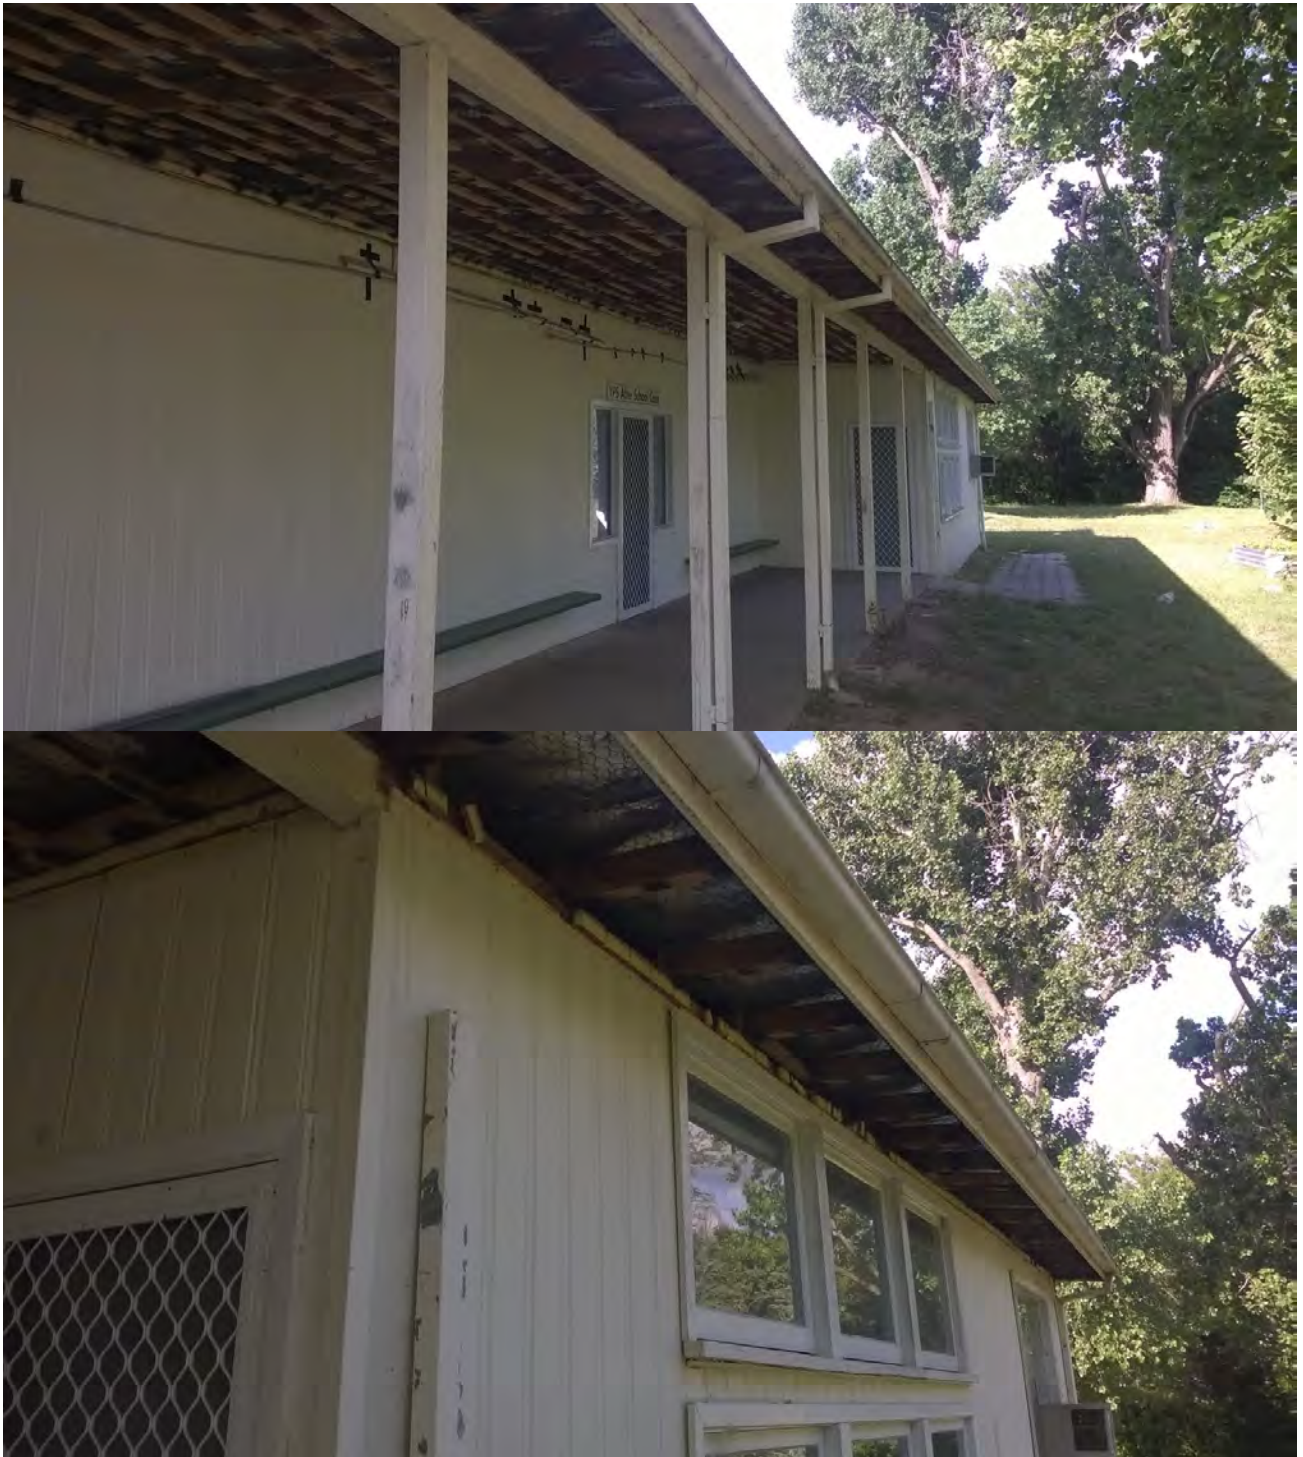
Appendix B – Photo(s)

The inspection found no visible asbestos residue from the asbestos work in the area or in the vicinity of the area where the work was carried out.
