ROOF CONDITION REPORT, HAWKER COLLEGE,
MURRANJI STREET, HAWKER

Prepared by [REDACTED] on the 19/04/2022
On behalf of the ACT Property Group

Background Notes: This roof report has been prepared on behalf of the ACT Property Group to investigate the current condition of the roof and help determine the location and cause of ongoing roof leaks. Hawker College has a long history of ongoing roof leaks (pers comm school).

Aim: Inspect and assess the current condition of the roof catchment. Provides options to repair.

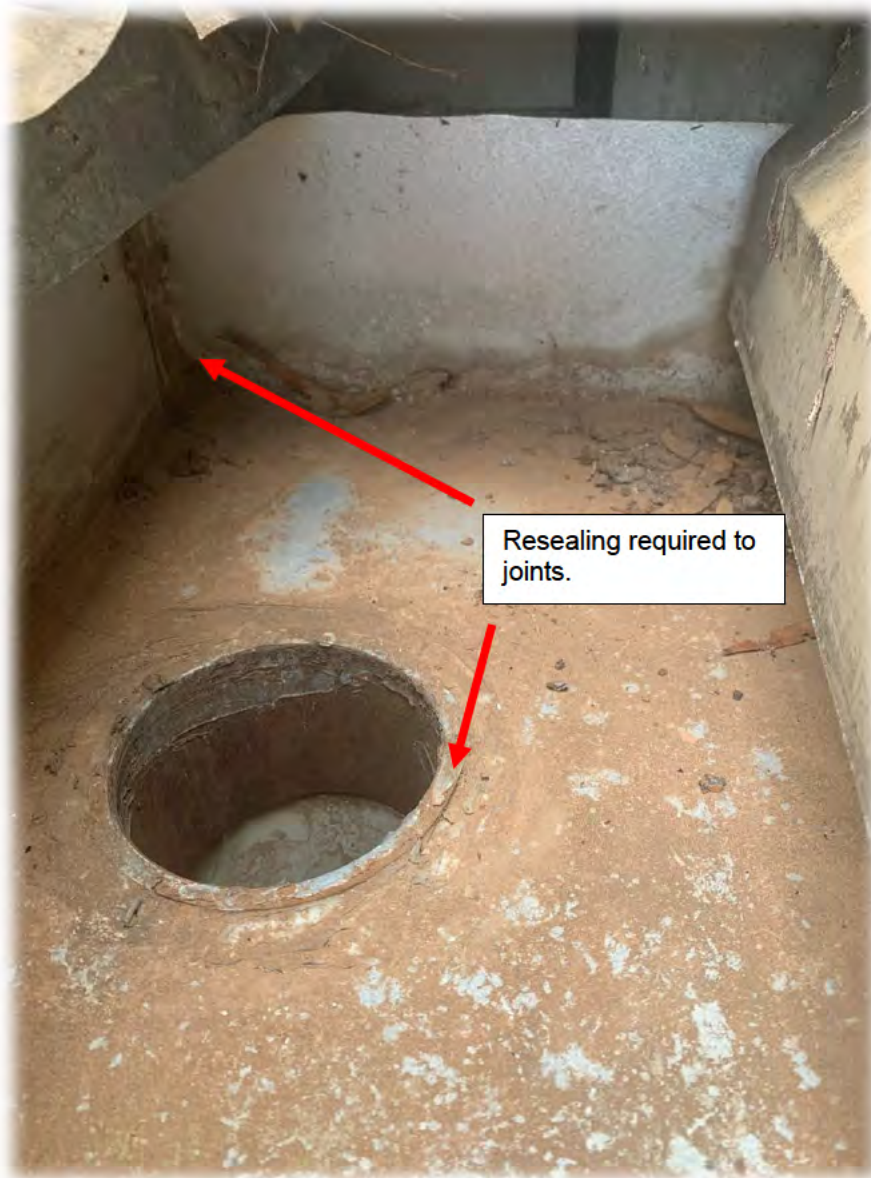
Figure 9: Box gutter outlet

The box gutter and stormwater outlet on the opposite end of the hall also appears to be contributing to the leak. As seen in figure 9, the seal around the outlet and stop end appears to be compromised. Some further exploratory work is required along the parapet wall and gutter to better evaluate and determine extent of the leak. This includes further work to remove existing flashings and associated fixings.

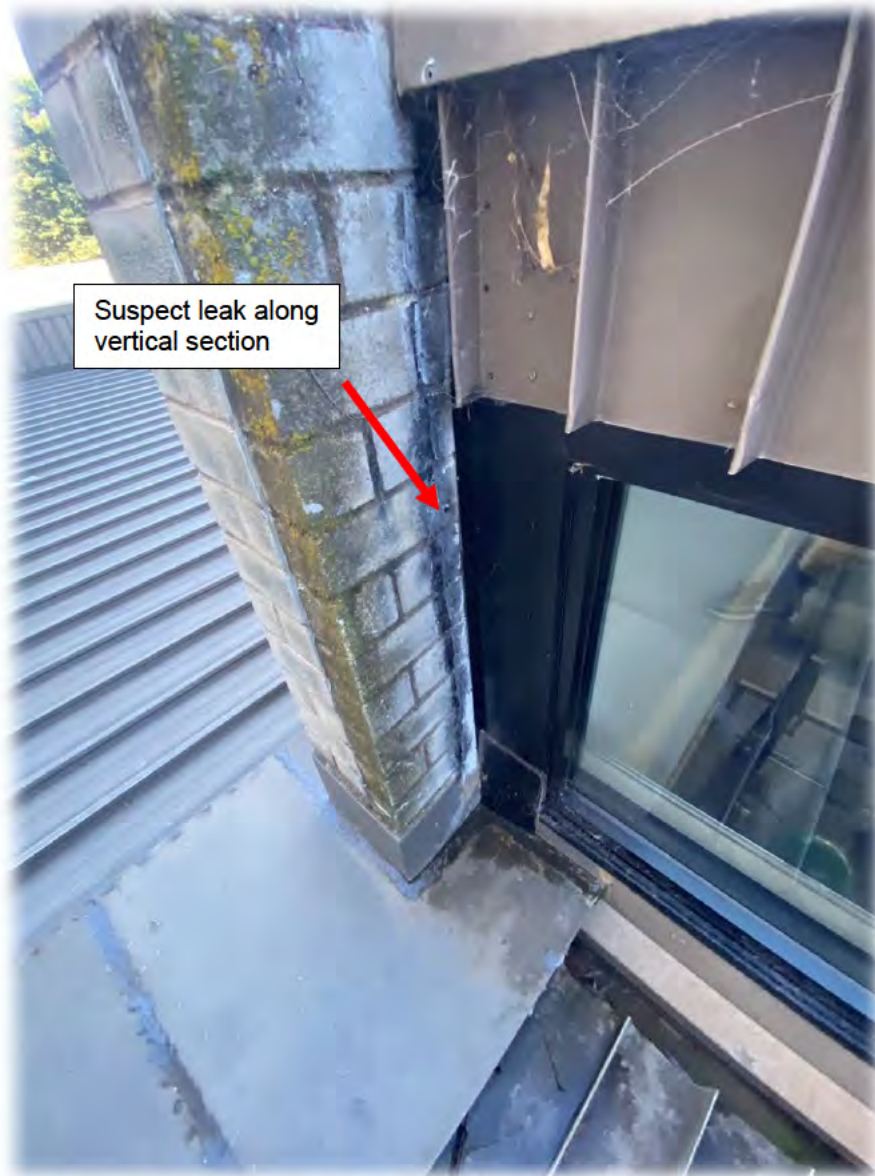
Figure 11: Connecting flashings between newer and original roof cladding over corridor

Findings: Two leaks were reported in this area. The first at the entrance to the fitness studio and the second within the fitness studio. The leak above the entry into the fitness studio was inspected. The box gutters require replacement. Inspection revealed that the gutters are galvanized metal in material with the base metal thickness (bmt) severely compromised due to rusting. As the gutters are galvanized and receiving water from a dissimilar metal, colourbond surface this has resulted in galvanic corrosion which is evident in figure 10. An additional area of concern is around the way in which the window and gutter has been flashed and finished around the brick column as seen in figure 11. The installation is of a poor quality and has resulted in a large area vertical area along the internal window flashing being open to water egress.

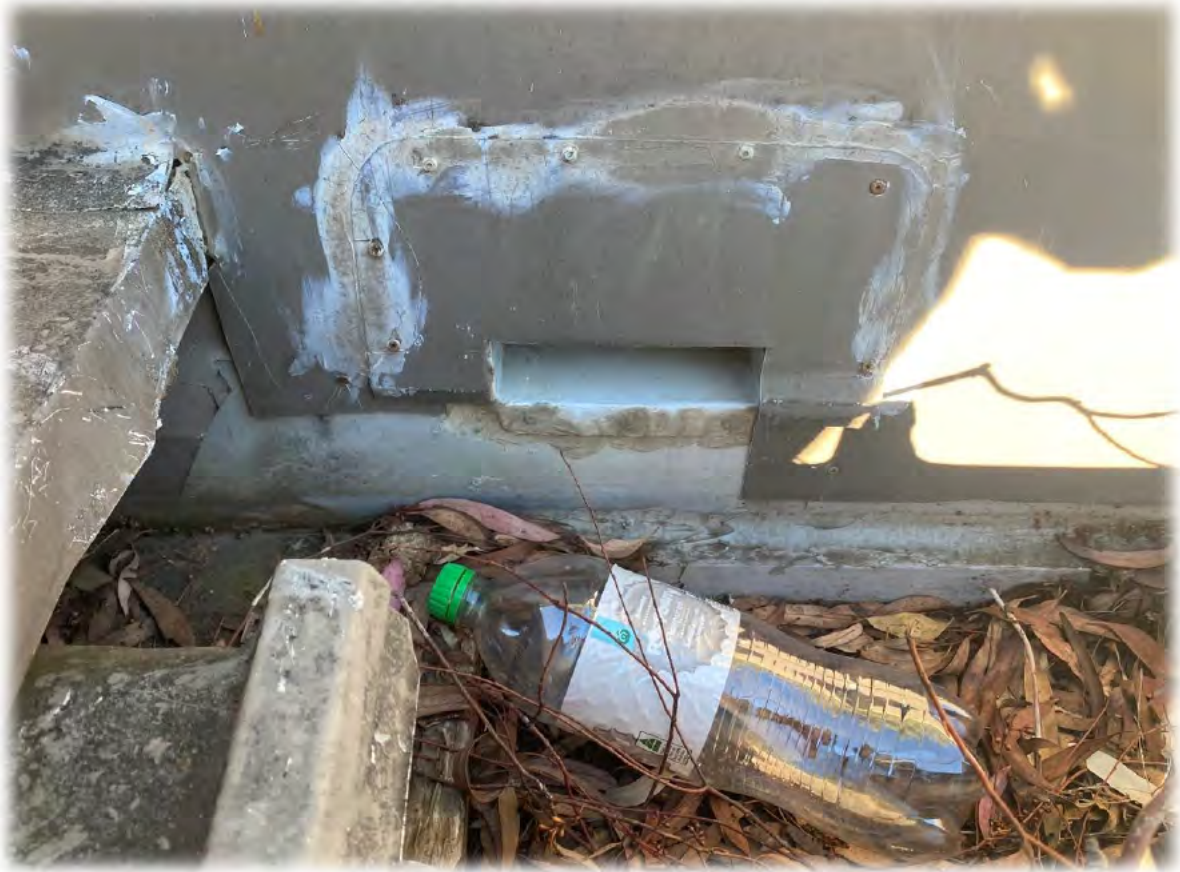
Figure 12: Blocked sump

The second leak was inspected and found to have resulted due to blocked sumps and gutters as seen in figure 12. The gutter has two overflows installed however they appear to have been installed slightly high resulting in their reduced effectiveness.

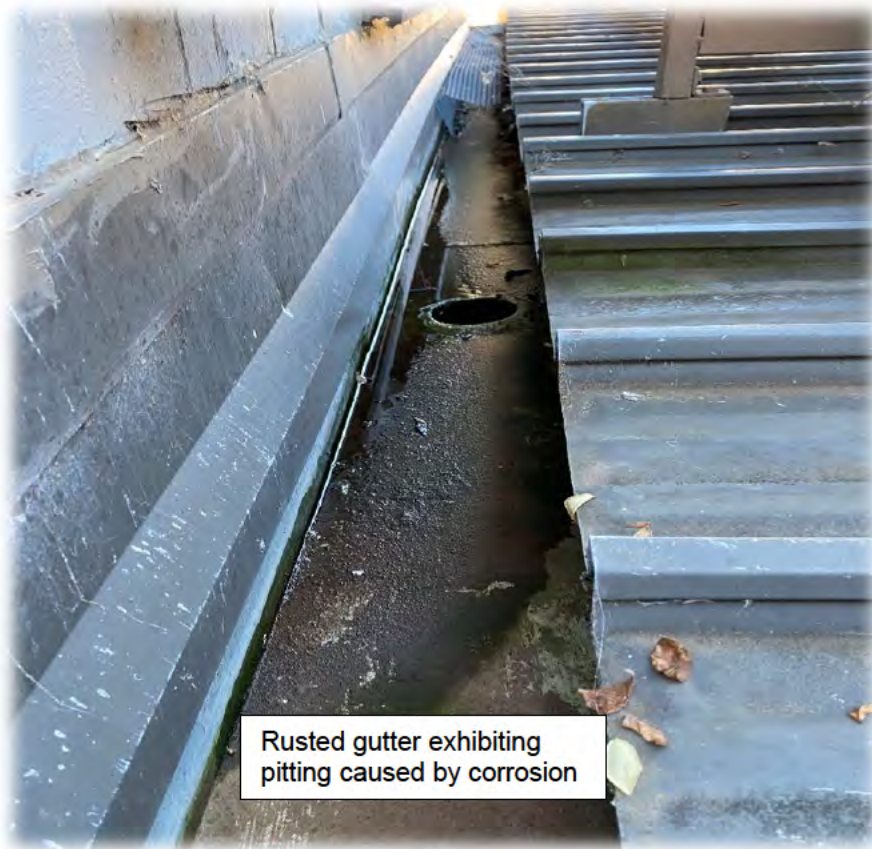
Figure 15: Box gutter along library wall

The roof leaks along the rear wall of library were investigated. The box gutter directly above appeared rusted and in need of replacement as seen in figure 15. The gutter is galvanized in material and appears to be rusted most likely the result of the incorrect use of materials which has resulted in galvanic corrosion. Several issues appear to be contributing to the leaks in this area and include the gutters and downpipe outlets. Deteriorated mastic seals along concrete wall joints were also observed as seen in figure 16 and are obvious avenues for water egress.

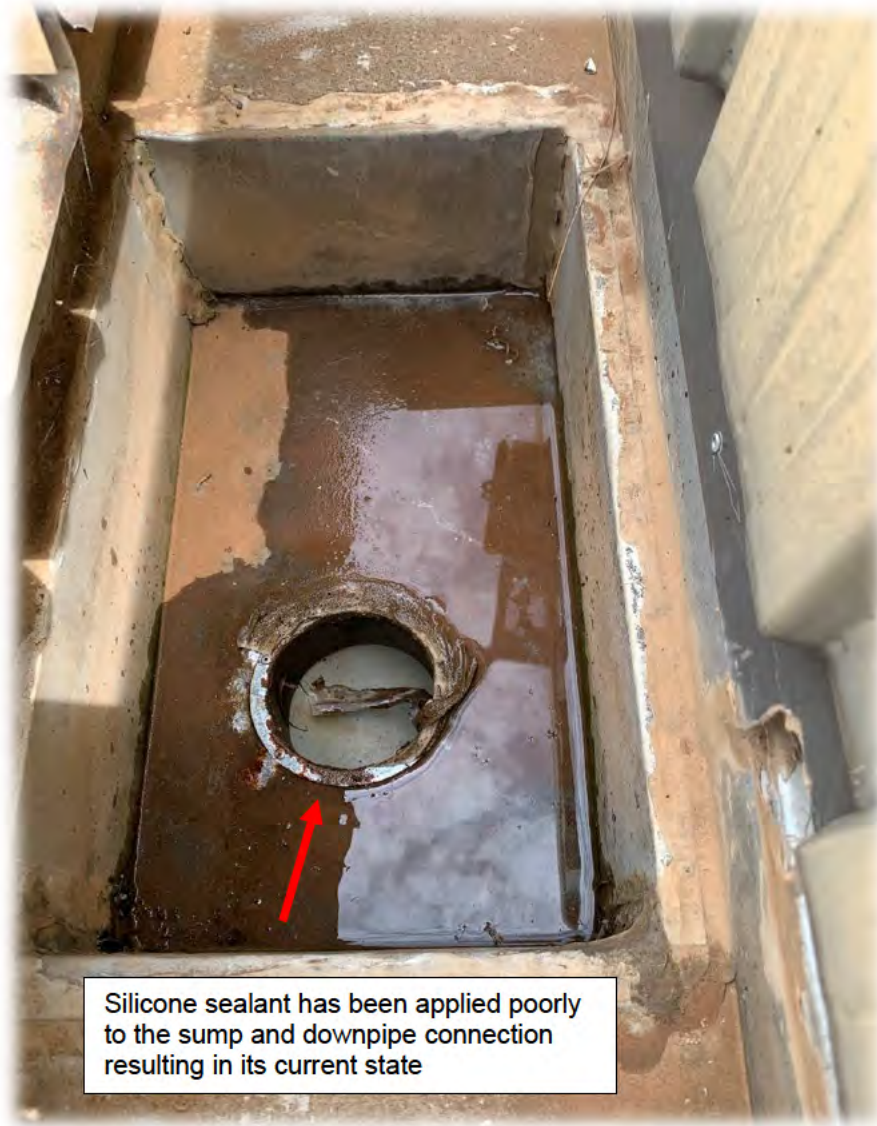
Figure 19: Box gutter and sump

Findings: The roof area above the roof leak was investigated and most likely found to be the result of a compromised seal around the sump and downpipe nozzle outlet as seen in figures 18-19. From figure 19 it can be seen that the sump has been replaced before using zincalume metal. The silicone sealant which has been applied to the lap joints appears to have been poorly applied resulting in the early deterioration of the seal.

Silicone sealant has been applied poorly to the sump and downpipe connection resulting in its current state

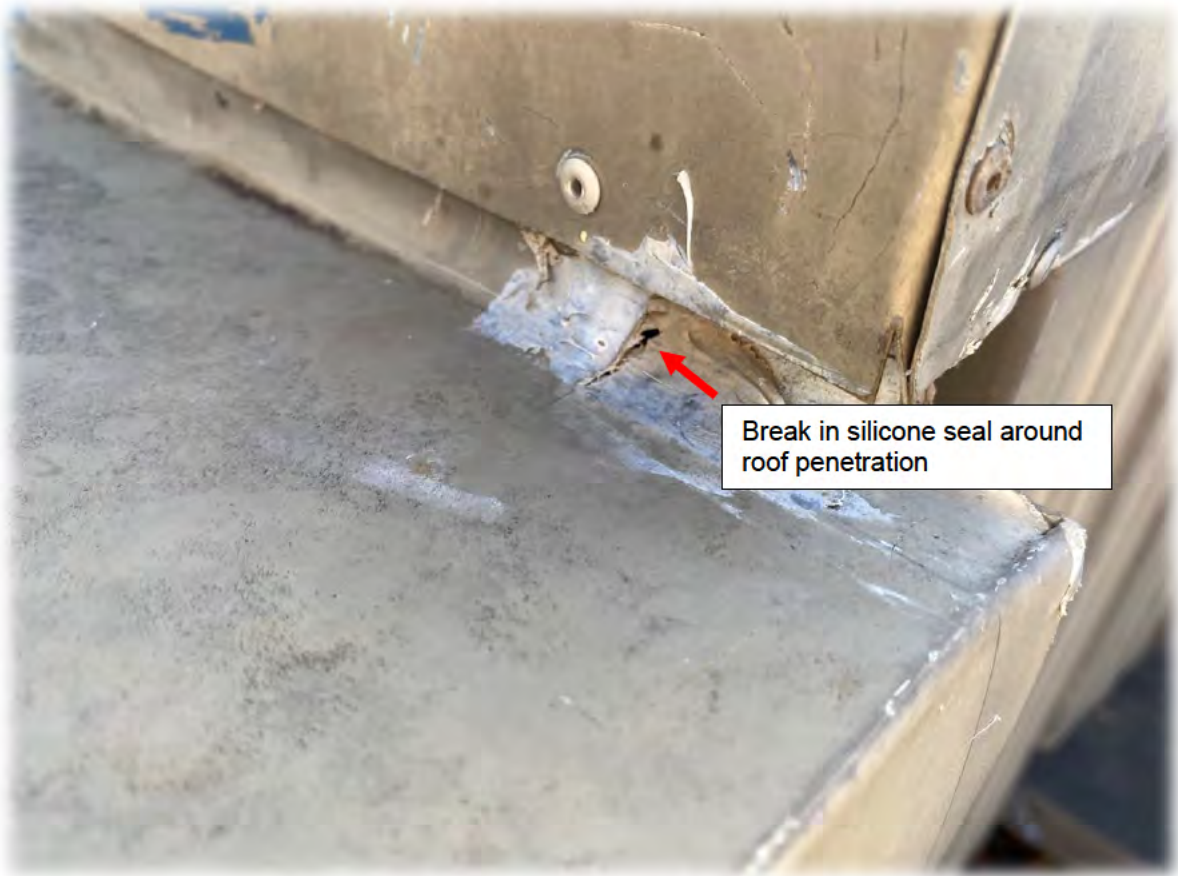
Figure 23: Break in silicone

Findings: From figure 22 it can be seen that the roof area above hospitality is heavily covered with mechanical plant and equipment. Three leaks were reported across the roof area and appear to be associated with the redundant mechanical plant and equipment. Inspection revealed several breaks in silicone sealant across the flashings associated with the supply and exhaust ducts.

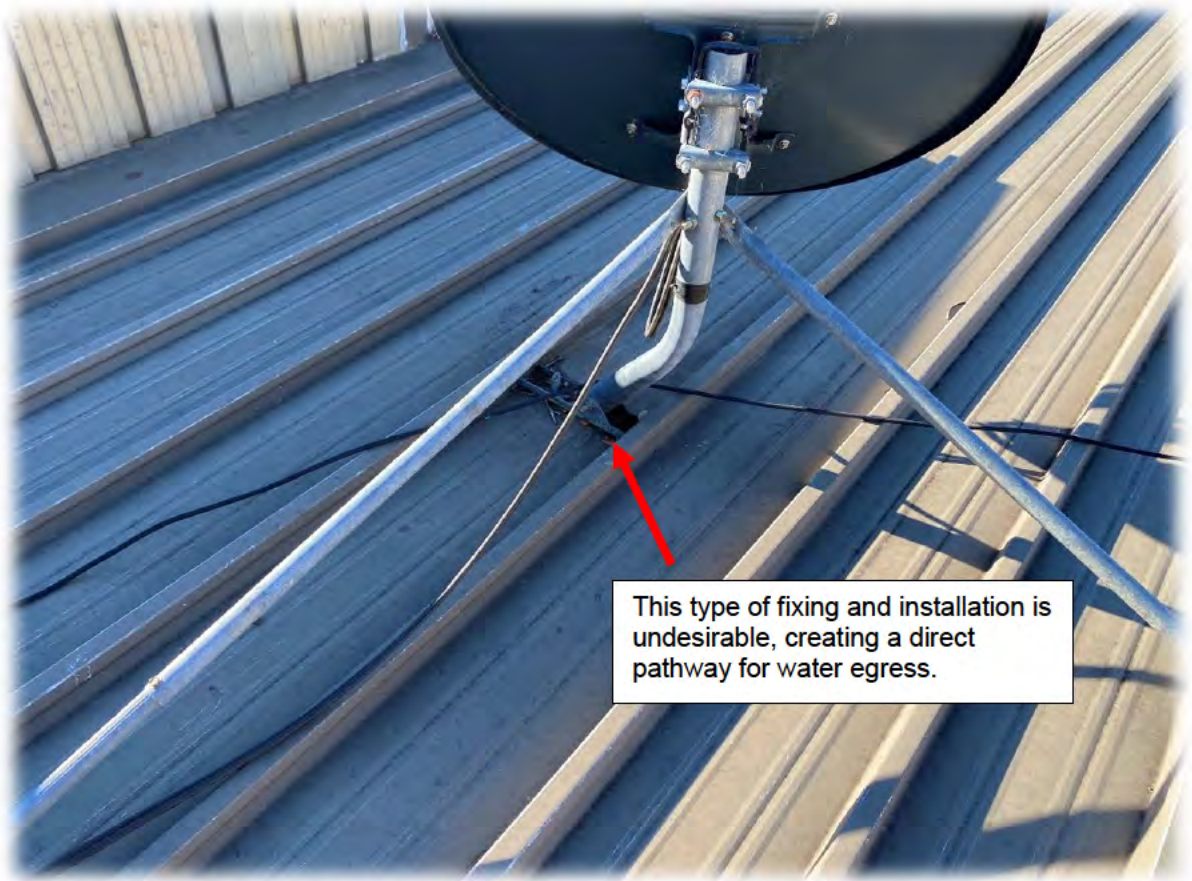
Figure 25: Poorly mounted satellite dish

Findings: The roof area above the reported leak was investigated. Several faults were observed that relate to a flooded box gutter as seen in figure 24 and potential issues surrounding the incorrect fixing of a satellite dish as seen in figure 25. Work is required to remove the existing box gutter in question and correct fall to alleviate flooding. Care must be taken in relation to the removal and reinstatement of the wall cladding to ensure all overlapping joints and seams are well sealed. The satellite support leg has been fixed directly to the valley of the roof sheet. This type of fixing and installation severely compromises the integrity of the roof. Work is required to modify fixing to span across roof sheet rib rather than fixing through the valley of the pan.

This type of fixing and installation is undesirable, creating a direct pathway for water egress.
