Re: Analysis of the sprayed coating debris on top of pinboards of the 1st floor Class room 7.15 (Tracker location 015), Staff room 7.A.1 (Tracker location 011) and Class room 7.6 (Tracker location 023) on 03 February 2021 at Hawker College 51 Murrarji Street Hawker 2614

Removal of light fixtures to ceilings with attached ACM sprayed coating within room 7.4 (TL013) and the Learning Hub (TL017) at Hawker College – on 3 March 2021.

Lead Paint Assessment

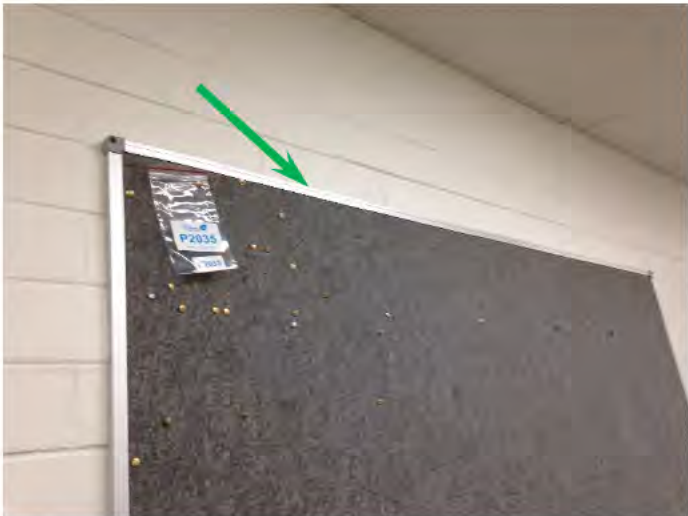
Sample Number	Location Description	Material	Photograph(s)
P2035	Room 7.15 (Tracker loc 015) - on top of pin board	Sprayed coating debris

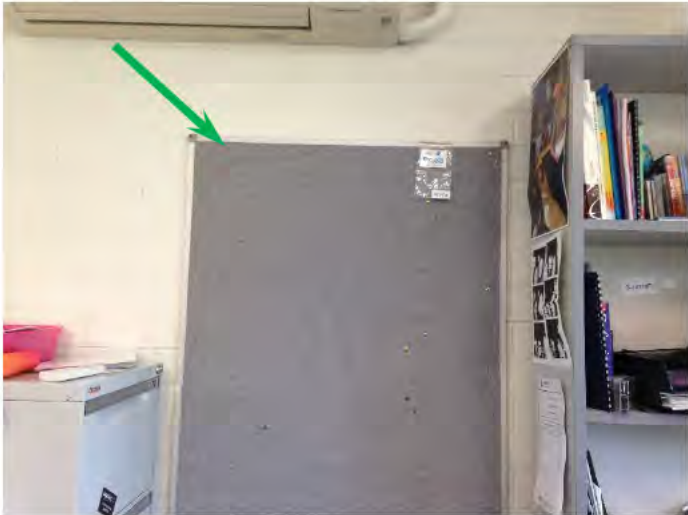
P2038	Room 7.A.1 (Tracker loc 011) - on top of pin board	Sprayed coating debris

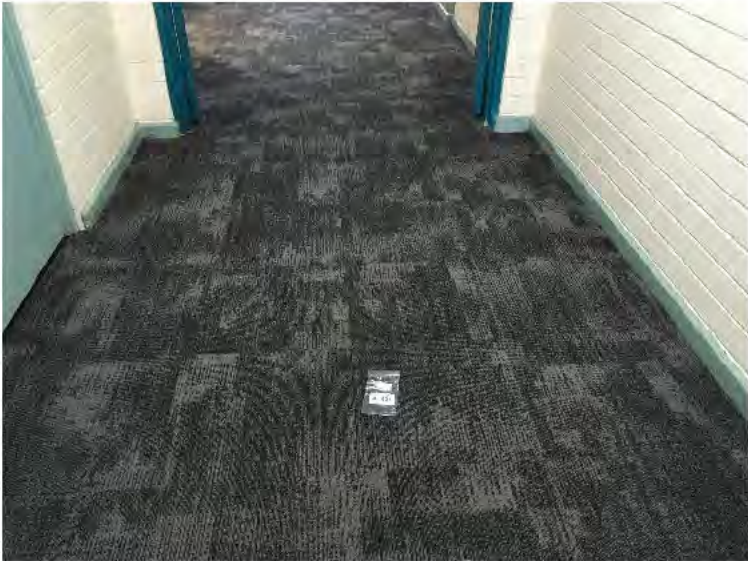
Sample Number	Location Description	Material	Photographs
A3435	Ground floor hallway outside Tracker room 128 - to carpet floor	Surface debris

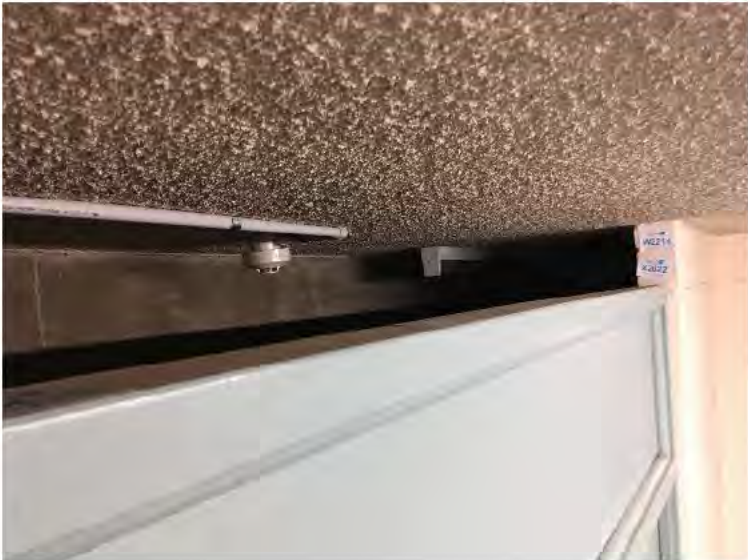
A3436	Ground floor hallway outside Tracker room 128 - above coats room door frame	Surface debris

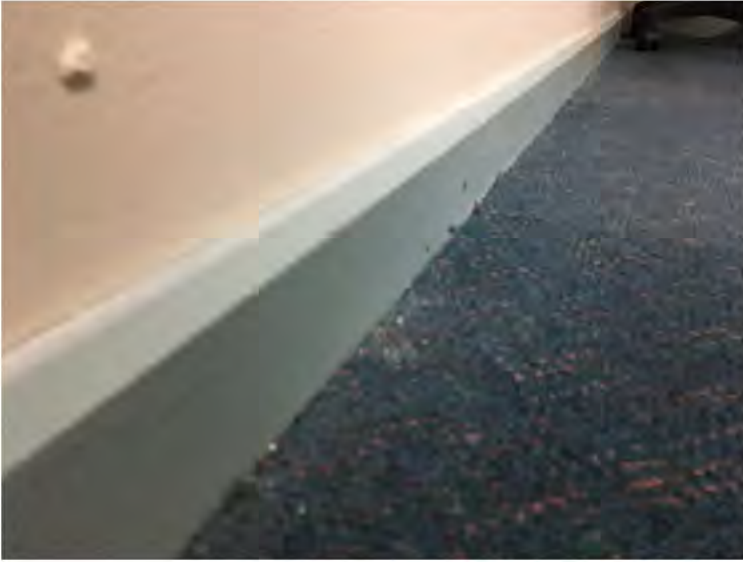
Sample Number	Location Description	Material	Photographs
A3443	1st floor Room 7.M.1 (Tracker location 030) - top of floor skirting	Surface debris

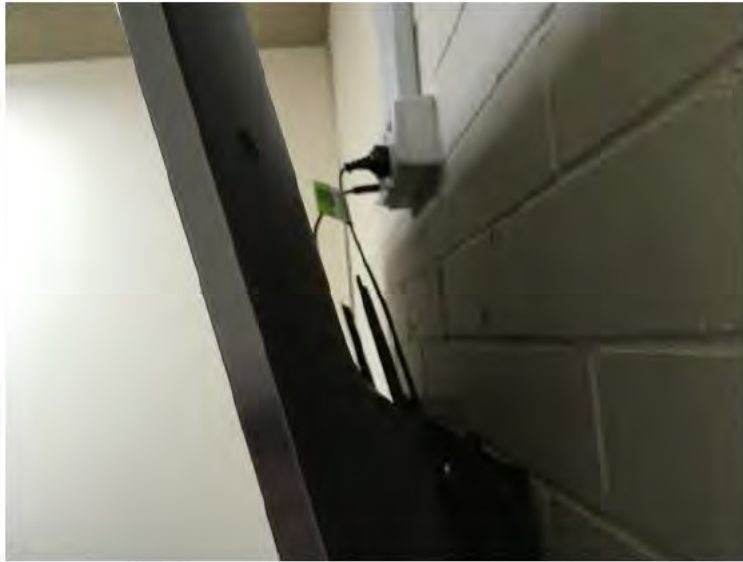
A3444	1st floor Room 7.M.1 (Tracker location 030) - surfaces behind TV	Surface debris

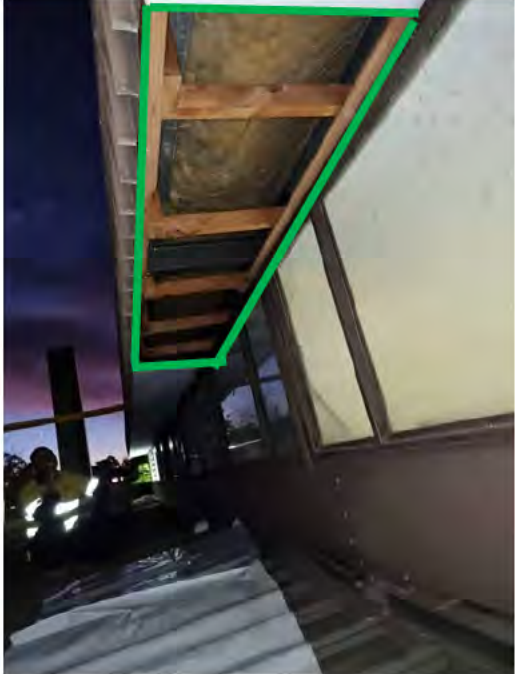
PHOTO NO	LOCATION DESCRIPTION	MATERIAL	PHOTOGRAPH
1	Central roof of the Science lab – Specified section only	Sheet

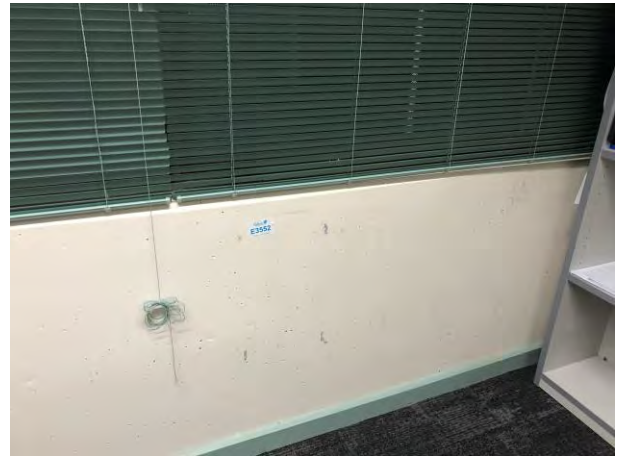
Figure 2: E3552

E3549	Office 056 - Northwest plasterboard wall	Photo not available	White	Sound	<0.005	No	N/A	
E3550	Office 056 - Southeast wall	Appendix 2 Figure 45	White	Sound	<0.005	No	N/A	
E3551	Office 055 - Southwest wall	Appendix 2 Figure 46	Cream	Poor	<0.005	No	N/A	
E3552	Office 058 - Southeast rendered wall	Appendix 1 Figure 2	Cream	Sound	0.15	Yes	Likely	Medium
E3553	Office 058 - Southwest wall	Appendix 2 Figure 47	Cream	Sound	<0.005	No	N/A	
E3554	Office 057 - Southwest wall	Appendix 2 Figure 48	White	Sound	0.069	No ²	N/A

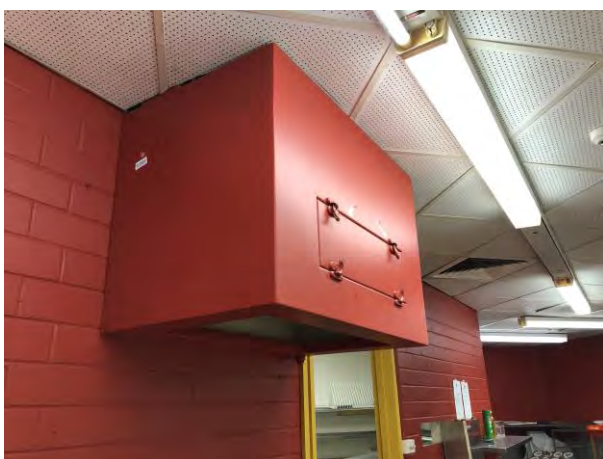
Figure 5: E3563

Sample ID	Sample Location	Photo Reference	Paint Colour	Paint Condition	Lead Conc. (%w/w)	Lead Paint?	Exposure Likelihood	Risk Rating
E3555	Office 057 - Southeast wall	Appendix 2 Figure 49	Cream	Sound	<0.005	No	N/A	
E3556	Office 066 - Northwest masonry wall	Appendix 2 Figure 50	Cream	Sound	<0.005	No	N/A	
E3557	Office 066 - Southwest masonry wall	Appendix 2 Figure 51	Cream	Sound	0.094	No ¹	N/A	
E3558	Kitchen 083 - metal pipe adjacent rangehood	Appendix 2 Figure 52	White	Poor	0.02	No	N/A	
E3559	Kitchen 083 - Southwest brick wall	Appendix 2 Figure 53	White	Poor	<0.005	No	N/A	
E3560	Kitchen 083 - rangehood	Appendix 1 Figure 3	Cream	Poor	0.11	Yes	Very Likely	High
E3561	Kitchen 083 - East brick wall	Appendix 2 Figure 54	White	Sound	<0.005	No	N/A	
E3562	Kitchen 083 - storage cupboard doorframe	Appendix 1 Figure 4	Yellow	Sound	0.17	Yes	Very Likely	Medium
E3563	Kitchen 083 - rangehood	Appendix 1 Figure 5	Red	Sound	0.28	Yes	Likely	Medium

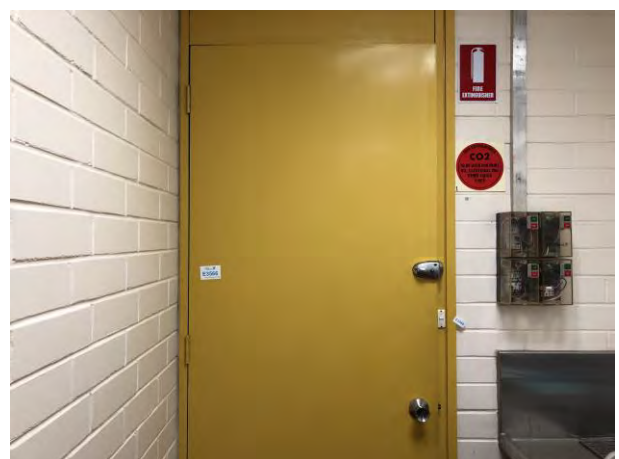
Figure 6: E3566

E3564	Kitchen 083 - South brick wall	Appendix 2 Figure 55	Red	Sound	<0.005	No	N/A	
E3565	Kitchen 083 - bulkhead above serving hatches	Appendix 2 Figure 56	Red	Sound	0.056	No ²	N/A	
E3566	Kitchen 083 - main entry door inside panel	Appendix 1 Figure 6	Yellow	Sound	0.34	Yes	Very Likely	Medium
E3567	Kitchen 083 - main entry door outside panel	Appendix 1 Figure 7	Blue	Poor	0.17	Yes	Very Likely	High
E3568	Kitchen 083 - concrete structural support beam adjacent main entry	Appendix 2 Figure 57	White	Sound	<0.005	No	N/A

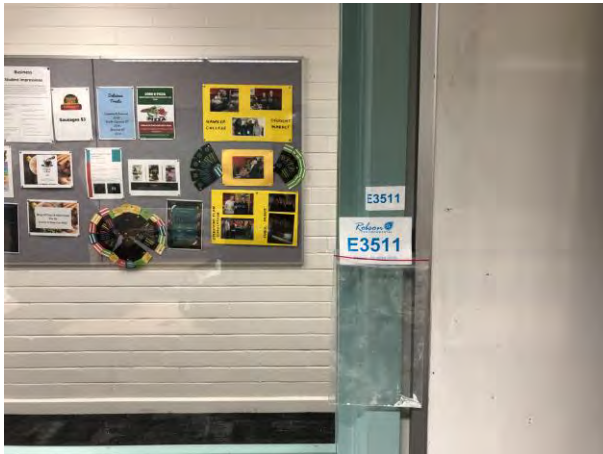
Figure 8: E3511

Sample ID	Sample Location	Photo Reference	Paint Colour	Paint Condition	Lead Conc. (%w/w)	Lead Paint?	Exposure Likelihood	Risk Rating
E3511	Classroom 103 - internal window frame	Appendix 2 Figure 8	Ocean green	Sound	<0.005	No	N/A	
E3512	Classroom 104 - internal window frame	Appendix 2 Figure 9	Ocean green	Poor	<0.005	No	N/A	
E3513	Classroom 105 - internal window frame	Appendix 2 Figure 10	Ocean green	Sound	<0.005	No	N/A	
E3514	Classroom 110 - internal window frame	Appendix 2 Figure 11	Ocean green	Sound	<0.005	No	N/A	
E3515	Classroom 113 - internal window frame	Appendix 2 Figure 12	Ocean green	Sound	<0.005	No	N/A	
E3516	Arts and Crafts room 173 - Northeast plasterboard wall	Appendix 2 Figure 13	White	Sound	<0.005	No	N/A	
E3517	Arts and Crafts room 173 - Northeast flashing under window	Appendix 2 Figure 14	White	Sound	<0.005	No	N/A	
E3518	Arts and Crafts room 173 - Northeast concrete support column	Appendix 2 Figure 15	White	Sound	<0.005	No	N/A

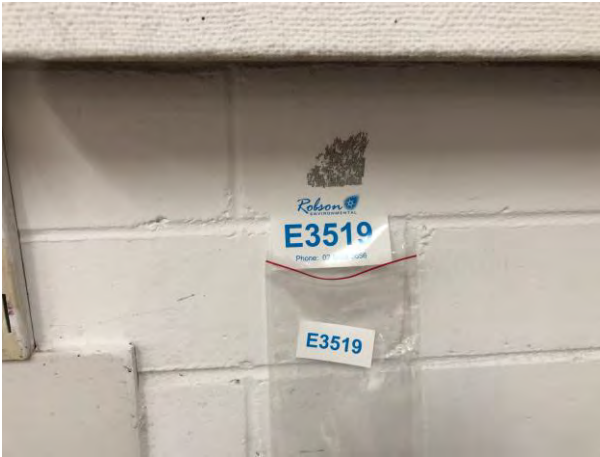
Figure 16: E3519

E3519	Arts and Crafts room 173 - Southeast masonry wall	Appendix 2 Figure 16	White	Sound	<0.005	No	N/A	
E3520	Arts and Crafts room 173 - Northeast masonry wall	Appendix 2 Figure 17	White	Poor	<0.005	No	N/A	
E3521	Arts and Crafts room 173 - Northwest masonry wall	Appendix 2 Figure 18	White	Sound	<0.005	No	N/A	
E3522	Arts and Crafts room 173 - Northwest concrete support column	Appendix 2 Figure 19	White	Sound	<0.005	No	N/A	
E3523	Arts and Crafts room 173 - Southeast metal support column	Appendix 2 Figure 20	White	Sound	0.01	No	N/A	
E3524	PC Laboratory 026 - internal window frame	Appendix 2 Figure 21	Ocean green	Sound	<0.005	No	N/A

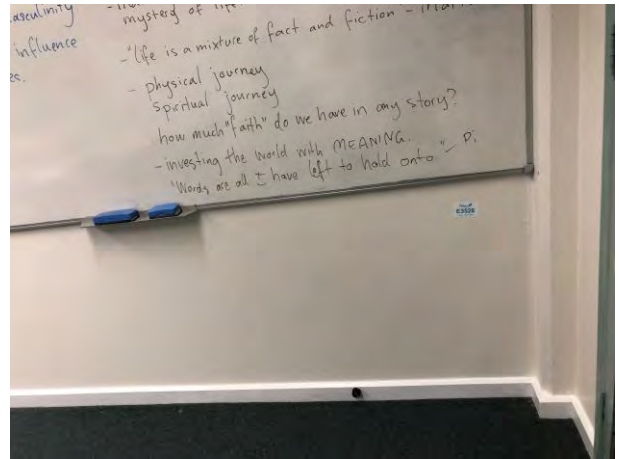
Figure 22: E3525

Sample ID	Sample Location	Photo Reference	Paint Colour	Paint Condition	Lead Conc. (%w/w)	Lead Paint?	Exposure Likelihood	Risk Rating
E3525	PC Laboratory 025 - internal window frame	Appendix 2 Figure 22	Ocean green	Sound	<0.005	No	N/A	
E3526	PC Laboratory 025 - Southeast wall	Appendix 2 Figure 23	White	Sound	0.04	No	N/A	
E3527	Classroom 024 - internal window frame	Appendix 2 Figure 24	Ocean green	Sound	<0.005	No	N/A	
E3528	Classroom 024 - Southwest wall	Appendix 2 Figure 25	Cream	Sound	0.03	No	N/A	
E3529	Classroom 023 - internal window frame	Appendix 2 Figure 26	Ocean green	Poor	<0.005	No	N/A	
E3530	Study Support 016 - internal window frame	Appendix 2 Figure 27	Ocean green	Sound	<0.005	No	N/A	
E3531	Study Support room 016 - Southwest wall	Appendix 1 Figure 1	Cream	Sound	0.13	Yes	Likely	Medium
E3532	IPS Hub 015 - internal window frame	Appendix 2 Figure 28	Ocean green	Sound	<0.005	No	N/A	
E3533	Classroom 013 - internal window frame	Appendix 2 Figure 29	Ocean green	Sound	<0.005	No	N/A

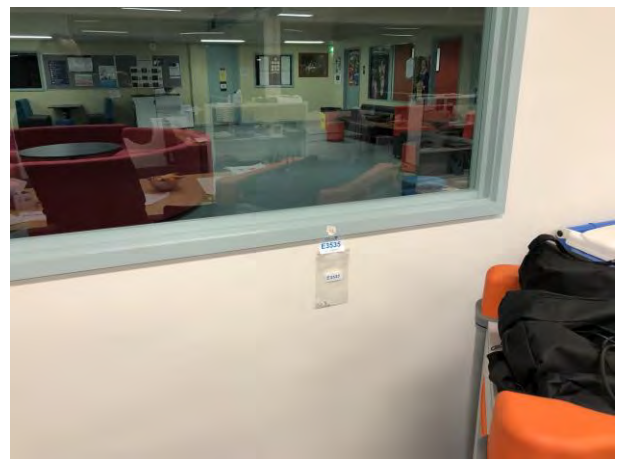
Figure 30: E3534

E3534	Classroom 013 - Northwest masonry wall	Appendix 2 Figure 30	Cream	Sound	<0.005	No	N/A	
E3535	Staffroom 011/012 - internal window frame	Appendix 2 Figure 31	Ocean green	Sound	<0.005	No	N/A	
E3536	Classroom 006 - internal window frame	Appendix 2 Figure 32	Ocean green	Sound	<0.005	No	N/A	
E3537	Classroom 006 - Northwest wall	Appendix 2 Figure 33	Cream	Poor	<0.005	No	N/A	
E3538	Classroom 004 - internal window frame	Appendix 2 Figure 34	Ocean green	Sound	<0.005	No	N/A	
E3539	Classroom 004 - Northeast wall	Appendix 2 Figure 35	Cream	Sound	0.063	No ²	N/A

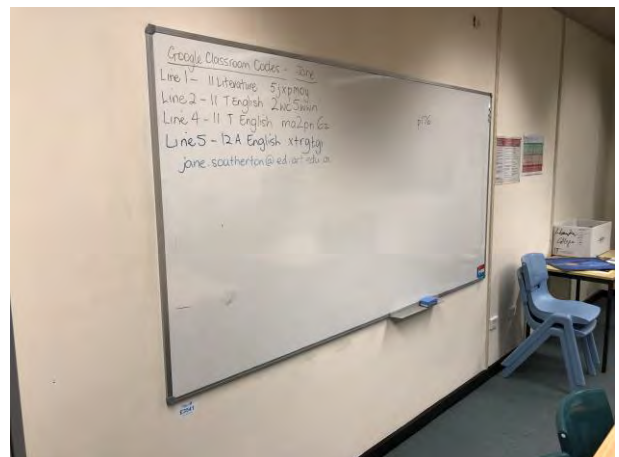
Figure 36: E3540

Sample ID	Sample Location	Photo Reference	Paint Colour	Paint Condition	Lead Conc. (%w/w)	Lead Paint?	Exposure Likelihood	Risk Rating
E3540	Classroom 003 - internal window frame	Appendix 2 Figure 36	Ocean green	Sound	<0.005	No	N/A	
E3541	Classroom 003 - Southwest wall	Appendix 2 Figure 37	Cream	Sound	0.076	No ²	N/A	
E3542	Makers Space room 031 - internal window frame	Appendix 2 Figure 38	Ocean green	Sound	<0.005	No	N/A	
E3543	PC Laboratory 029 - internal window frame	Appendix 2 Figure 39	Ocean green	Sound	<0.005	No	N/A	
E3544	Student Service Area 052 - masonry wall	Appendix 2 Figure 40	Cream	Sound	<0.005	No	N/A	
E3545	Student Services Office 052 - Southeast plasterboard wall	Appendix 2 Figure 41	Cream	Poor	<0.005	No	N/A	
E3546	Office 054 - Northeast masonry wall	Appendix 2 Figure 42	Lavender	Sound	<0.005	No	N/A	
E3547	Office 054 - Southeast wall	Appendix 2 Figure 43	Cream	Sound	<0.005	No	N/A	
E3548	Office 054 - Southwest plasterboard wall	Appendix 2 Figure 44	Cream	Poor	<0.005	No	N/A

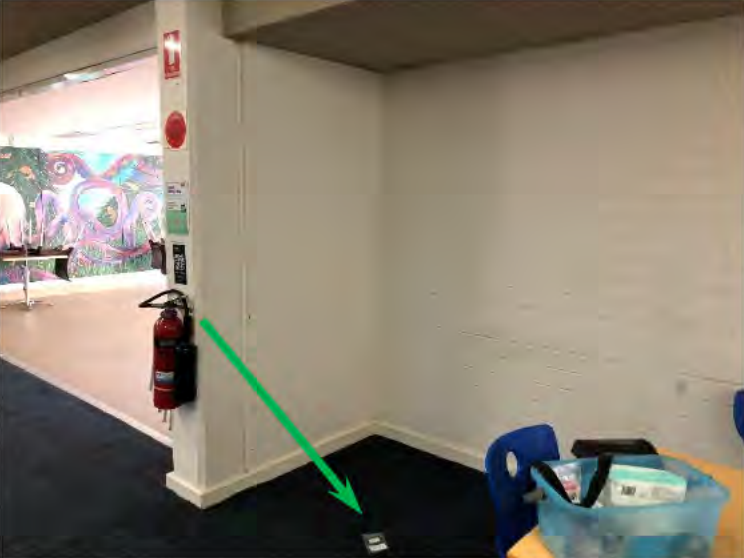
Sample Number	Location Description	Material	Photographs
J3116	Ground floor Library south east alcove adjacent courtyard	Surface debris

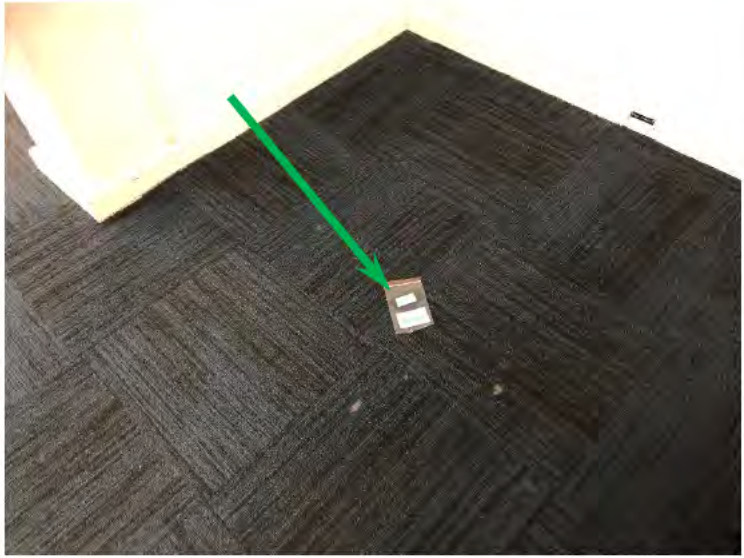
J3116	Ground floor Library south east alcove adjacent courtyard	Surface debris
