OPERATIONAL PLAYGROUND INSPECTION CHECKLIST - SCHOOL NAME:

Garran Primary

Garran Primary School Gilmore Crescent Garran ACT Playground Safety Inspection Report

Garran Preschool Robson St Garran ACT

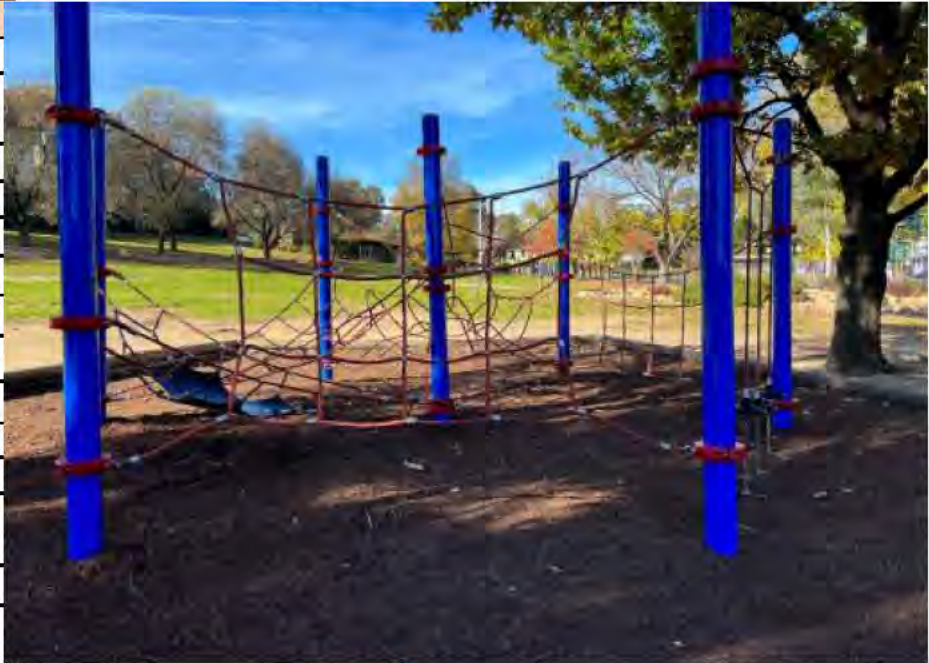
AnimalAccess		Limited				Accessible to small animals							
	CarerAccess		Limited				climbing only access							
	DisabilityAccess		Low				Poor access to cluster							
	Electrical		OK				No major facilities close by							
	Industry		OK				None close by							
	Litter		OK				Clean site							
	MtceAccess		OK				Double gates							
	ShelterShade		Partial				Trees							
	Usage		High				Intensive on weekdays							
	Supervision		Comprehensiv				Supervised							
	Transport		OK fenced				Close but fenced							
	Toilets		<50 metres				In Building							
	Water		OK				Good access to drinking water							
C Activity/Assets														
	Surface	1	PineBark(SF)	2	PGsurface	Impact attenuation	Depth: 150mm. This is too low for these Free Heights of Fall Mulch is heavily pulverised	3	4	12	H	Monitor frequently, especially at key impact areas. Maintain at minimum 300mm consolidated depth Refer Advisory Note 1 below Replace compacted mulch	2000

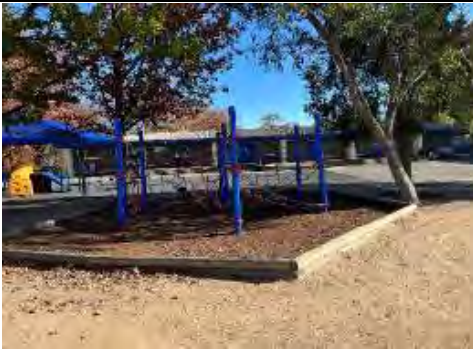
ASSET					HAZARD			RISK				RECTIFICATION		PHOTO
No	Item/Activity	Qty	Description	Condition	Type	Description	Comment	Probability	Severity	Value	Risk	Action/Comments	Cost \$	
	Surface	1	Edging	2	Structural	Inadequate	Too low to achieve a 300mm bark depth	3	4	12	H	Raise the edging height	2400

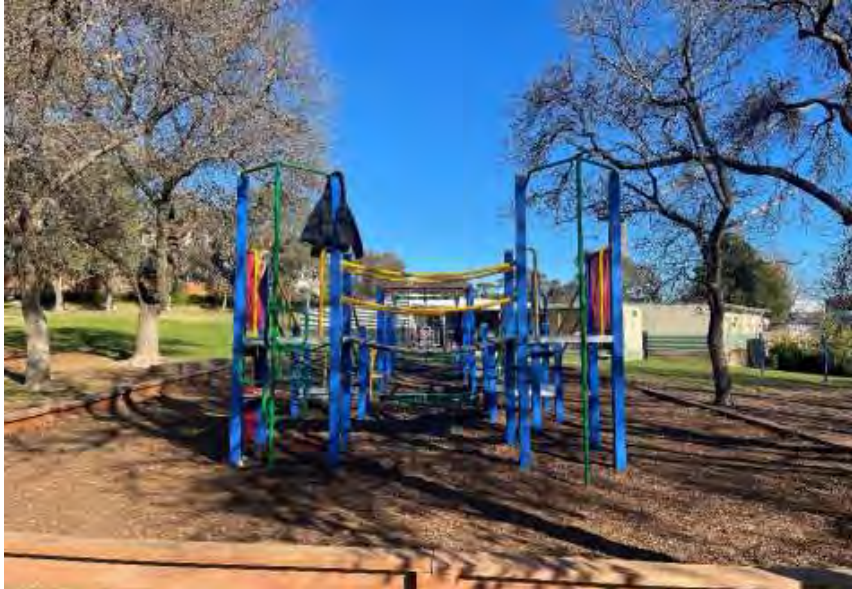
AnimalAccess		Limited				Accessible to small animals							
	CarerAccess		OK				Ladder access to cluster							
	DisabilityAccess		Low				Poor access to cluster							
	Electrical		OK				No major facilities close by							
	Industry		OK				None close by							
	Litter		OK				Clean site							
	MtceAccess		OK				Double gates							
	ShelterShade		Partial				Trees							
	Usage		High				Intensive on weekdays							
	Supervision		Comprehensiv				Supervised							
	Transport		>20 metres											
	Toilets		<50 metres				In Building							
	Water		OK				Good access to drinking water							
C Activity/Assets														
	Surface	1	PineBark(SF)	2	PGsurface	Impact attenuation	Depth: 150-200mm Mulch is significantly pulverised and sticks present	3	4	12	H	Monitor frequently, especially at key impact areas. Maintain at minimum 300mm consolidated depth. Refer Advisory Note 1 below Replace pulverised mulch	4000

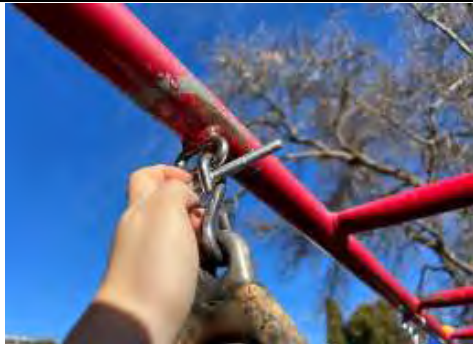
ASSET					HAZARD			RISK				RECTIFICATION		PHOTO
No	Item/Activity	Qty	Description	Condition	Type	Description	Comment	Probability	Severity	Value	Risk	Action/Comments	Cost \$	
	Hanging	1	Rings	2	Entrapment	Finger	In s hooks	2	4	8	M	Refer Advisory note 2	450

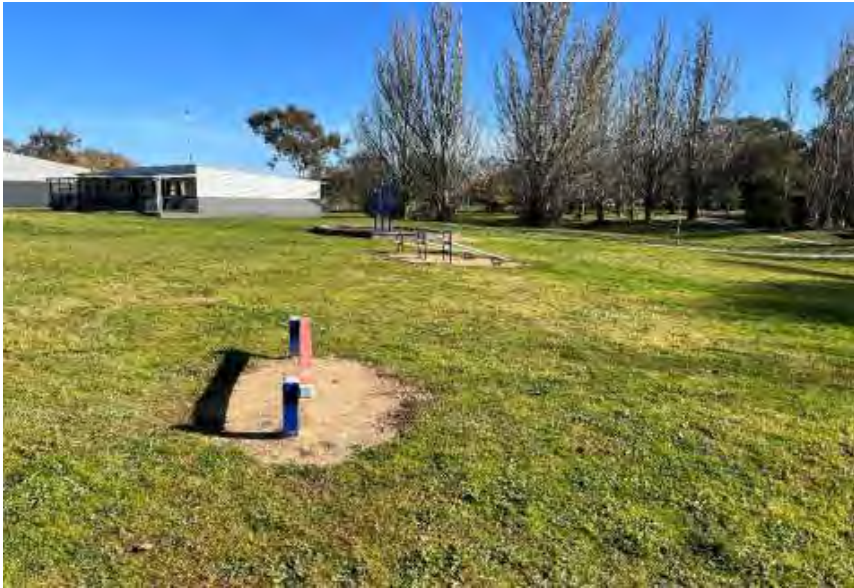
Surface	1	PineBark(SF)	2	PGsurface	Impact attenuation	Depth: 50-200mm Note the requirement for softfall varies with each item and is referred to in the notes on each item below. Whitewood fragments present	3	3	9	M	Monitor frequently, especially at key impact areas. Maintain mulch at minimum 300mm consolidated depth Refer Advisory Note 1 below Edging will need to be raised Remove whitewood		 
	Surface	1	Edging	2			Refer each item below

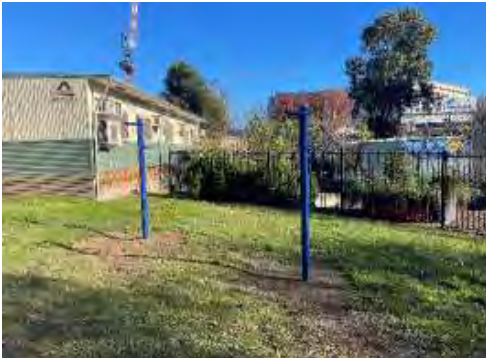
ASSET					HAZARD			RISK				RECTIFICATION		PHOTO
No	Item/Activity	Qty	Description	Condition	Type	Description	Comment	Probability	Severity	Value	Risk	Action/Comments	Cost \$	
Assets are listed in anticlockwise order starting with the hanging loops														
	Hanging	1	Handles	2	PGsurface	Impact attenuation	In actual use, children may climb up onto the loops.	4	5	20	VH	Softfall is required under these items. Refer Advisory note 2	3000

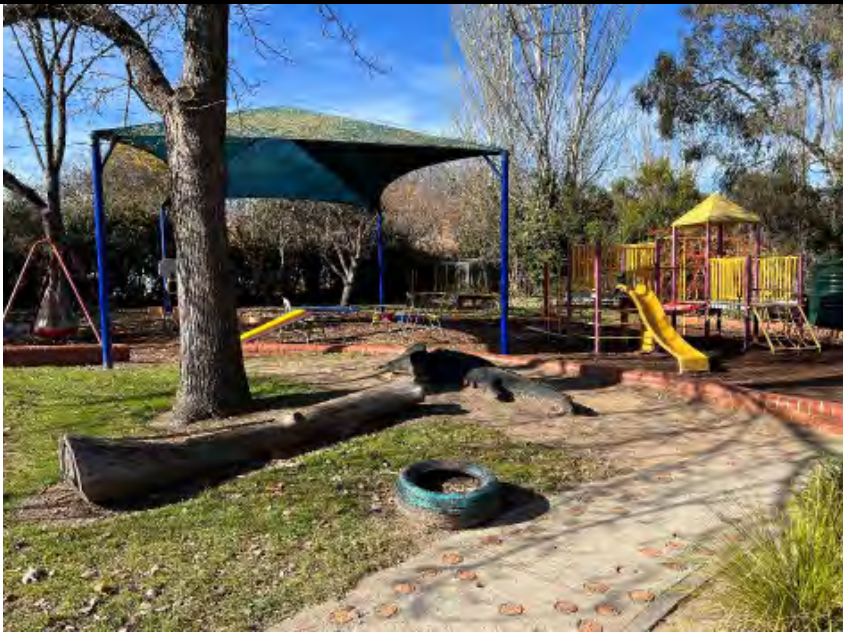
A Documents & Marking														
	Equipment Certification		Compliance to AS 4685:2021 series, AS 4685.0 2017, AS 4685.11 2012 and AS 4422 2022. for the installed, completed works				Not Sighted

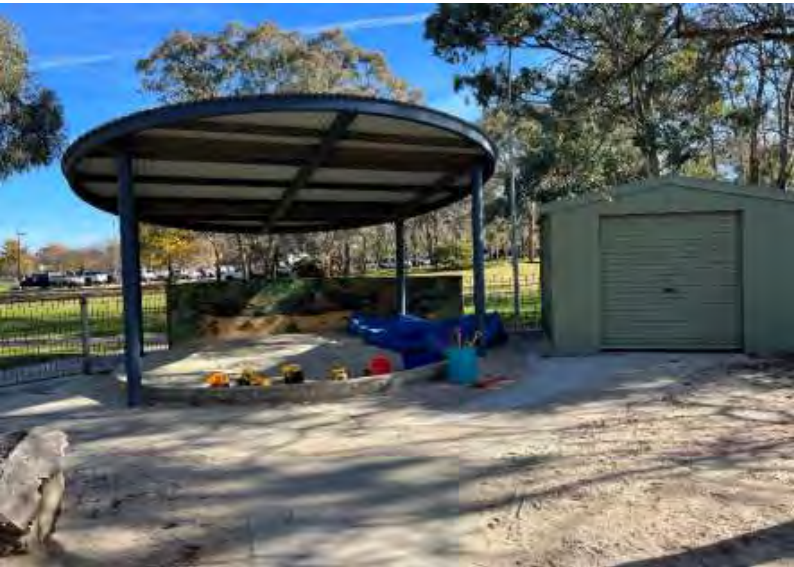
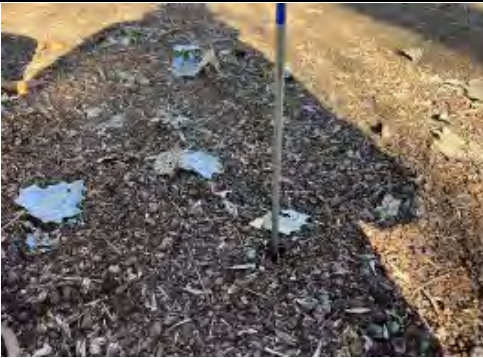
Surface	1	PineBark(SF)	2	PGsurface	Impact attenuation	Playspace equipment Depth 200mm Compacted in fall zones and pulverised	3	4	12	H	Monitor frequently, especially at impact areas. Maintain at minimum 300mm consolidated depth. Refer Advisory Note 1 below Replace pinebark.	2500

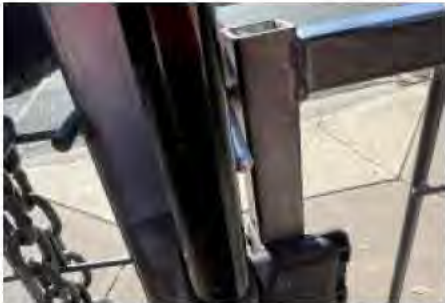
ASSET					HAZARD			RISK				RECTIFICATION		PHOTO
No	Item/Activity	Qty	Description	Condition	Type	Description	Comment	Probability	Severity	Value	Risk	Action/Comments	Cost \$	
	Access	1	Gate-Single	2	Entrapment	Finger	1. Closing gap is less than 12mm 2. Missing cap	2	4	8	M	1. Reconfigure to adjust gap to greater than 12mm 2. Replace missing cap	300

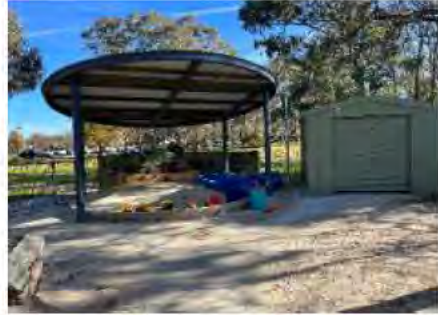
ASSET					HAZARD			RISK				RECTIFICATION		PHOTO
No	Item/Activity	Qty	Description	Condition	Type	Description	Comment	Probability	Severity	Value	Risk	Action/Comments	Cost \$	
	Access	1	Fence	2	OK									
	Landscape	1	Sand Pit	2	OK

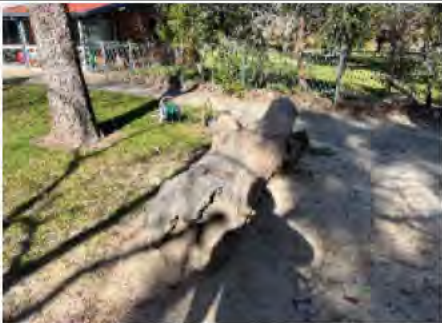
ASSET					HAZARD			RISK				RECTIFICATION		PHOTO
No	Item/Activity	Qty	Description	Condition	Type	Description	Comment	Probability	Severity	Value	Risk	Action/Comments	Cost \$	
	Balancing	1	Log	2	PGsurface	Impact attenuation	> 600mm and not impact attenuating surface underneath and next to concrete footpath that can be fallen onto from a higher level.	2	2	4	L	> 600mm height requires softfall underneath. Install or move to surface with softfall or reduce log height to <600mm. Refer advisory note 1

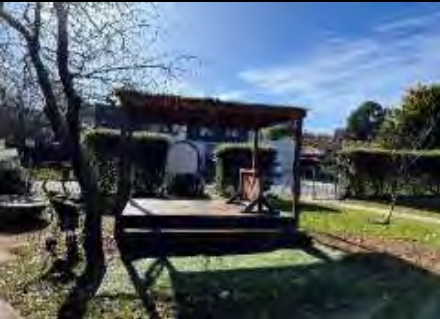
ASSET					HAZARD			RISK				RECTIFICATION		PHOTO
No	Item/Activity	Qty	Description	Condition	Type	Description	Comment	Probability	Severity	Value	Risk	Action/Comments	Cost \$	
	Landscape	1	Platform	2	OK
