Fibre Identification Certificate of Analysis

Laboratory Report Number: T0095614_T-12534

Hawker College 16 May 2022

Re: Visual inspection and Risk Assessment of water damaged sprayed coating areas to prioritise their removal at Hawker College on Friday 12 August 2022

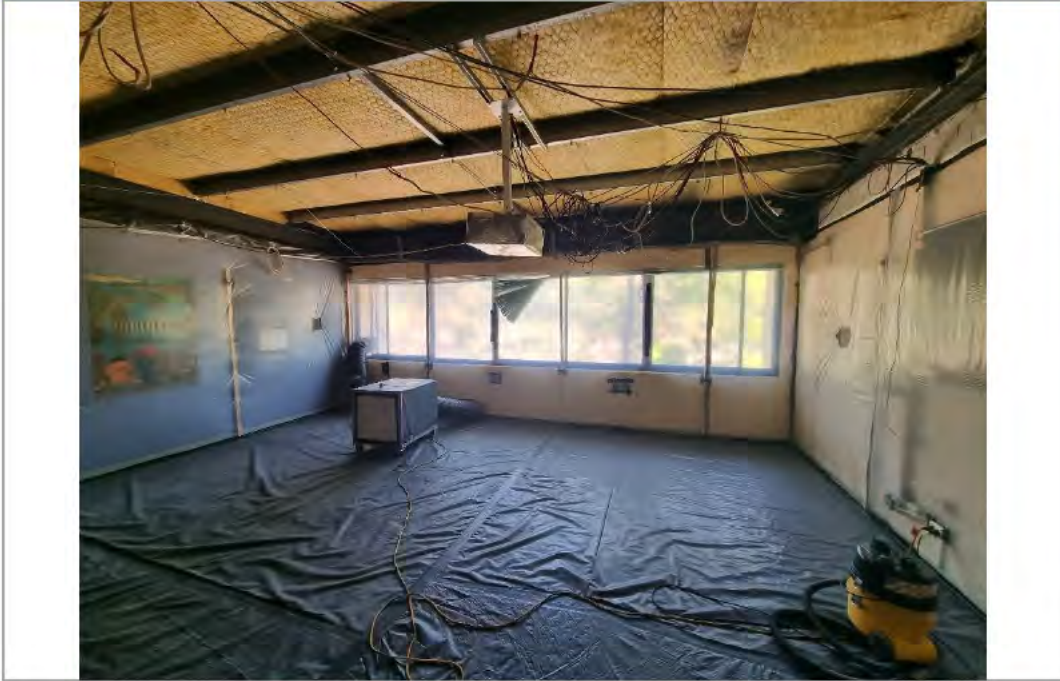
Photograph 1: Photograph following removal of asbestos spray coated ceiling from Room 7.4

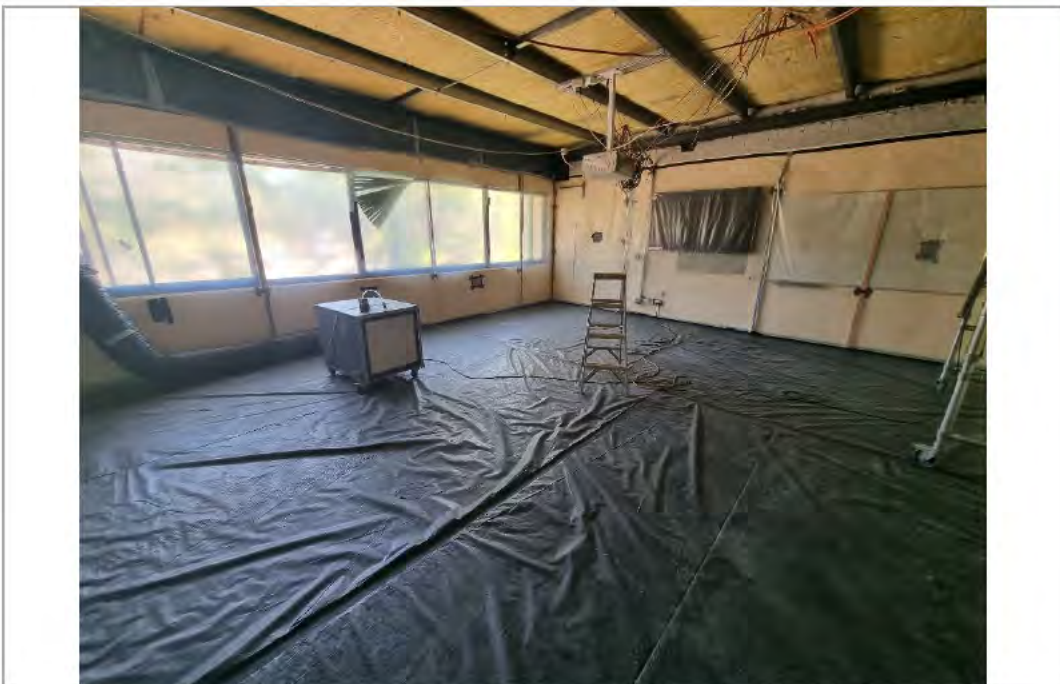
Photograph 2: Photograph following removal of asbestos spray coated ceiling from Room 7.4

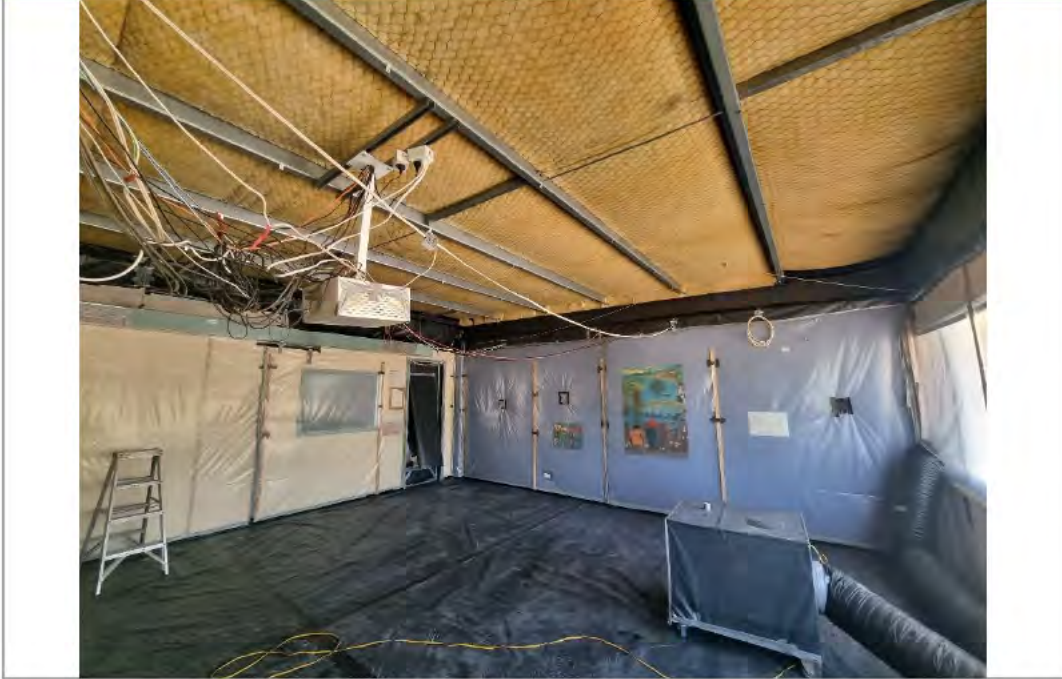
Photograph 3: Photograph following removal of asbestos spray coated ceiling from Room 7.4

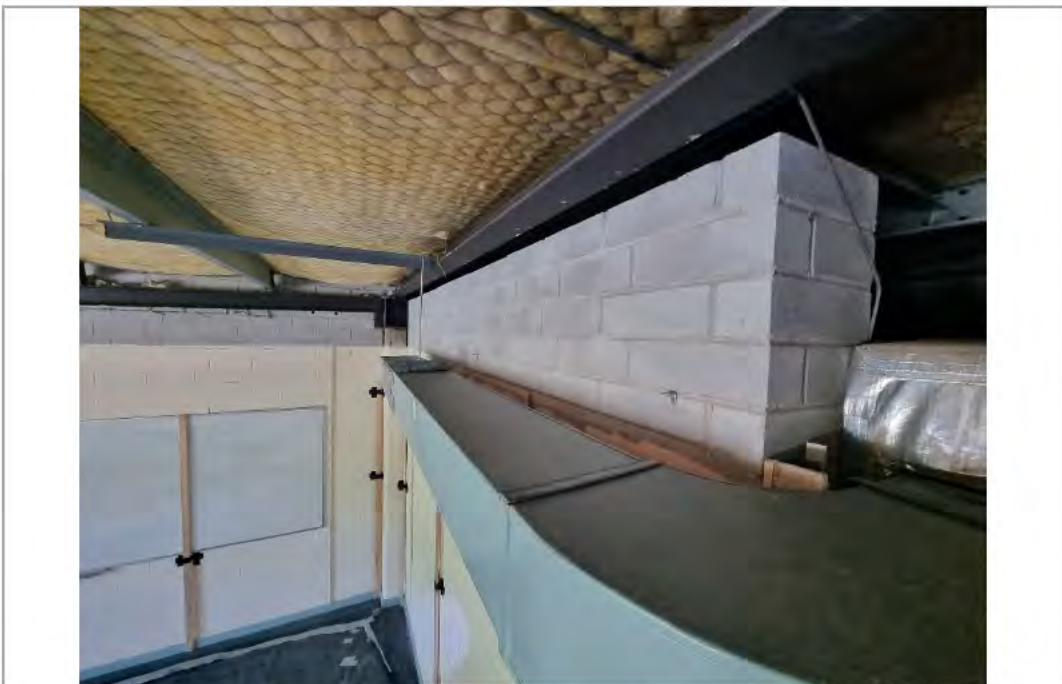
Photograph 4: Photograph following removal of asbestos spray coated ceiling from Room 7.4

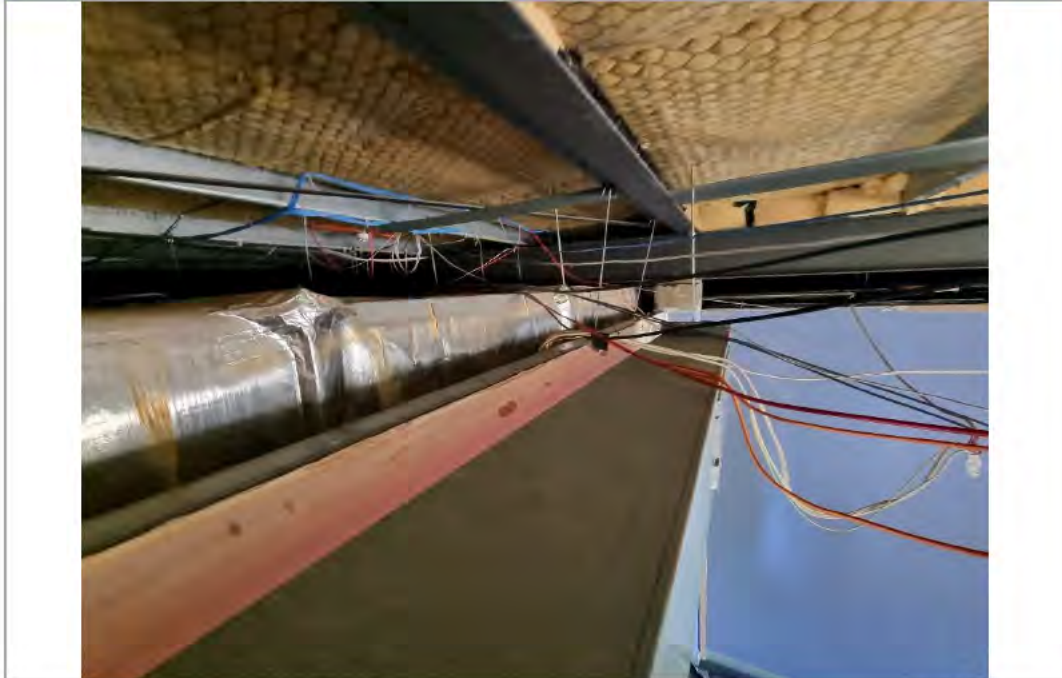
Photograph 5: Photograph following removal of asbestos spray coated ceiling from Room 7.4

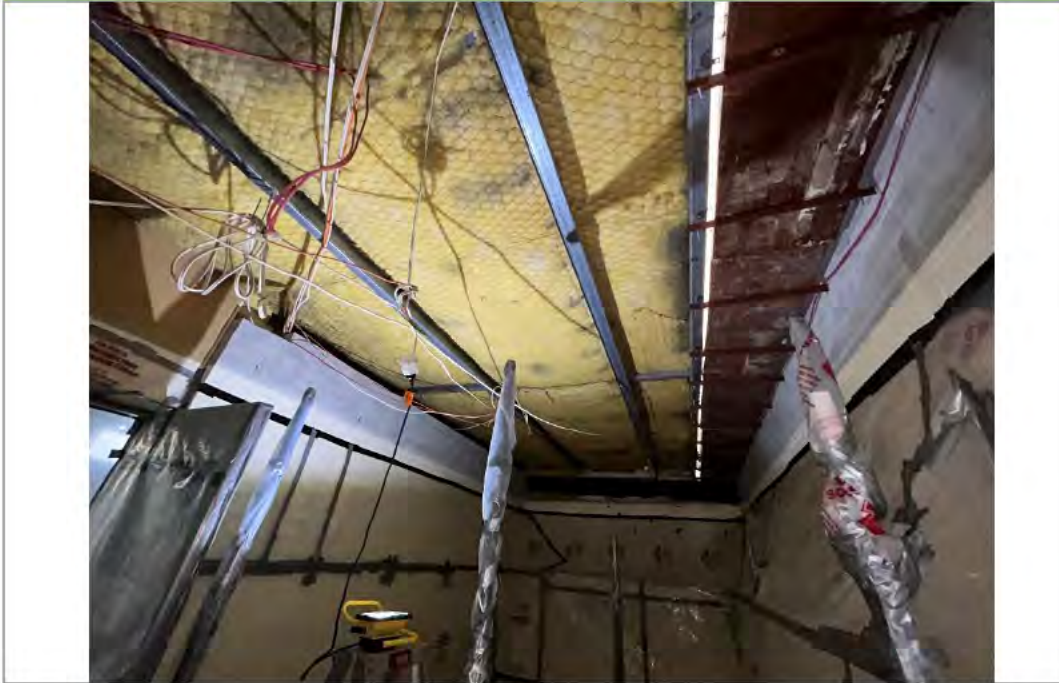
Photograph 1: Photograph following removal of asbestos spray coated ceiling

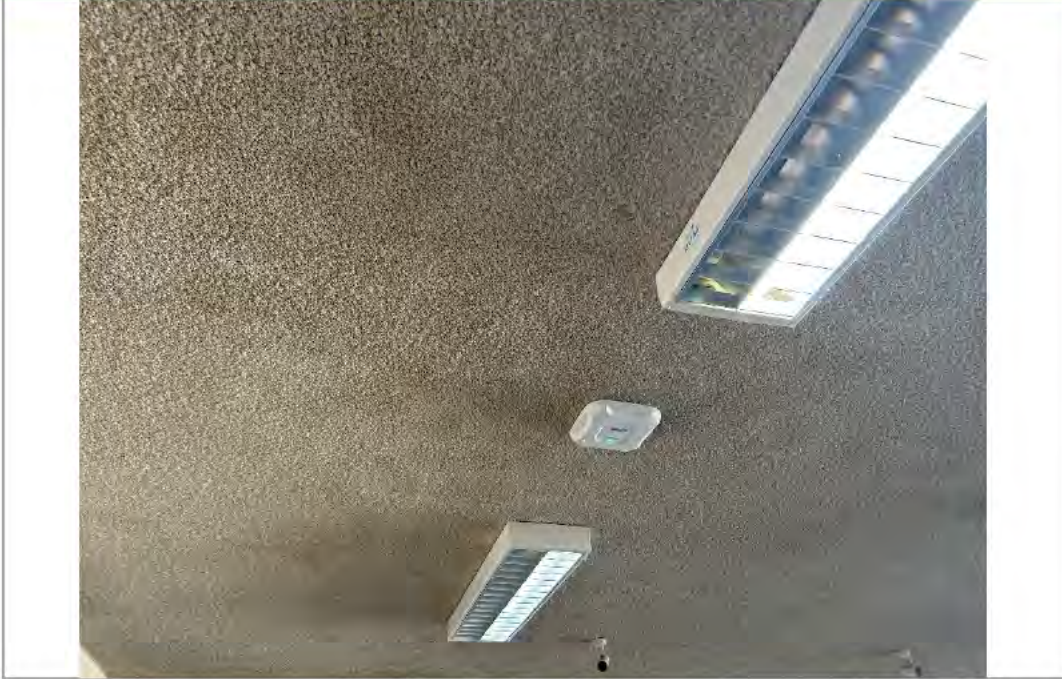
Photograph 1: Photograph following encapsulation

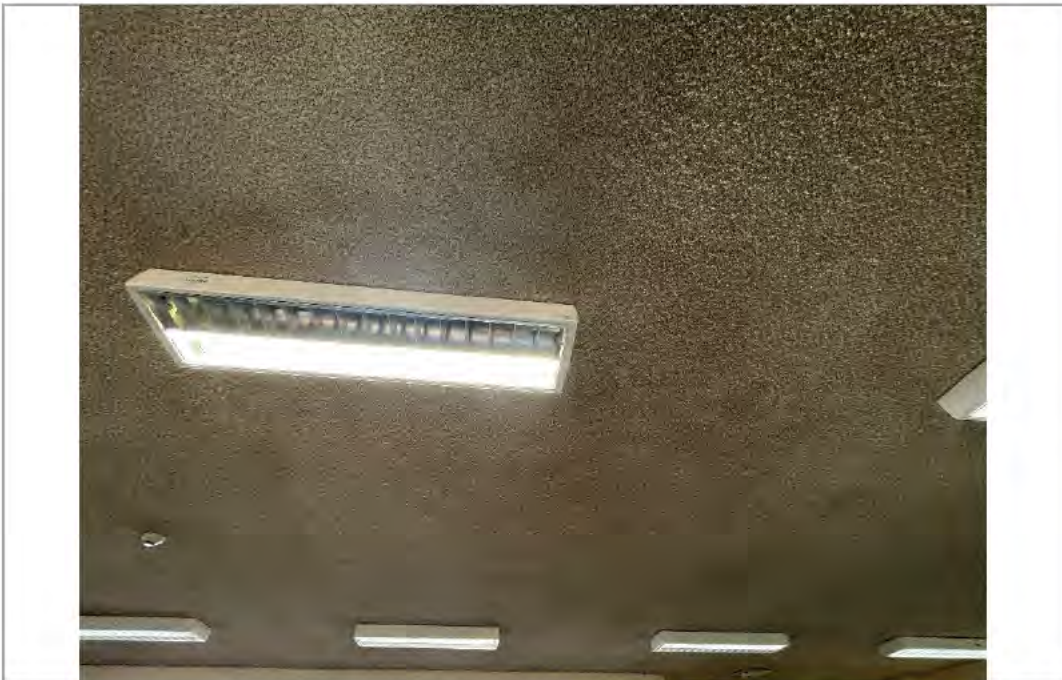
Photograph 1: Photograph following encapsulation
