Lead Dust Investigation

Yarralumla Primary School and Montessori Preschool

24 July 2020

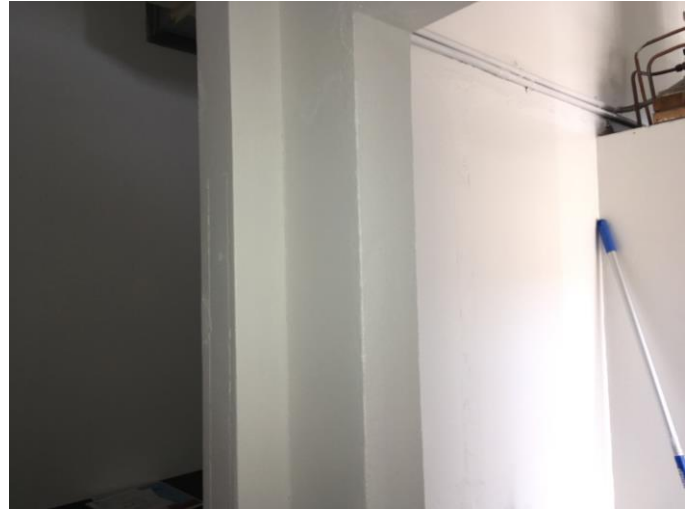
Figure 4: Pb03 After Stabilisation 16/09/2019

Sample ID	Sample Location	Photo Reference	Paint Colour	Paint Condition	Lead Conc. (%w/w)	Lead Paint?	Exposure Likelihood	Risk Rating as at 16/09/19	Known Management History
Pb01	Yarralumla Primary School Main Building – Internal window frames, door frames and skirting boards throughout	Appendix 1 Figure 1	White	Poor Non-stabilised	0.29	Yes	Very Likely	High	
Pb02	Yarralumla Primary School Main Building – Internal radiator heating pipes throughout	Appendix 1 Figure 2	White	Sound	0.090	No	N/A		
Pb03	Yarralumla Primary School Main Building – Internal Cleaners’/Bathroom masonry walls	Appendix 1 Figure 3 Figure 4	Grey	Sound Stabilised	0.19	Yes	Possible	Medium	Lead paint has been stabilised via over painting 11/08/19.
Pb04	Yarralumla Primary School Main Building – Internal Cleaners’/Bathroom doors	Appendix 1 Figure 5	Dark Blue	Sound Non-stabilised	0.82	Yes	Likely	High	
Pb05	Yarralumla Primary School Main Building – Internal Cleaners’/Bathroom riser walls and pipes	Appendix 1 Figure 6	Green	Poor Non-Stabilised	0.26	Yes	Unlikely	Low

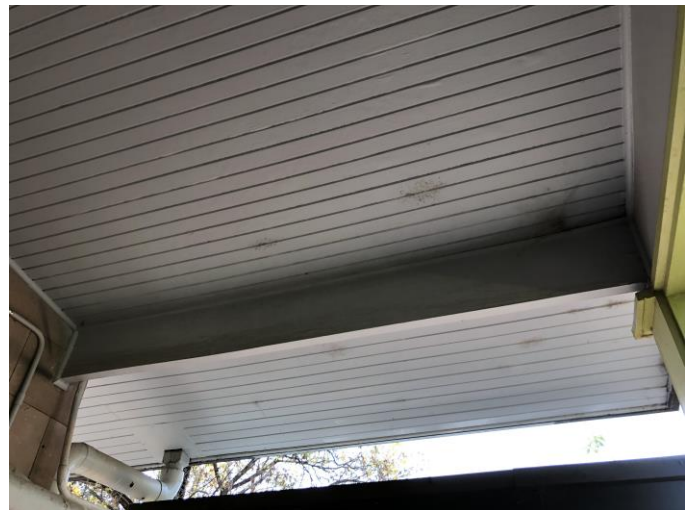
Figure 11: Pb10 23/04/2019

Sample ID	Sample Location	Photo Reference	Paint Colour	Paint Condition	Lead Conc. (%w/w)	Lead Paint?	Exposure Likelihood	Risk Rating as at 16/09/19	Known Management History
Pb09	Yarralumla Primary School Main Building – Exterior down pipes and fascias	Appendix 1 Figure 10	Grey	Sound	0.1	No		N/A	
Pb10	Yarralumla Primary School Main Building – Exterior timber eave soffits	Appendix 1 Figure 11	Grey	Sound	<0.005	No		N/A	
Pb11	Yarralumla Primary School Main Building – External window frames and doors	Appendix 1 Figure 12	Grey	Sound	0.05	No		N/A	
Pb12	Yarralumla Gambarri and Preschool – Exterior window frames, doors, masonry walls and eave soffits	Appendix 1 Figure 13 Appendix 1 Figure 14	White	Poor Non-stabilised	0.13	Yes	Very Likely	High	Stabilisation by over-painting on 13/07/19. Over-painted surfaces have deteriorated as of 16/09/2019.
Pb13	Yarralumla Primary School After School Care – Exterior window frames and eave soffits	Appendix 1 Figure 15 Appendix 1 Figure 16	White	Poor Non-stabilised	0.28	Yes	Possible	High	Stabilisation by over-painting on 17/07/19. Over-painted surfaces have deteriorated as of 16/09/2019.

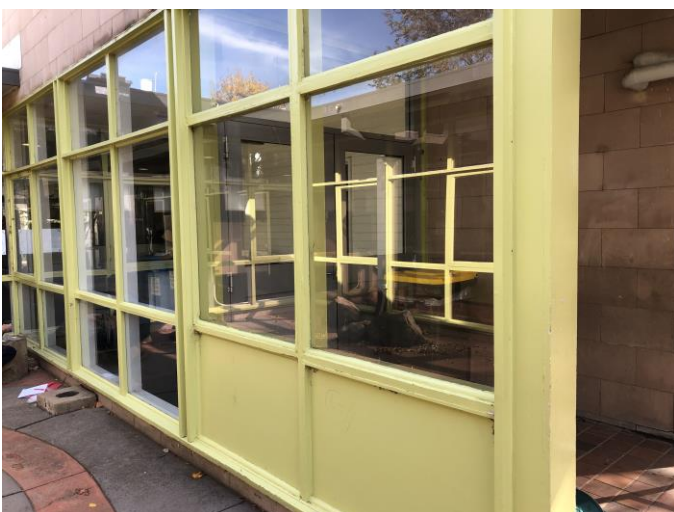
Figure 9: Pb08 23/04/2019

Pb06	Yarralumla Primary School Main Building – Internal brick walls throughout	Appendix 1 Figure 7	White	Sound	<0.005	No	N/A		
Pb07	Yarralumla Primary School Main Building – Internal masonry walls throughout	Appendix 1 Figure 8	Yellow	Sound	<0.005	No	N/A		
Pb08	Yarralumla Primary School Main Building – Exterior windows and infill panels	Appendix 1 Figure 9	Green	Poor Non-stabilised	0.32	Yes	Very Likely	High	Some areas have been stabilised by over-painting on 18/07/19. Over-painted surfaces have deteriorated as of 16/09/2019.

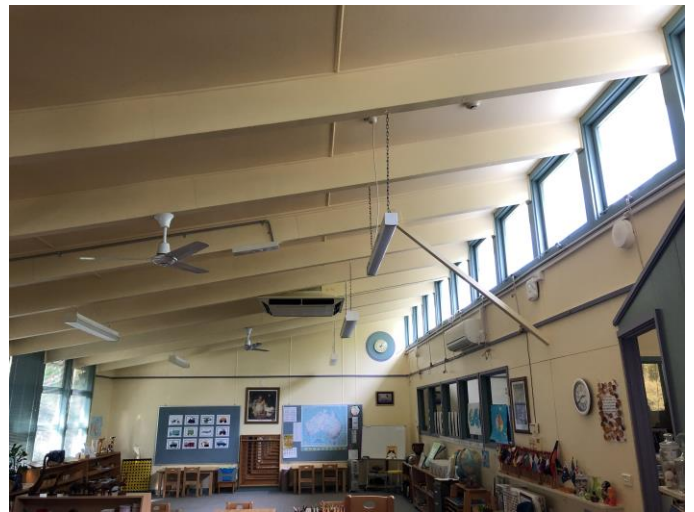
Figure 17: Pb14 23/04/2019

Pb14	Yarralumla Preschool – Internal roof support beam	Appendix 1 Figure 17	Yellow	Sound	<0.005	No		N/A	
Pb15	Yarralumla Preschool – Internal and external window frames, pergola frame and doors	Appendix 1 Figure 18	Grey	Sound	<0.005	No		N/A	
C2560	Yarralumla Primary School Canteen – Pantry bench top	Appendix 1 Figure 19 Appendix 1 Figure 20	White	Poor Non-stabilised	0.22	Yes	Very Likely	High	
T010351	Yarralumla Canteen and Hall – Wall between serving windows	Appendix 1 Figure 21	White	Poor Non-stabilised	0.18	Yes	Very Likely	High

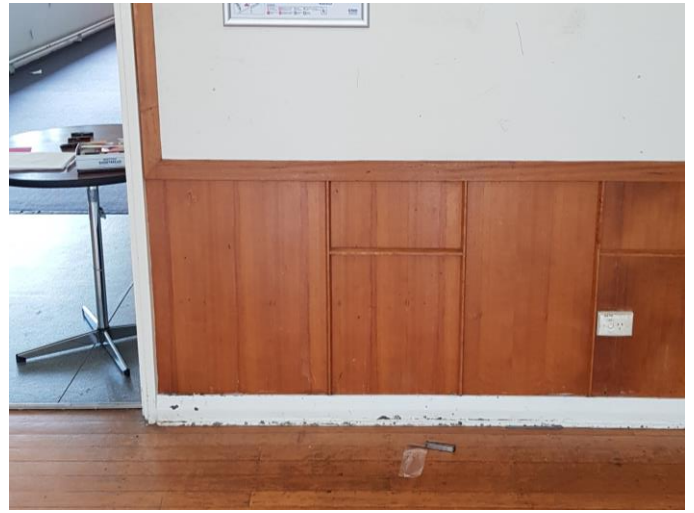
Figure 23: T010353 27/08/2019

Sample ID	Sample Location	Photo Reference	Paint Colour	Paint Condition	Lead Conc. (%w/w)	Lead Paint?	Exposure Likelihood	Risk Rating as at 16/09/19	Known Management History
T010352	Yarralumla Canteen and Hall – Skirting board south (window side) Hall	Appendix 1 Figure 22	White	Poor Non-stabilised	0.15	Yes	Very Likely	High	
T010353	Yarralumla Canteen and Hall – Skirting board North (internal side) Hall	Appendix 1 Figure 23	White	Poor Non-stabilised	0.092*	Probable	See note below. This paint should be managed the same as the paint from sample T010352 as it likely to contain a similar amount of lead, on average.		
T010354	Yarralumla Canteen and Hall – Between windows in Quad outside Hall	Appendix 1 Figure 24	Green	Poor Non-stabilised	0.15	Yes	Very Likely	High	
T010355	Yarralumla Canteen and Hall – Skirting under windows in Quad outside Hall	Appendix 1 Figure 25	Green	Poor Non-stabilised	0.44	Yes	Very Likely	High
