Fibre Identification Certificate of Analysis

Laboratory Report Number: T0095614_T-12534

Hawker College 16 May 2022

Re: Visual inspection and Risk Assessment of water damaged sprayed coating areas to prioritise their removal at Hawker College on Friday 12 August 2022

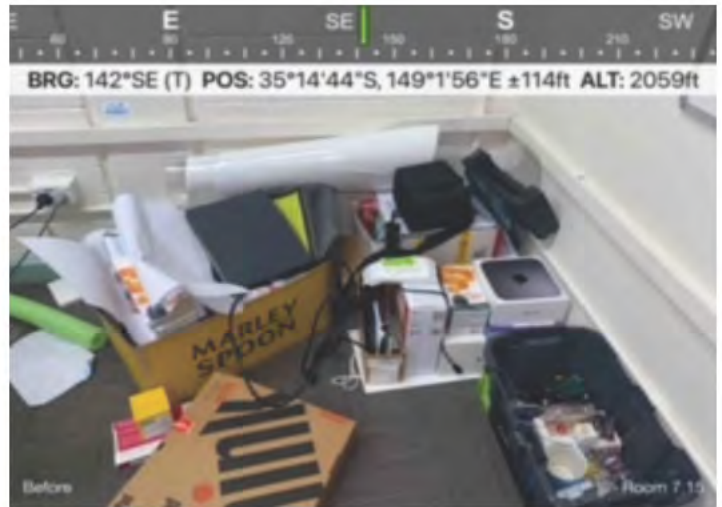
Before removal

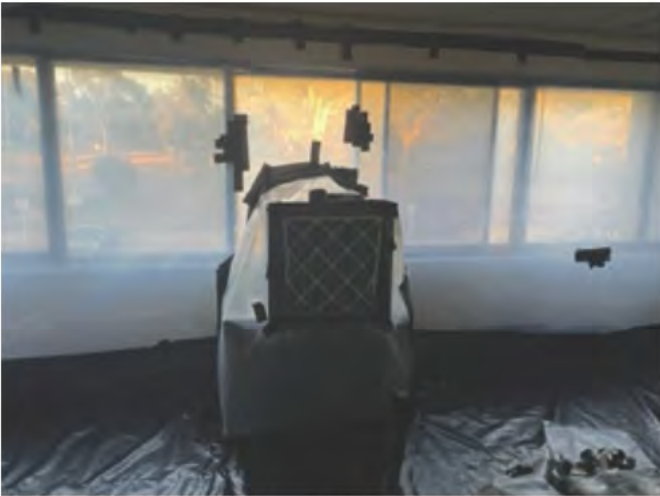
Negative pressure unit

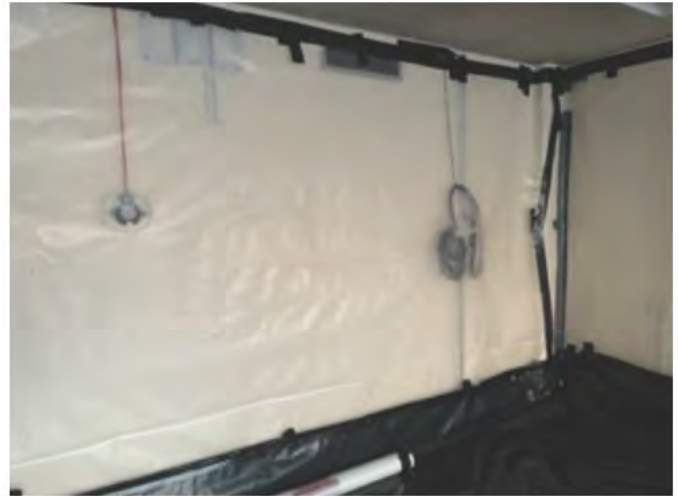
Encapsulation

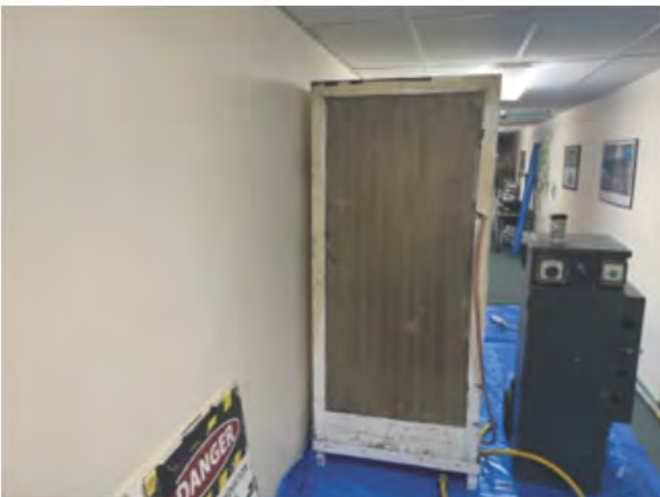
Decontamination unit

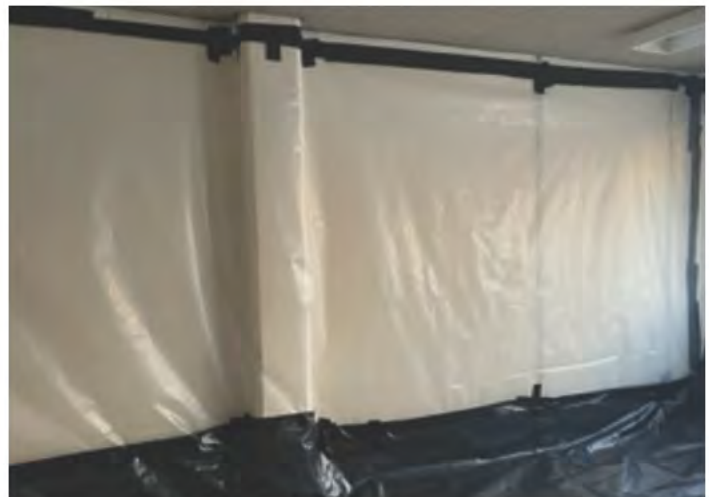
Encapsulation

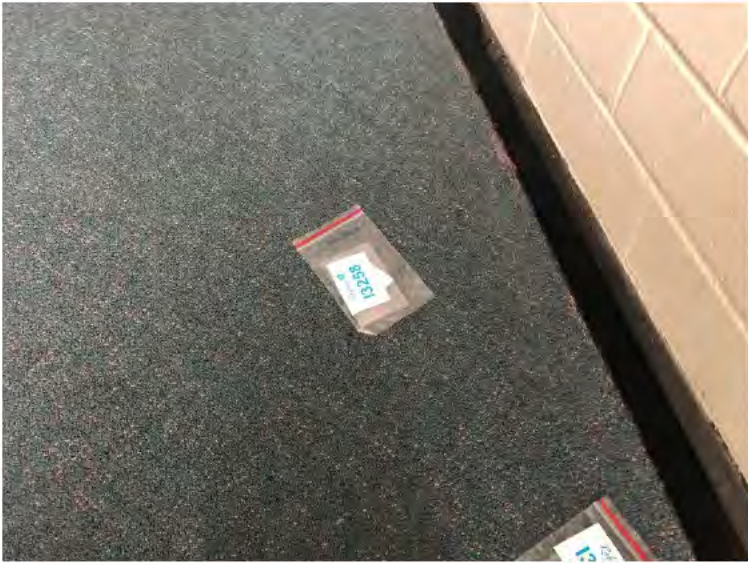
Sample Number	Location Description	Material	Photograph(s)
I3258	Stairwell adjacent stage - From skirting board	Debris

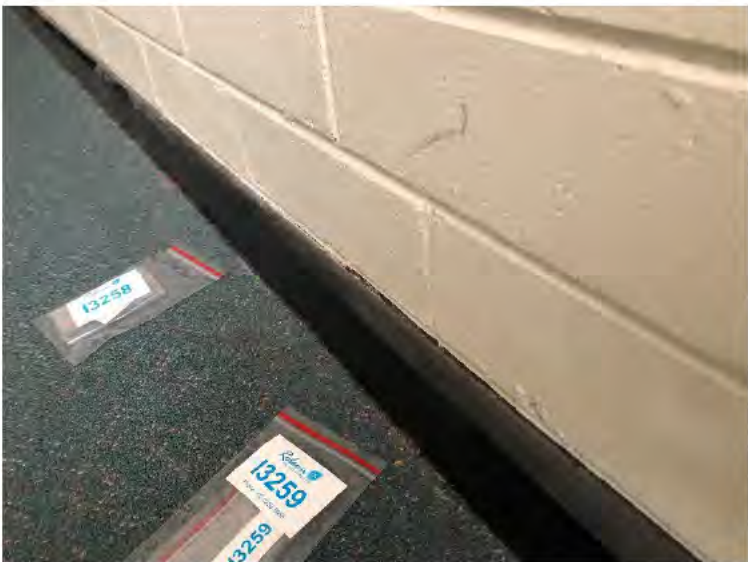
<p>A photograph showing a small, clear plastic bag containing debris, labeled 'I3258', lying on a dark, textured carpet. The bag is positioned near a white skirting board that runs along the base of a light-colored brick wall.</p>
I3259	Stairwell adjacent stage - On carpet	Spray coating debris

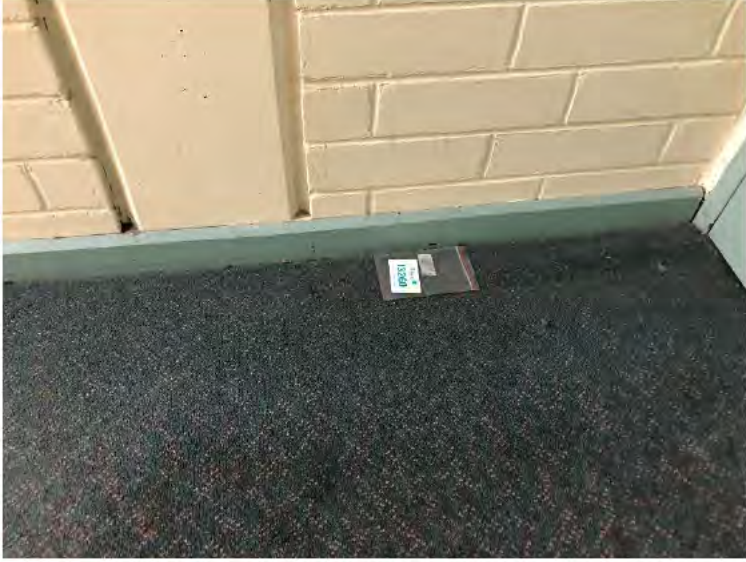
Sample Number	Location Description	Material	Photograph(s)
I3260	Stairwell adjacent wheelchair lift - On carpet	Debris

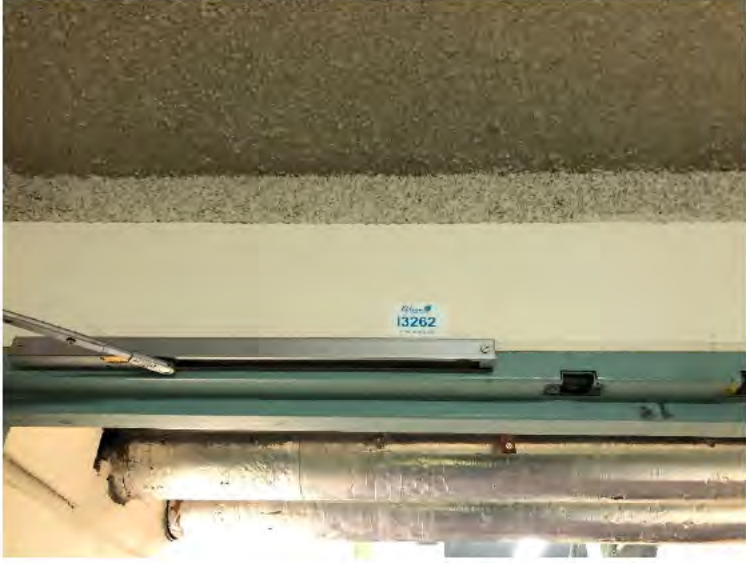
I3262	Corridor adjacent cafe (128) - On top of fire door	Debris

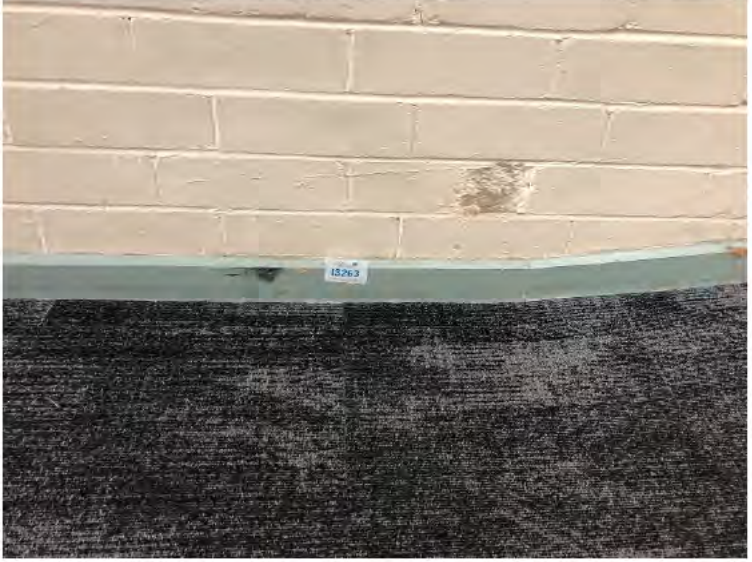
Sample Number	Location Description	Material	Photograph(s)
I3263	Corridor adjacent cafe (128) - From skirting board	Debris

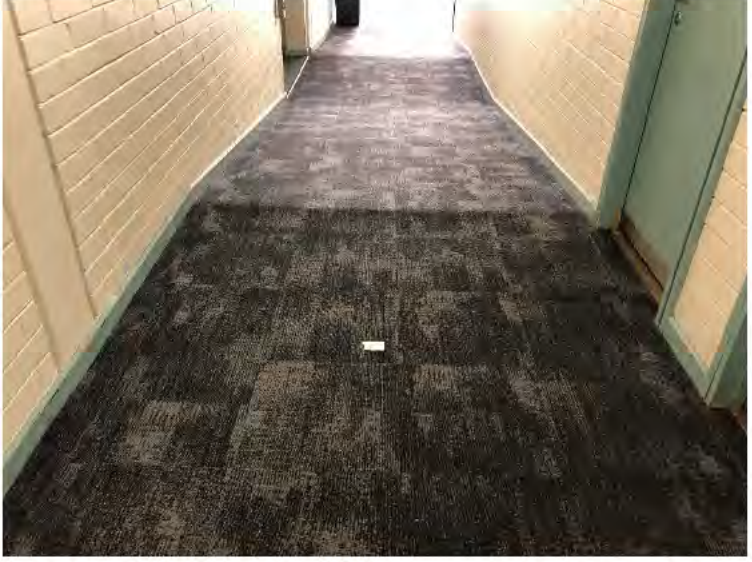
I3264	Corridor adjacent cafe (128) - On carpet	Debris

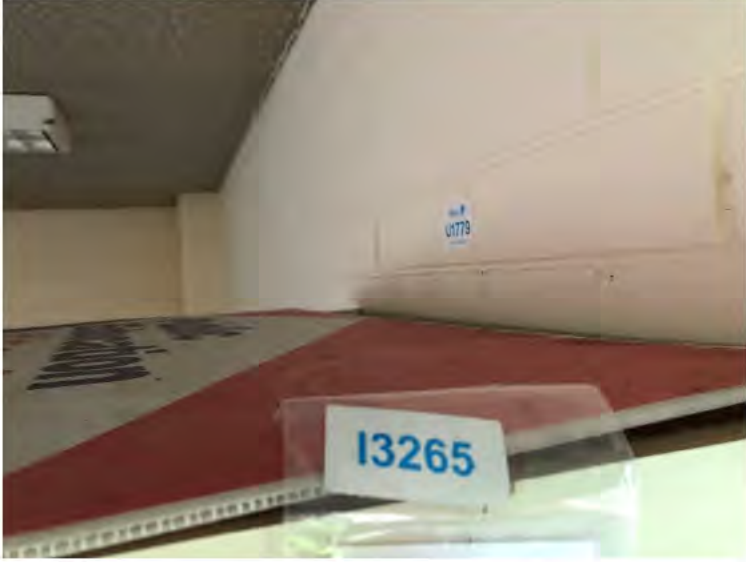
Sample Number	Location Description	Material	Photograph(s)
I3265	Staff room (098) - On top of fridge cupboard	Debris

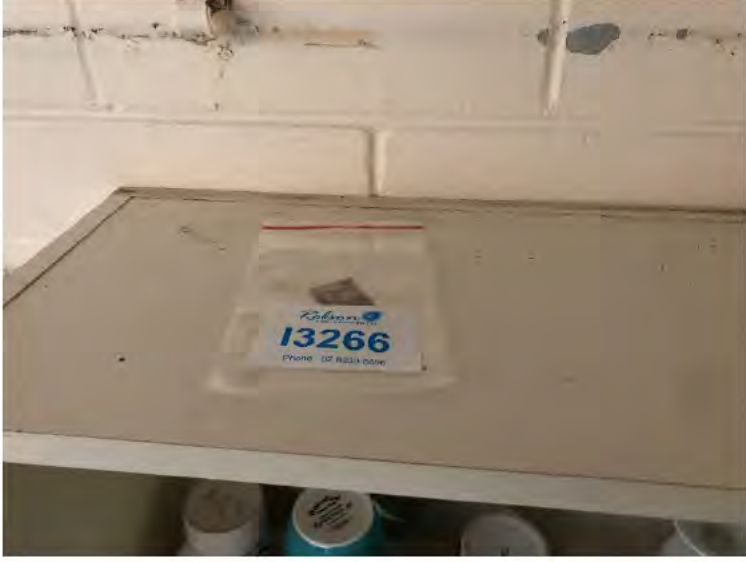
I3266	Staff room (098) - On cupboard above sink and light switch	Debris

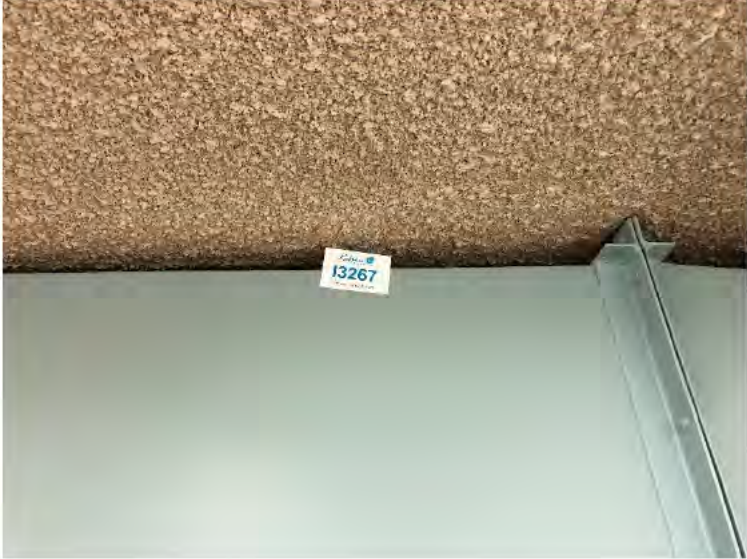
Sample Number	Location Description	Material	Photograph(s)
I3267	Meeting room 7.M.1 (030) - On top of ductwork	Spray coating debris

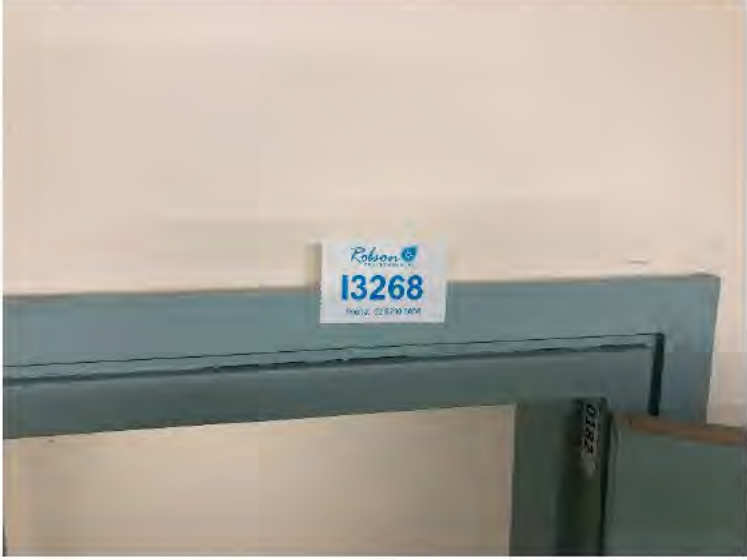
I3268	Meeting room 7.M.1 (030) - On top of door frame	Debris

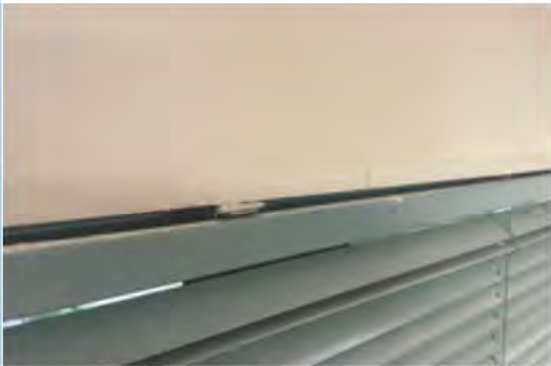
Asbestos detected				Presumed to contain asbestos			No asbestos detected	
LOCATION	MATERIAL	SAMPLE ID	Approx Qty m ²	TYPE & CONDITION	RISK OF EXPOSURE	RESULT	RECOMMENDATIONS	PHOTO
Dust to top of blinds in room 7.4	Dust	A1	-	N/A	N/A	No Asbestos Detected	No further action required

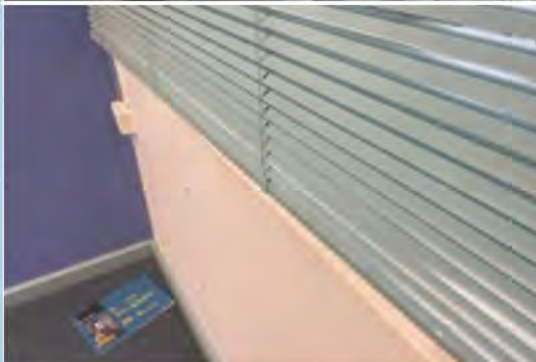
Dust on blinds left side of room 7.4	Dust	A2	-	N/A	N/A	No Asbestos Detected	No further action required

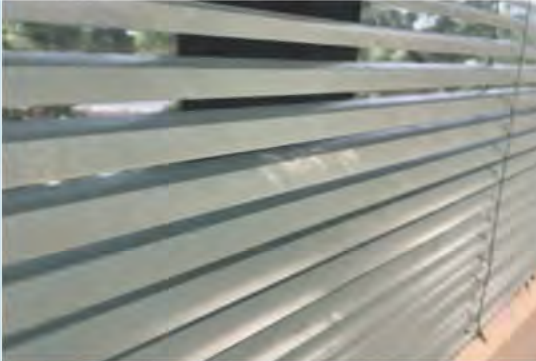
Asbestos detected				Presumed to contain asbestos			No asbestos detected	
LOCATION	MATERIAL	SAMPLE ID	Approx Qty m ²	TYPE & CONDITION	RISK OF EXPOSURE	RESULT	RECOMMENDATIONS	PHOTO
Dust on blinds middle of room 7.4	Dust	A3	-	N/A	N/A	No Asbestos Detected	No further action required

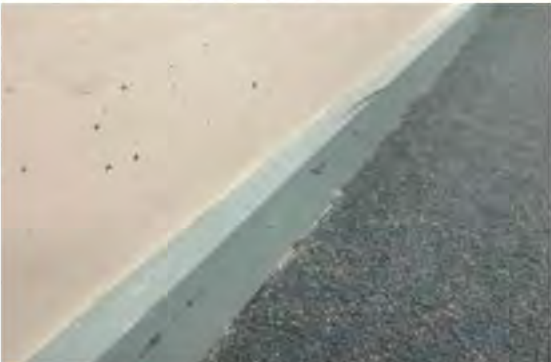
Dust on skirting boards room 7.4	Dust	A4	-	N/A	N/A	No Asbestos Detected	No further action required

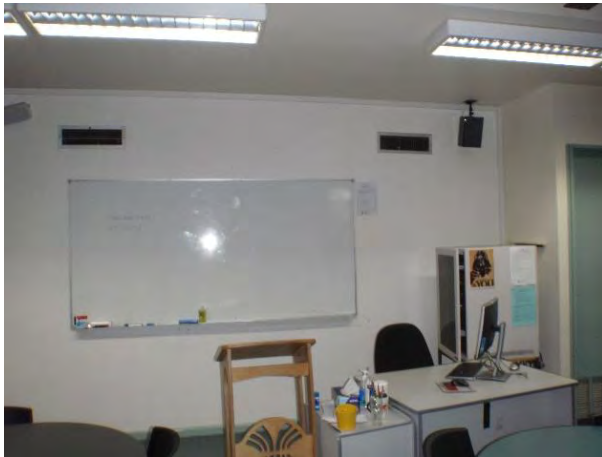
Figure 13 – L3131 – Stud wall

L3127	Textiles 3.1 – masonry wall	-	White	Sound	<0.005	No		-	
L3128	Graphics 3.4 – masonry wall	Appendix 2 Figure 10	White	Sound	<0.005	No		-	
L3129	Art Photography Ceramics 3.7 (173) – masonry wall	Appendix 2 Figure 11	White	Sound	<0.005	No		-	
L3130	Science Lecture Theatre (200) – masonry wall	Appendix 2 Figure 2	White	Sound	<0.005	No		-	
L3131	Makers Space 7.13 (031) – stud wall	Appendix 2 Figure 13	White	Sound	0.059	No		-
